Chapter 2 Aircraft accident and serious incident investigations

1. Aircraft accidents and serious incidents to be investigated

3. Statistics of investigations of aircraft accidents and serious incidents

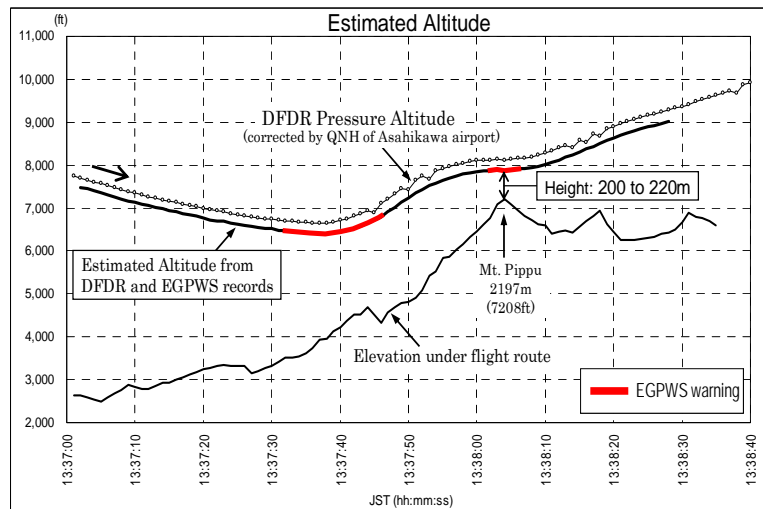
Estimated Flying Altitude

Probable causes: It is highly probable that this serious incident occurred because the aircraft experienced a ground proximity and its flight crew took an emergency maneuver responding to its EGPWS*1 warnings during its descent toward its destination aerodrome, Asahikawa Airport, under the ATC instructions.
