Chapter 1 Summary of Recommendations and Opinions Issued in 2015

Aircraft Serious Incident Involving a Bombardier CL-600-2B19 Registered JA206J, Operated by J-AIR Corporation

Opinions on the improvement of safety of the freight train operation

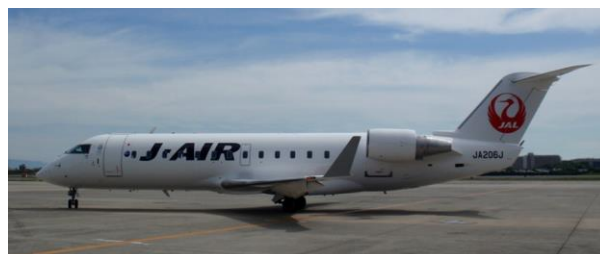
It is highly probable that the cause of this serious incident was that the coupling nut connecting the right engine fuel manifold (fuel supply piping) and fuel injector (fuel injection nozzle) No. 14 was loose, fuel leaked from this area and was ignited by the heat of the engine, which resulted in fire within the engine fire-prevention area.

Although it is somewhat likely that the reason why the coupling nut was loose was the insufficient tightening force of the coupling nut, resulting in gradually loosening caused by factors such as engine vibration, the Japan Transport Safety Board couldn't determine the cause of the loosening.

When conducting engine overhauls, reconfirm that the system ensures that important work for safety is surely carried out, including the tightening of the coupling nuts connecting the injector and manifold.

Enhance education and training involving important system functions for safety and reconsider the contents of training in response to an outbreak of fires.
