## Chapter 5 Marine accident and incident investigations

## 5 Statistics of investigations of marine accidents and incidents (As of end of February 2018)

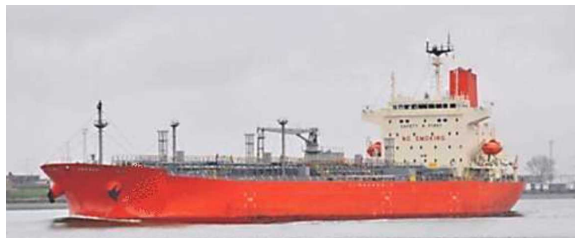
Report	<a href="http://www.mlit.go.jp/jtsb/eng-mar_report/2017/2016tk0009e.pdf">http://www.mlit.go.jp/jtsb/eng-mar_report/2017/2016tk0009e.pdf</a>	
11	Date of Publication	Date and location	Vessel type and name, accident type
	October 26, 2017	September 9, 2016 Off to the south of Gobo City, Wakayama Prefecture	Oil/Chemical tanker EIWA MARU 3 Explosion
	Summary	<p>While the tanker was sailing southeast off to the south of Gobo City, Wakayama Prefecture for Yokkaichi Port, Yokkaichi City, Mie Prefecture, with a master and other nine crew members onboard, after unloading base oil, which is a base material of lubricants and other products, at Wakayama Shimotsu Port, Wakayama Prefecture, and with her crew cleaning her cargo tanks, an explosion occurred in her cargo tanks.</p> <p>One crew member of the tanker was killed and two crew members suffered serious injuries. The tops and bulkheads of the vessel's No. 2 and No. 3 cargo tanks were bent.</p>

<p><b>Probable Causes</b></p>	<p>It is probable that the accident occurred when, as the Vessel was proceeding southeast off to the south of Gobo City while conducting cleaning of the cargo tanks at night after unloading base oil in her No. 1 and No. 3 cargo tanks at Wakayama Shimotsu Port and leaving port, explosions occurred when, under conditions in which the tanker began cleaning the cargo tanks using seawater with Butterworth cleaning machines and the cargo pumps and, in the course of the cleaning, base oil that remained in No. 2 cargo pump, bottoms of the No. 1 and No. 3 cargo tanks, and cargo-handling piping for the tanks was sprayed in the No. 3 cargo tank and became airborne up to the starboard No. 3 cargo tank ventilation duct, base oil in the duct and starboard No. 3 cargo tank vaporized and ignited because the chief engineer conducted welding on the starboard No. 3 cargo tank ventilation duct.</p> <p>It is somewhat likely that the chief engineer conducted the welding of the starboard No. 3 cargo tank ventilation duct as cleaning work was being done in tanks that had carried base oil with a high flash point because he thought there was no danger because the welded area was small and welding ted quickly. It is probable that not flushing the cargo tanks, etc., prior to cleaning of the cargo tanks contributed to the circumstances in which base oil was sprayed in the No. 3 cargo tank and became airborne up to the starboard No. 3 cargo tank ventilation duct.</p> <div style="text-align: center;"> <p>(Looking forward from the back of starboard No. 3 tank) (Looking forward from the front of starboard No. 3 tank)</p> <p>Note: The (1) to (5) appearing in the photos correspond to items 2.3 (1) to (5).</p> </div> <div style="text-align: center;"> </div>

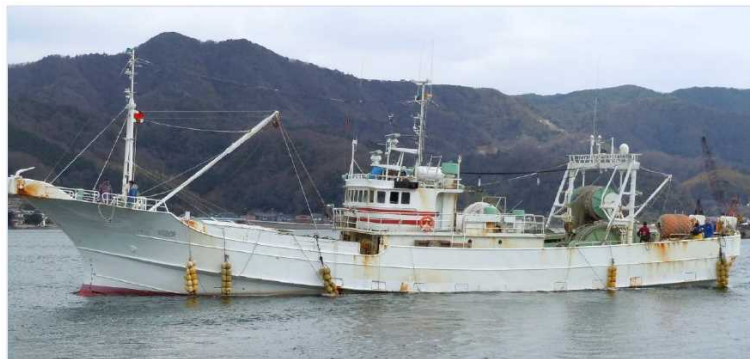
DAIFUKU MARU

Fishing vessel DAIFUKU MARU, with its skipper and eight crew members onboard, developed engine failure while sailing toward Sakaiminato, Tottori Prefecture. While being towed by a consort ship, it capsized and sank some 1,600 km north of the Mihonoseki lighthouse in Matsue

Of the nine crew members onboard DAIFUKU MARU, four died and five went missing.

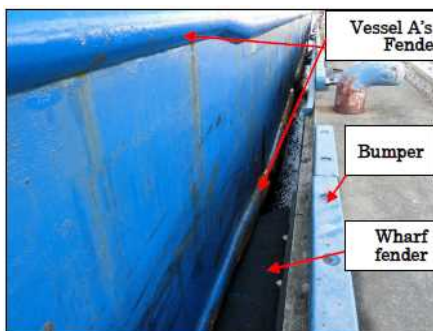
It is probable that Vessel A rolled and inclined approximately 7° to the starboard side at the time of the accident when the underside of the hull fender on Vessel A's starboard midship hull came off the tops of the wharf fenders when the Pipes were hoisted by the No. 1 crane and then stopped under conditions where the underside of the hull fender was caught on the tops of the wharf fenders and Vessel A's starboard inclination was arrested because, among other reasons, the height of tide had fallen compared to that at the time of docking and the vessel's draft had increased.

**Probable Causes (excerpt):** It is probable that the accident occurred when the Pipes which had been hoisted and then stopped by the No. 1 crane swung to the starboard side, and as a result, two stevedores and one lashing worker, who had been standing by and doing other activities on top of the cargoes that had been stowed on the starboard side, were caught between the Pipes and starboard wall, as Vessel A was being loaded with cargo starboard-side alongside at Shinko East Quay T Wharf, Kobe Section, Hanshin Port.

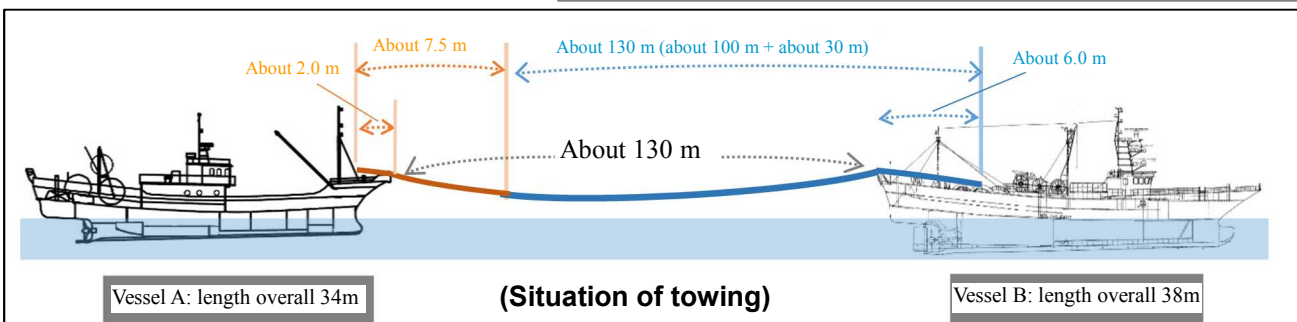
**(Situation of capsizing)**

- It is probable that the stability of Vessel A was reduced due to addition of structural objects, etc. to it and water tanks on its deck and the freeboard of the ship also decreased.
- Vessel A was exposed to the risk of a sudden increase in heeling moment because the towing rope was not long enough. It is somewhat likely that the heeling moment increased due to the.
- It is probable that the angle of the heel of Vessel A became larger than the bulwark submerge angle due to a combination of Vessel A's steady heel caused by wind, rolling motions caused by waves and Vessel A's heeling energy caused by the tension on the towing rope.
- While Vessel A's angle of heel exceeded the bulwark submerge angle and the righting lever became smaller, it is somewhat likely that continuous waves capsized Vessel A with the bulwark acting as resistance to stability.

**Probable Causes (excerpt):** It is somewhat likely that the accident occurred as follows: The main engine of Vessel A stopped at night when the ship's stability was reduced and its freeboard decreased. While being towed southeast by Vessel B north of the Mihonoseki lighthouse, Vessel A became almost unable to regain stability as the angle of the heel exceeded the bulwark submerge angle and capsized by continuous waves.

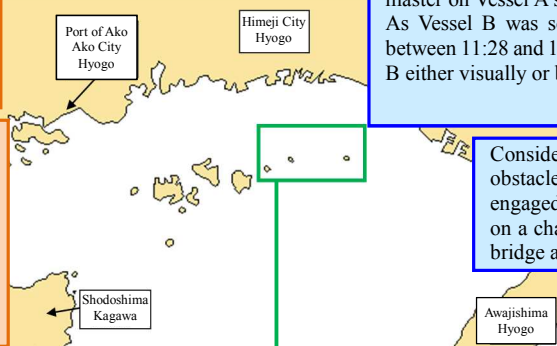
(Diagrammatic illustration of accident site)

As Vessel A did not change its course and showed no signs of giving way to Vessel B, the officer turned Vessel B to starboard when Vessel A came to a distance of 200-300m, decreased the number of the main engine's rotations and sounded the electronic horn again.

Vessel A was sailing in automatic steering mode, with the master on Vessel A serving as the sole bridge watchkeeper. As Vessel B was southwest of Kurakake Island roughly between 11:28 and 11:31, the master could not detect Vessel B either visually or by radar.

Considering that there was no ship ahead as an obstacle to Vessel A's sailing, the master engaged in such work as filling in a document on a chart table in the rear part of the portside bridge and did not maintain a lookout.

**Probable Causes (excerpt):** It is probable that the accident occurred as follows: Vessel A was sailing southwest off the east coast of Kurakake Island while Vessel B was traveling southeast. The master on Vessel A did not notice Vessel B early enough as he engaged in such work as filling in a document and did not maintain a lookout, considering that there was no ship ahead as an obstacle. At the same time, the navigation officer on Vessel B noticed Vessel A on Vessel B's portside bow but thought Vessel A would eventually give way. Although the officer sounded a whistle signal, he did not take actions to avoid the collision in time.
