Feature 2: 10th anniversary of Japan Transport Safety Board — Future Direction of Priority Activities

Direction of Our Focused Commitments with an Eye toward the Next 10 Years

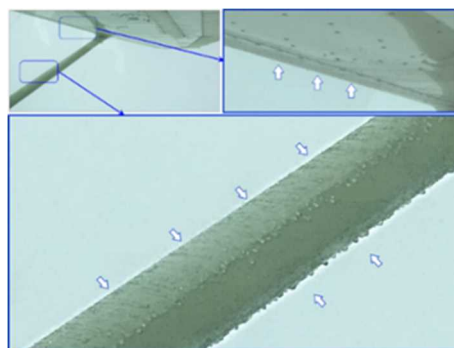
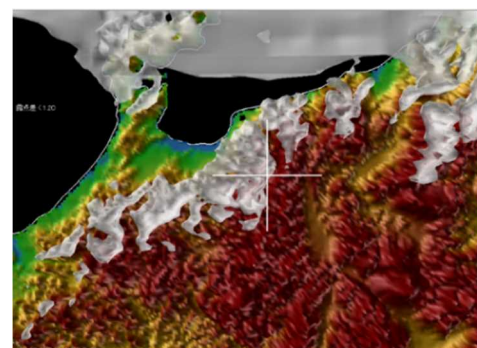
For this crash accident, photos recorded in the smartphone of a person on board the same aircraft

revealed that the aircraft was flying in clouds at that time and that the pilot did not wear a harness. In addition, analysis of photo data indicated that icing had been observed on the aircraft which destabilized the flight.

Center to conduct numerical analysis, using a supercomputer, based on the numerical prediction model provided by the Meteorological Agency in order to visualize at high resolution the wind conditions and cloud amount at that time around the Tateyama mountain range. These analyses revealed that aircraft had flown in clouds, which had caused ice to form on a wing, resulting in significant degradation in flight performance.

Based on these findings, the board made recommendations to the Minister of Land, Infrastructure and Transport, requiring safety measures that prohibit light aircraft or the like incapable of in-cloud flight from flying into clouds.

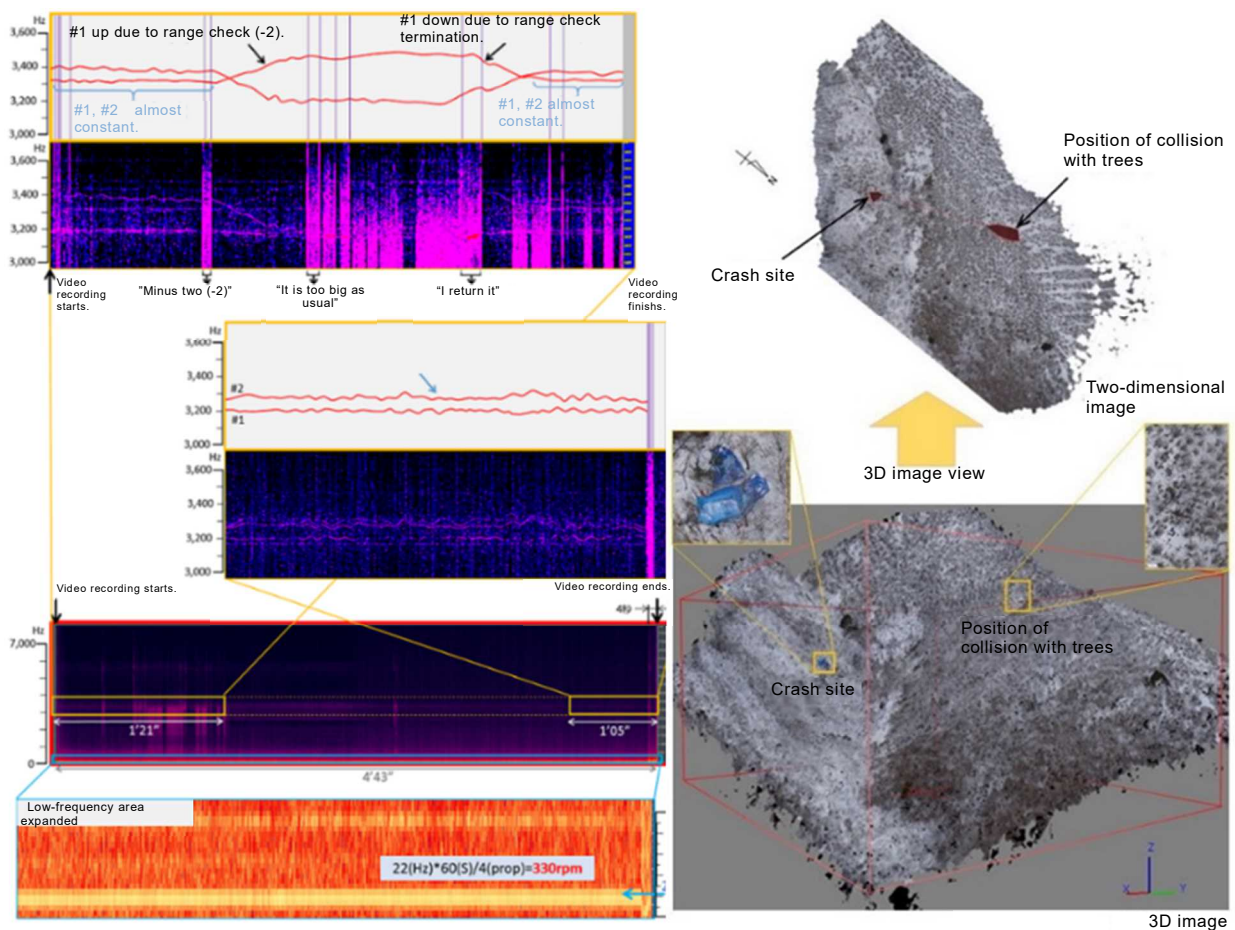
For this crash accident, we analyzed video data recorded in a video camera attached to the helmet of a person on board the same helicopter to estimate the flight path, speed, and altitude of the aircraft. We also analyzed the acoustic data in the video camera to estimate the conditions of the engine operation and part of the conversation between the persons on board.

These analyses revealed that there had been nothing wrong with the aircraft until it collided with a

tree; that it was operated by one pilot; that the pilot had not stated his conditions correctly when applying for aviation medical certification; and that none of those on board had responded to the coming danger.

With these facts, the Fire and Disaster Management Agency decided to require fire-fighting disaster-relief helicopters to be crewed by two pilots and is trying to enhance the safety management system, training programs, and so on. In addition, the board required the Minister of Land, Infrastructure and Transport to instruct aircraft crews to report their health conditions correctly.

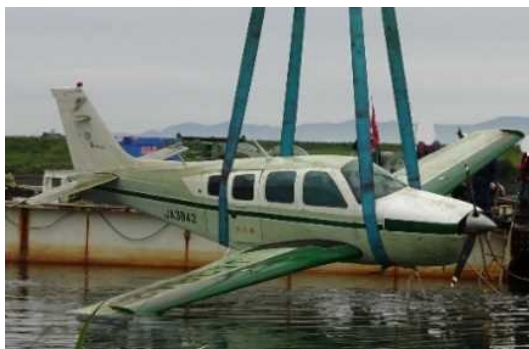
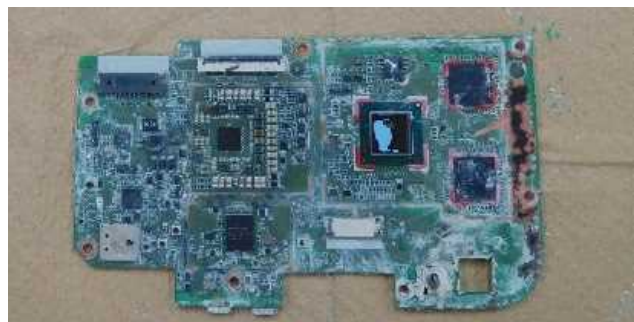
In this serious incident, an aircraft continued to fly using the fuel in only one fuel tank without switching between the fuel tanks provided on both of the right and left sides, which caused a fuel shortage and a subsequent engine stop, resulting in a forced landing and ditched in the river and the submersion of the aircraft.

The JTSB took out the GPS receiver and drive recorder from the aircraft and retrieved recorded electronic data in an intact state from the submerged disabled devices (for information about the retrieval of data from damaged electronic devices, see Page 127). We analyzed the electronic data and determined the flight conditions and the problem with the engine of the aircraft to track down the cause.

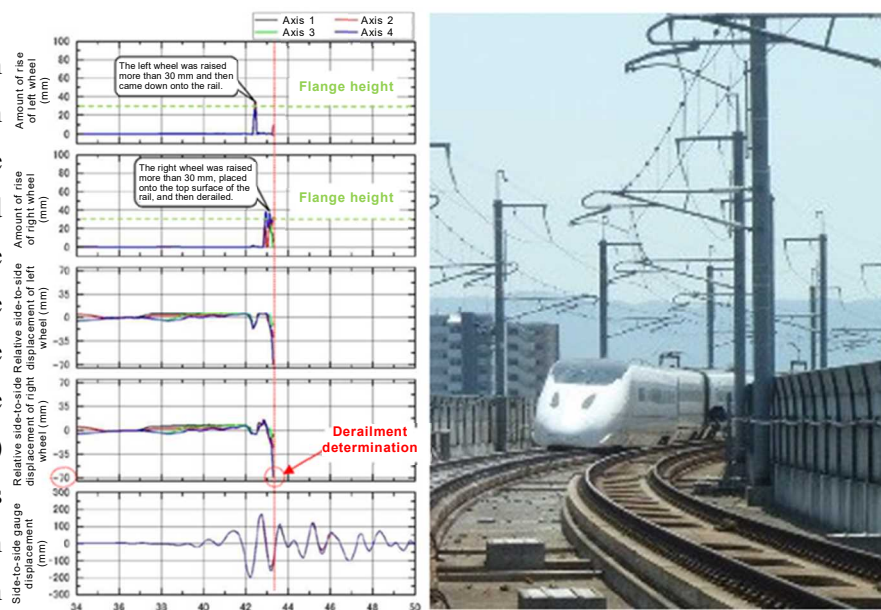
For this derailment accident, we decided to use a simulation to identify the cause of the derailment by reproducing the conditions of the rail cars derailed by the seismic vibration. In addition, to validate the execution conditions and results for each stage of the simulation, we appointed expert board members with knowledge about special fields (earthquake, structure, and rail car) to enhance the analytical system and asked the Railway Technical Research Institute for cooperation.

In the simulation, based on the seismic vibration observed when the earthquake occurred and the conditions of the ground, we estimated the earthquake wave immediately below the structure (elevated bridge) where the train was derailed and even estimated the vibration on the elevated bridge to analyze the behavior of the rail cars.

Based on these analysis results, the board requested in the accident investigation report further promotion of measures against derailment and deviation as preventive measures. The railway operators that run shinkansen are conducting studies to promote measures against earthquakes with preventive measures taken into account.

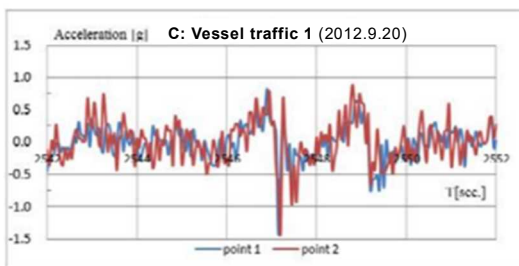
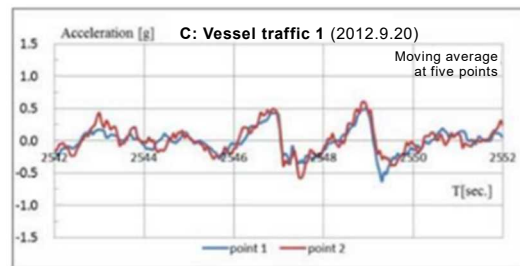
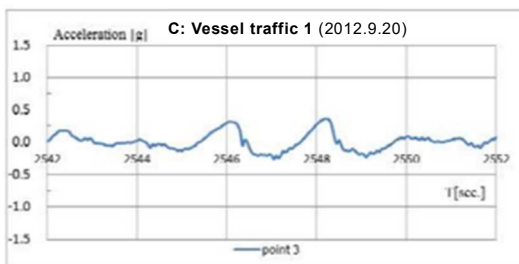
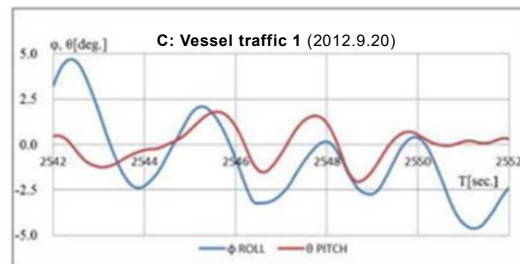
All of the passengers injured in this accident were seated in seats in the front part of the front cabin; they suffered lower-back injuries because of the impact they received when they were lifted by the shake and then dropped. For this reason, we measured and estimated the up and down accelerations at their seating positions. In addition, we compared the up and down accelerations at the various points between the two boats to evaluate the risk of lumbar fracture and reviewed accident prevention measures (safety of seats, seat belts, and others).

(a) Up and down accelerations at Points 1 and 2

(b) Up and down accelerations at Points 1 and 2 (smoothed)

(c) Up and down accelerations at Point 3

(d) Rolling ϕ and Pitching θ at Point 3

Based on these analyses, we presented preventive measures, such as guiding passengers to seats in the rear part of the vessel, ensuring proper usage of seat belts, and cushioning seats.

Under the situation, we made recommendations to the Minister of Land, Infrastructure and Transport, requiring the minister to ensure, for example, that small high-speed vessel operators

follow the manual for safe operation in stormy weather; that passengers are guided to seats in the rear of the vessel, which are less affected by shakes, and that passengers properly use seat belts.

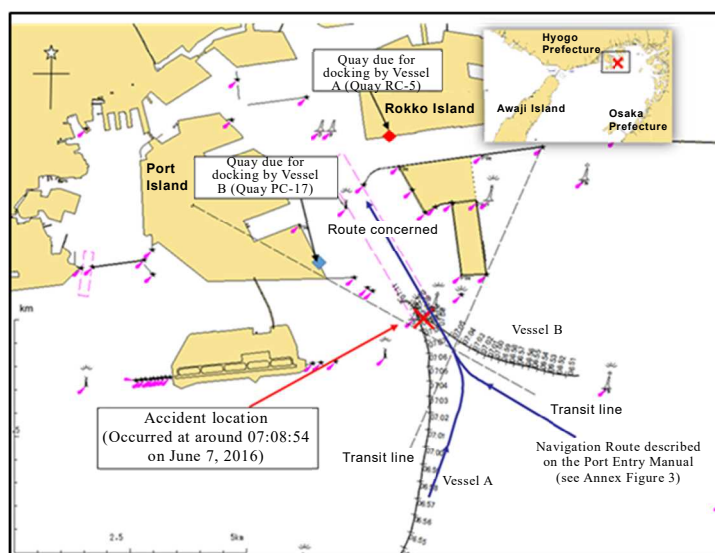
Location of Accident Occurrence and Navigation Route

For this collision accident, the collision risk was evaluated based on the AIS data of both vessels, which quantitatively indicated that the vessels had been in a dangerous state.

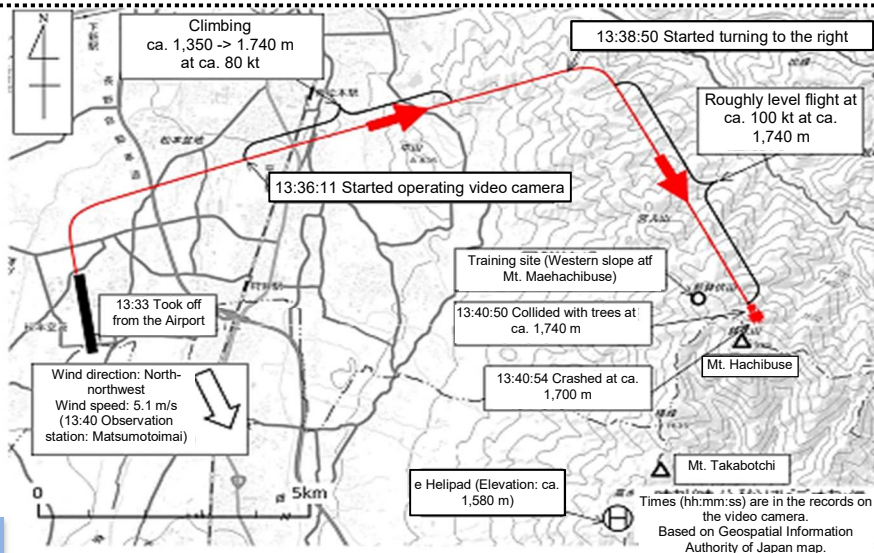
Estimated flight route

- It is highly probable that the helicopter did not take either the avoidance route at a constant altitude by directly heading for the destination or the avoidance route by climbing, and that the helicopter continued to fly toward Mt. Hachibuse at a constant altitude until it approached the ground.

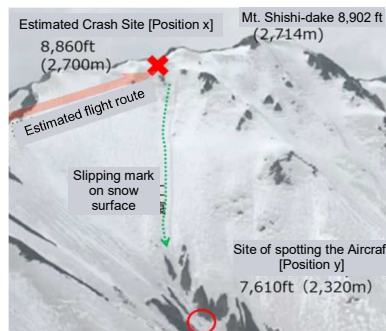
Flight situation of the aircraft after deciding on turning back (Point d in the estimated flight route map)

- It is likely that because the aircraft went into in-cloud flight and the pilots also noticed ice build-up on the aircraft, they tried to go back. (It is somewhat likely that the flight performance deteriorated extremely due to ice build-up and the aircraft became unable to maintain its altitude.)
- It is probable that the aircraft was flying while looking for clouds rifts.
- It is probable that it became difficult for the pilot to grasp its own position and surroundings, causing the Aircraft to crash into the mountain surface near the top of Mt. Shishi-dake

Probable Cause: It is probable that as the Aircraft got into clouds during VFR flight over the mountain region, it became difficult for the PIC and the Pilot to grasp its own position and surroundings by confirming visually the terrain, then, the Aircraft approached the vicinity of the mountaintop and crashed into it.

It is somewhat likely that the Aircraft approached the vicinity of the mountaintop and crashed into it due to loss of visual contacts making the crash unavoidable, or due to failure to maintain minimum safe altitude caused by the Aircraft icing or stalled condition, or due to encountering a severe turbulence. However, it could not be determined, since the PIC and all members on board suffered fatal injuries .

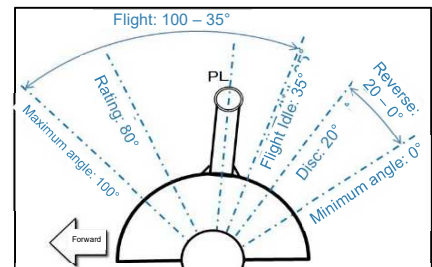
Figure 2. PLA

(Failure to obtain sufficient braking force required for deceleration because the PL was not set to the Disc position during the time from touchdown to stop of the aircraft)

- It is probable that the PIC mistook the PL position during the time from touchdown to stopping of the aircraft and did not check it in the meantime.
- It is probable that the co-pilot did not realize that the intentions of the captain differed from his own.

Probable Cause (excerpt): In this serious incident, it is highly probable that the aircraft overran the runway because the aircraft could not obtain the braking force due to the delay of braking operation start by the PIC and PL (Power Lever) was not set at the Disc position. Moreover, it is somewhat likely that the bad conditions with snow fall around the end of the runway and the overrunning zone contributed to the aircraft overrunning.

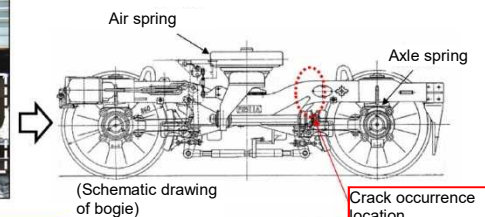
It is probable that, before the derailment, the crack already extended from the bottom plate to around the upper part of the side surface of the side beam in the right side of the bogie, and that the wheel load of the front axle right wheel of the bogie was decreasing, causing wheel load unbalance exceeding the control value.

It is probable that, because in this state the 5th vehicle entered the left curving track of 178 m radius, the lateral force of the front axle right wheel of the bogie in question increased, causing the wheels to climb up the right rail of the curve.

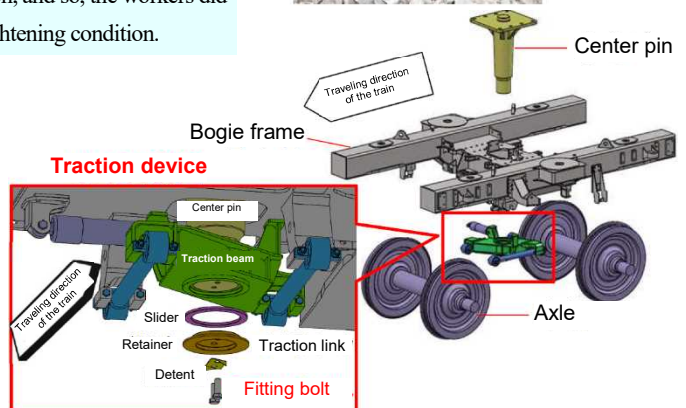
Traction device (damaged)

Probable Causes (excerpt): It is probable that the accident occurred as all axles, i.e., the 5th and 6th axles, in the rear bogie in the 1st vehicle, i.e., the locomotive, of the freight train derailed because the traction device had hung down due to the removal of two fitting bolts fastening the center pin and the traction device in the rear bogie during running operation, following the process described in below.

- (1) The left traction link broke when the traction device hit the left guard rail in the Iriechou level crossing.
- (2) The wheels in all axles, i.e., the 5th and 6th axles, in the rear bogie derailed to right due to the lateral force in right direction acted on the traction device, as the traction device, hanging more after broken, hit the lead rail of the turnout in the premises of Kita-Irie signal station.

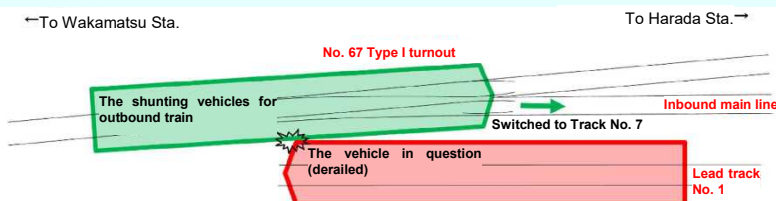
Based on the above, it is probable that the shunting vehicles collided with the car stop and derailed due to the impact.

It is somewhat likely that, although the driver noticed that the shunting vehicle derailed, he did not recognize the need to take train protection measures because the driver did not feel a large impact when the train collided with the car stop, and so the driver thought that the derailment was not significant and that the situation was not so serious as that the train could disturb the adjacent main line in the up track.

* Concerning the outbound deadhead train, the figure above shows only the first vehicle to describe the contact situation.

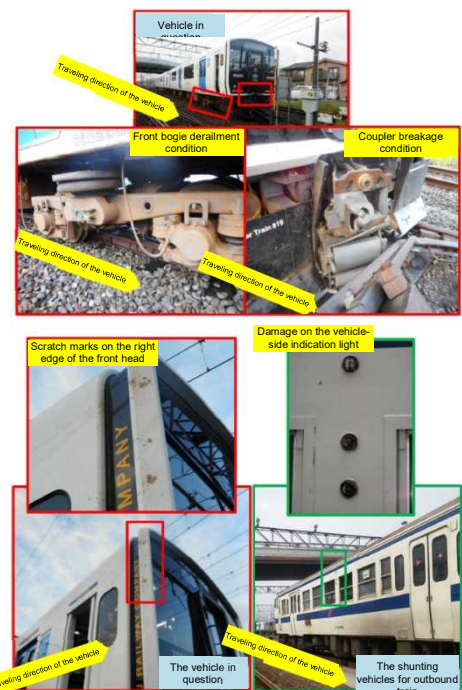
As the measures such as train protection etc., accompanied with disturbing main line in the up track had not been implemented, the inbound Electric 6520H train and the shunting vehicles for outbound Deadhead Diesel 1533D train were passing through the disturbed track, and the car side pilot lamp of the shunting vehicle of the outbound Deadhead Diesel 1533D train contacted with the right edge of the front head of the shunting vehicle of the inbound Electric 6620M train and both vehicles were damaged.

It is somewhat likely that the shunting vehicle in question hit another shunting vehicle because the other shunting vehicle had, among others, a larger displacement amount during curve passing than up-trains and also had a large maximum width.

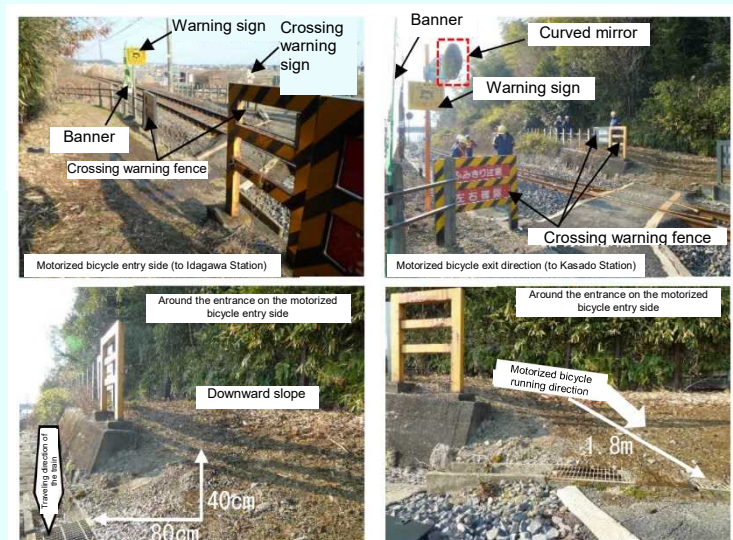
It is probable that, although the driver of the train applied the emergency brake, braking could not prevent the collision because the motorized bicycle entered the crossing only 1 to 2 seconds before the collision.

Concerning the visibility during passing of the inbound train, the front marker light of the train would start to be seen on the curved mirror only about 7 seconds before the train reached the crossing. If directly seen with the eyes, the train would start to be seen about 2.5 seconds before the train reached the crossing, due to the land features, etc. Based on the above, it is considered that this crossing is in a state where one will find it difficult to secure enough time from when one notices that a train is coming until when the train arrives.

Probable Causes: It is probable that the accident occurred as the train collided with the motorized bicycle at Bozuyama level crossing, class 4 level crossing without automatic barrier machine nor road warning device, because the motorized vehicle had entered the level crossing in the situation that the train was approaching.

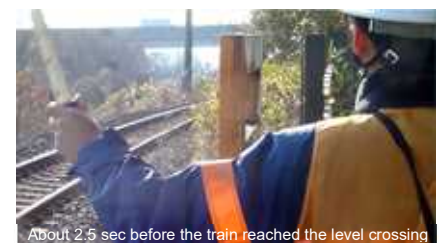
It could not be determined the reason why the motorized bicycle had entered the level crossing in the situation that the train was approaching, because the driver of the motorized bicycle was dead in the accident.

Class 4 level crossings without automatic barrier machines nor road warning devices should be abolished or be provided with crossing security equipment. Concerned parties, such as railway business operators, road administrators (local governments) and local residents, should actively hold talks for that purpose to determine a policy as soon as possible and proceed with concrete efforts. However, there are cases where the talks take long time, during which another accident may occur. JTSB will work to provide information useful to eliminate class 4 level crossings as early as possible, by investigating and analyzing concrete cases associated with the elimination of class 4 level crossings, including providing nearby class 1 level crossings with a sidewalk to improve safety of pedestrians, and abolishing dangerous class 4 level crossings.

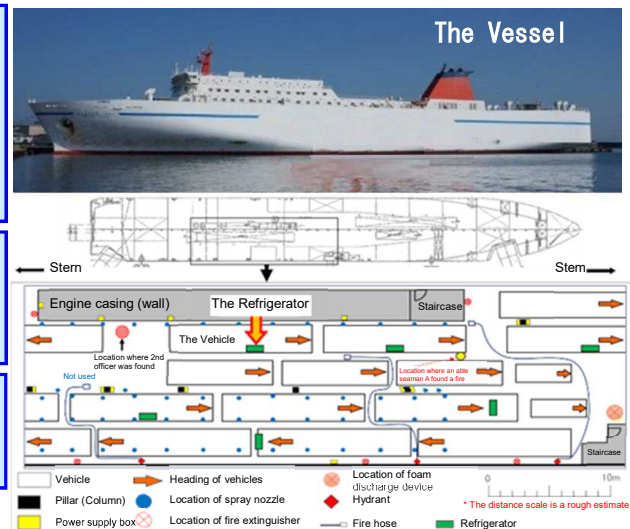
Situation on the 2nd deck when the Accident occurred)

At around 17:10 on the bridge, a fire detection device with a location identification function issued a preliminary fire alarm which changed to a fire alarm around 17:13. The crew found that the vicinity of the in-vehicle refrigerating unit (the Refrigerator) on a track (the Vehicle) loaded in the center of the starboard side to the engine casing in the starboard midship on the 2nd deck was glowing orange and a fire spread to the bridge.

The crew tried to extinguish the fire on the 2nd deck with fire extinguishers but were unsuccessful. The fire spread to vehicles loaded adjacent to the starboard of the vessel and the force of the fire increased to spread to the 3rd deck.

The Chief Officer abandoned continuation of firefighting efforts and ordered crew members engaged in firefighting to leave the site, but could not find the 2nd Officer.

Order to leave ship (around 18:30), 2nd Officer died

- It is probable that the fire could not be extinguished because the origin of the fire was inside the cover of the Refrigerator and the crew could not effectively discharge fire-extinguishing agent to the origin of the fire when the fire was found. It is also probable that the fire had spread to the left side of the Vehicle while some crew were fighting the fire with 16 fire extinguishers without using fire hoses while wearing fireman outfits.
- It is probable that fire extinguishing and prevention of the spread of fire from the Vehicle to the adjacent vehicles by spraying water were not possible because the crew did not take systematic fire-fighting activities and because they did not know enough about the usage of water spray devices to spray the 5 sections that exceeded the capacity of the pressurized water spray pump.

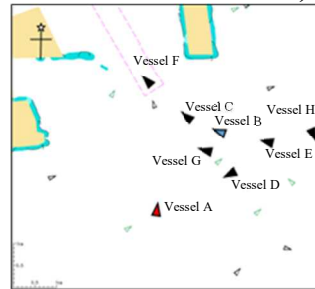
(Situation at around 07:00)

On the Vessel B, Master B and Officer B were keeping lookout by eyesight and radar, and first noticed Vessel A by radar at around 06:50.

Master B thought that Vessel A would navigate astern of Vessel B because he had heard the communication "Follow Vessel B" between other vessels on VHF at around 07:00, and moreover because the distance to Vessel C which was navigating ahead of Vessel B was about 0.3M, and he therefore thought that it would be dangerous for Vessel A to pass between Vessel B and Vessel C.

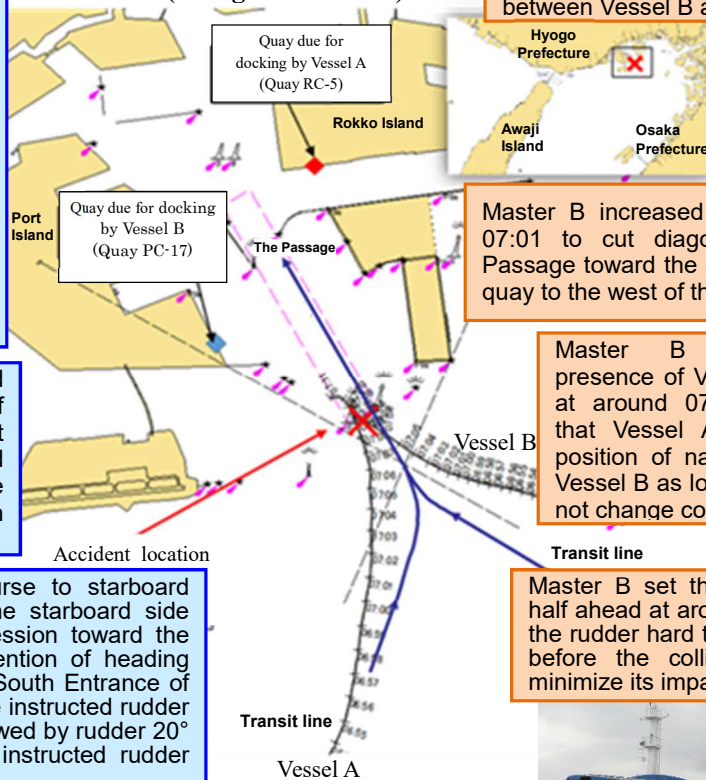
(Navigation Routes)

Pilot A thought that Vessel A would be given priority when entering the Passage because (1) Vessel A is a large vessel in the 400m class and (2) he had made a request for the order of Passage entry via Port Radio, and (3) Vessel D accepted this and decided on entering the Passage after Vessel A, he set the main engine to slow ahead at around 07:01 in order to enter the Passage at the scheduled time.

Master B increased speed at around 07:01 to cut diagonally across the Passage toward the scheduled docking quay to the west of the Passage.

Master B confirmed the presence of Vessel A with radar at around 07:04, and thought that Vessel A would be in a position of navigating astern of Vessel B as long as Vessel A did not change course.

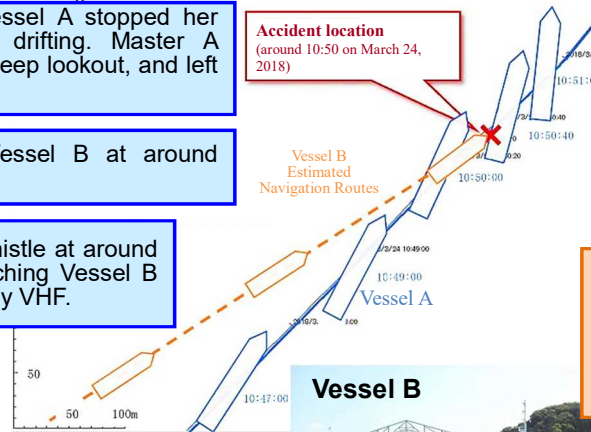
Vessel B Estimated Navigation Routes

Accident location (around 10:50 on March 24, 2018)

In Vessel B, Master B alone assumed lookout on the bridge and the vessel was sailing east-northeast at around 14kn with the auto pilot.

As there was good visibility, Master B set the radar to the stand-by condition and kept visual lookout.

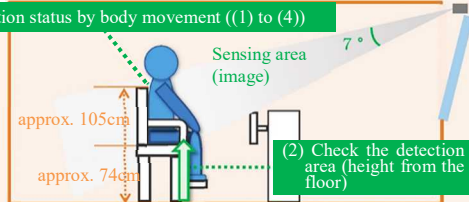
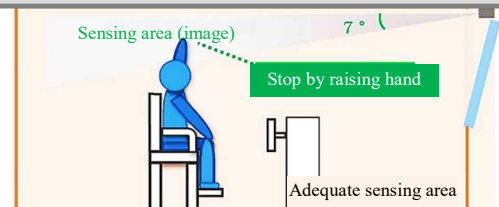
(1) Investigate the detection status by body movement ((1) to (4))

The watch alarm system of Vessel B was set as the alarm would be issued only if the sensor did not detect movement of the watchkeeper for 4 min. As the sensor was oriented to a position lower than the manufacturer recommended mounting location, it is probable that the alarm was not triggered because the sensor detected the movement of the body or leg of Master B.

- (1) If no movement, alarm triggered in around 4 min.
- (2) If the head moved, alarm triggered in around 4 min.
- (3) If the hand moved, alarm triggered in around 4 min.
- (4) If the leg moved, no alarm.

Recurrence prevention measures: Any vessel with a watch alarm system shall not put too much confidence in the system and shall try to avoid dozing off at the wheel and (a) keep the system active at all times while sailing, (b-1) check its operating condition extensively at departure, (b-2) adjust sensor mounting angle adequately and (b-3) set the quiescent time to as short a time as possible (3 to 5 min).

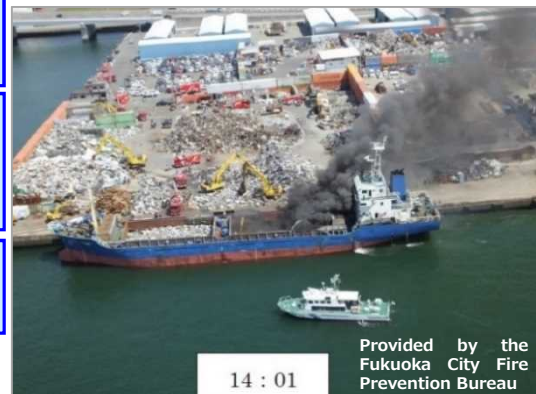
Circumstances of the fire of the vessel

It is somewhat likely that a spark created by contact between metal objects, a battery, etc., in the scrap was the source of the fire, and that the source ignited insulation material, plastic, rubber, vinyl, wood chips, pieces of paper, or combustible material mixed in the scrap.

- It is probable that the insulation material and other combustible items with low specific gravity floated in a burning state even when the water level in the cargo holds rose due to the continuous spraying of water and continued to burn on the water's surface.

- It is probable that the effect of water accumulated in the cargo holds led to the Vessel's foundering from her port bow side because no damage that could cause flooding had occurred.

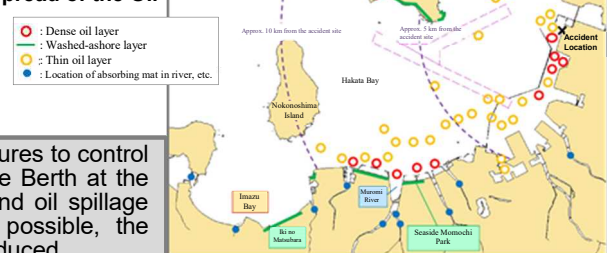
The Spread of the Oil

It is somewhat likely that had the readiness to implement measures to control oil, such as deploying oil fences and other equipment near the Berth at the time that the possibility the Vessel would founder emerged and oil spillage was anticipated been developed to the maximum degree possible, the amount of damage caused by spreading oil could have been reduced.
