## Chapter 4 Railway accident and serious incident investigations

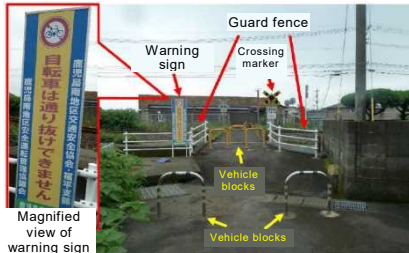
Probable Causes	<p>It is highly probable that the accident occurred as the train collided with a pedestrian entering the level crossing while the train was approaching Mukaihara No.2 level crossing, which is a class 4 level crossing without an automatic barrier machine or road warning device setup at the level crossing.</p> <p>It was not possible to clarify the reason the pedestrian entered the level crossing while the train was approaching because the pedestrian died in the accident.</p>

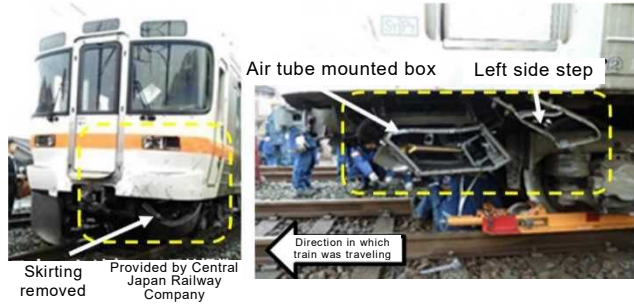
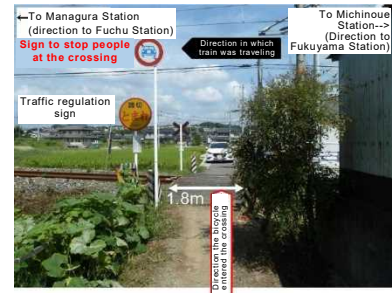
Probable Causes	<p>It is highly probable that the accident occurred as the train collided with the motorized bicycle at Iwasakinoichi level crossing, class 4 level crossing without automatic barrier</p>

<p>machine nor road warning device, because the motorized bicycle had entered the level crossing in the situation that the train was approaching.</p> <p>It is probable that the driver of the motorized bicycle had not come to a stop just in front of the level crossing and had entered the level crossing in the situation that the train was approaching, without confirming the approaching train well. However, it could not be determined the reason why the motorized bicycle had entered the level crossing, because the driver of the motorized bicycle was dead in the accident.</p>		
	Report	<p><a href="http://www.mlit.go.jp/jtsb/railway/rep-acci/RA2018-3-1.pdf">http://www.mlit.go.jp/jtsb/railway/rep-acci/RA2018-3-1.pdf</a>  <a href="http://www.mlit.go.jp/jtsb/railway/p-pdf/RA2018-3-1-p.pdf">http://www.mlit.go.jp/jtsb/railway/p-pdf/RA2018-3-1-p.pdf</a> (Explanatory material)</p>		
9	Date of Publication	Date and accident type	Railway operator	Line section (location)

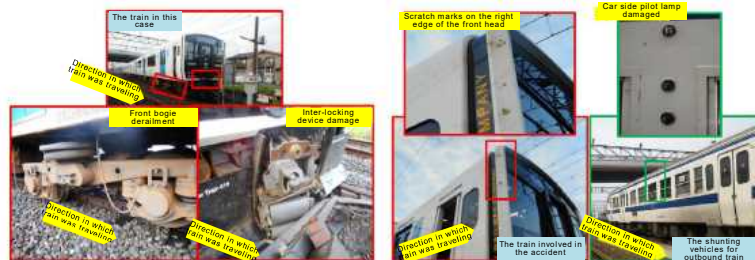
Probable Causes	<p>It is highly probable that the heavy property loss was induced in the railway facilities and the vehicles in the accident, as the vehicle collided with the car stop installed in the end edge of the track because the driver operating vehicles in shunting operation in the premises of Nogata station missed the timing of the braking operation, and the vehicle passing in the main line in the up track contacted with the vehicle derailed by the shock of the collision with the car stop and disturbed the main line in the up track.</p> <p>It is somewhat likely that the driver missed the timing of the braking operation related with temporary misunderstanding of the shunting route for the other vehicles as the route for his vehicles as he did not concentrate awareness to confirm safety of his route in the shunting operation.</p> <p>It is probable that the derailed vehicle contacted with the vehicle passing the main line in the up track in relation with that the procedure of train protection was not implemented promptly after the derailment had occurred.</p> <p>It is somewhat likely that the train protection procedure was not implemented promptly even though the derailed vehicle had disturbed the main line in the up track after the derailment, because the driver of the derailed vehicle had considered that the derailed vehicle was not in the situation as to disturb the neighboring main line in the up track as the deviation was not so large, although he had noticed the fact of the derailment.</p>

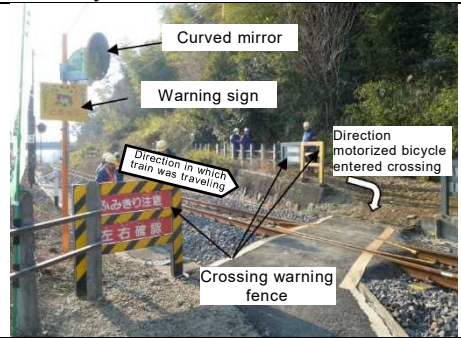
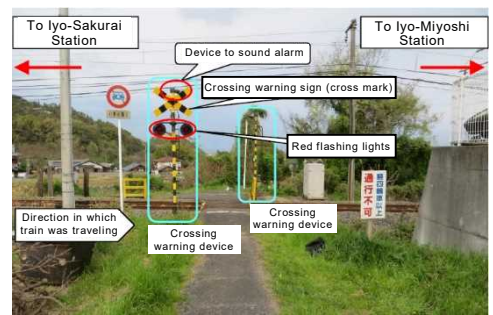
14	<b>Date of Publication</b>	<b>Date and accident type</b>	<b>Railway operator</b>	<b>Line section (location)</b>
	September 27, 2018	April 11, 2018 Level crossing accident	Shikoku Railway Company	Takabayashi level crossing, class 3 level crossing equipped with road warning device but without automatic barrier machine, between Iyo-Sakurai station and Iyo-Miyoshi station, Yosan Line, Saijo City, Ehime Prefecture
	<b>Summary</b>	<p>While the train was running at about 81 km/h between Iyo-Sakurai station and Iyo-Miyoshi station, the driver of the train noticed a public person lying down in Takabayashi level crossing, class 3 level crossing, then applied the emergency brake immediately, but the train hit the public person.</p> <p>The public person was dead in the accident.</p>		
	<b>Probable Causes</b>	<p>It is probable that the accident occurred as the train hit the public person at Takabayashi level crossing, class 3 level crossing equipped with road warning device, because the public person was lying down in the level crossing in the situation that the road warning device was operating according to the approaching train.</p> <p>It could not be determined the reason why the public person was lying down in the level crossing because the public person was dead in the accident.</p>

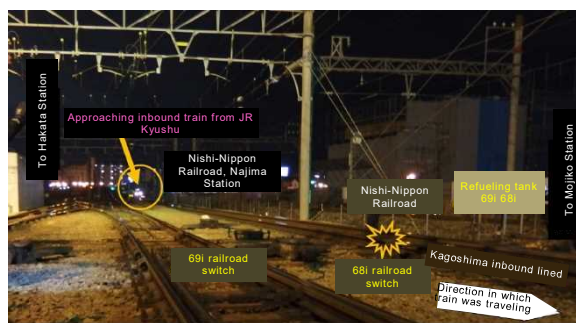
Publication	type		
October 25, 2018	December 16, 2017 Other accidents with casualties	Japan Freight Railway Company	In the premises of Chihaya yard, Kagoshima Line, Fukuoka City, Fukuoka Prefecture
Summary	<p>The company staff in charge of signal engaged in the work to ignite snow melting device for switches installed in the turnouts, contacted with the inbound 2352M train composed of 6 vehicles started from Kurume station bound for Kokura station of Kyushu Railway Company.</p> <p>On the other hand, the driver of the train applied the emergency brake to stop the train as he had noticed an abnormal sound. The driver checked the situation and found that the staff in charge of signal had been fallen down.</p> <p>The staff in charge of signal was dead in the accident.</p>		
Probable Causes	<p>It is highly probable that the accident occurred as the staff in charge of signal had entered the up track of Kagoshima Line where the train was running, when the staff in charge of signal and the switchman had been working to ignite the snow melting devices for switches, individually, without staff in charge of watching train.</p> <p>It is probable that the staffs were working to ignite snow melting devices individually without the watchman, as the training about safety for the company staffs in charge of the work had been insufficient, and their understanding about the importance of watching duties was poor.</p> <p>It could not be determined the reason why the staff in charge of signal had entered the up track of Kagoshima Line, because the staff in charge of signal was dead in the accident.</p>

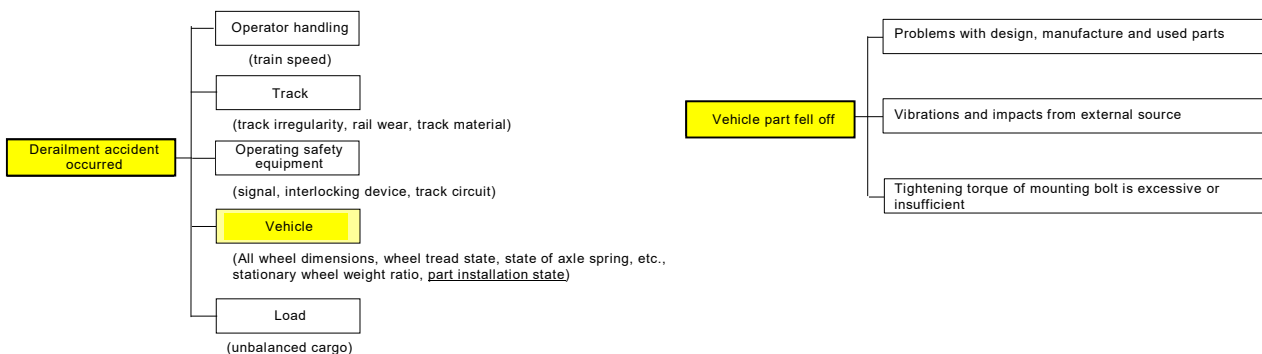
Factors involving the derailment accident occurrence (Ex.)

- The state immediately after the accident occurred  
⇒ Was the bolt broken? Did it come off? Is it in poor condition?
- When the part was installed  
⇒ When was the part installed? Was the correct torque used for the mounting bolt?
- Inspection after the part was installed  
⇒ Was a visual inspection or hammering test performed to test the installation? What was the inspection/test results? During a past investigation, we understood that it is not easy to accurately determine the fastened state during a hammering test such as when a large load is acting on the fastened point.
- Part degradation over time, presence of fatigue fractures  
⇒ Is the part worn or broken? Conduct a test such as a fracture investigation and flaw detection test.

- Presence of external factors that lead to the part falling off
  - ⇒ Does abnormal vibration occur on the train part caused by the vehicle itself or the track, or an external impact (such as flying objects). In the past, vibration generated by wheel tread detachment led to parts falling off.
- Defects when the part was manufactured
  - ⇒ Conduct an interview survey, etc., to ask the manufacturer about the part.
- Progression of the part falling off
  - ⇒ Verify the progression until the part fell off using a simulation and reproduction test that imitates the actual conditions of the vehicle when it was traveling. It is not easy to reproduce the conditions that were present at the time of the accident. However, it is effective to analyze the factors when the accident occurred.
