Chapter 3 Aircraft accident and serious incident investigations

8 Summaries of major aircraft accident and serious incident investigation reports (case studies)

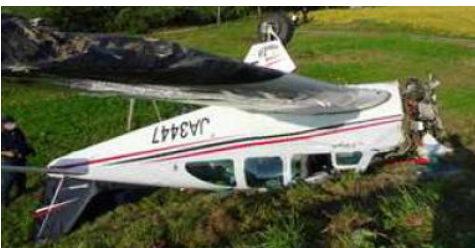
1	Date of Publication	Date and location	Operator	Aircraft registration number and aircraft type
	January 31, 2019	October 8, 2017 Semine Temporary Airfield in Kurihara City, Miyagi Prefecture.	Privately Owned	JA3447 BEEHCRAFT E33 (Small aeroplane)
	Summary	<p>The aircraft overran the runway after rejecting the take-off at Semine Temporary Airfield in Kurihara City, Miyagi Prefecture. It rolled over to a paddy field and suffered damage to its airframe. One passenger was seriously injured.</p>

Probable Causes	<p>It is highly probable that in this accident, the aircraft overran the runway after rejecting the take-off, rolled over to a paddy field, and suffered damage to its airframe.</p> <p>It is also highly probable that the reason why the aircraft overran the runway was because the weight of the aircraft exceeded the weight with which the aircraft would be able to safely take off within the range of the runway length at the airfield, and the remained distance to the runway end was reduced, leading to a delay in making a decision of rejecting the take-off.</p>

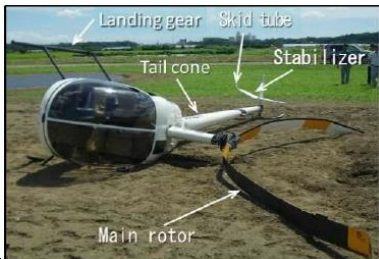
Report	https://www.mlit.go.jp/jtsb/eng-air_report/JA3447.pdf			
2	Date of Publication	Date and location	Operator	Aircraft registration number and aircraft type
	January 31, 2019	July 8, 2018 Near Fuseshita, Kashiwa-City, Chiba Prefecture	Privately Owned	JA7980 ROBINSON R22 BETA (ROTOR-CRAFT)
Summary	<p>The aircraft with two persons, a captain and passenger, on board, at a temporary helipad in Kashiwa-City, Chiba Prefecture rolled over during air-taxing and damaged the airframe.</p>

Probable Causes	<p>In this accident, it is somewhat likely that the helicopter rolled over while greatly changing the attitude because the captain was unable to perform an appropriate corrective action when the helicopter veered to the right during air-taxing due to a strong weathercock stability effect caused by a gust of wind from the right.</p>

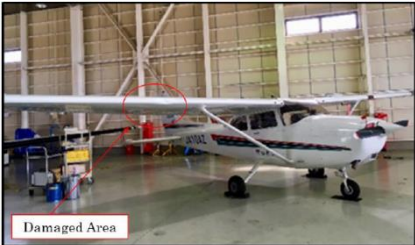
Okayama City, Okayama Prefecture	Ltd.	(Small aeroplane)
	Summary	<p>The aircraft collided with a bird while approaching the Aerodrome for training and sustained damage to the aircraft.</p> <p>There were three persons on board, consisting of the captain and two trainees, but there were no injuries.</p>		
	Probable Causes	<p>In this accident, it is certain that because the aircraft collided with a bird, while making a right turn to the Aerodrome during the power-off accuracy approach training, it suffered damage.</p>

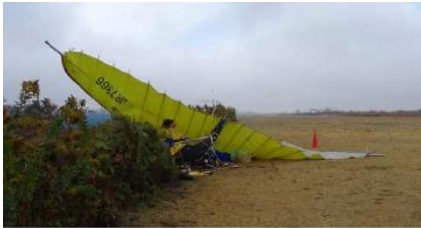
Summary	<p>The aircraft crashed while flying near the Ubuyama temporary airfield in Ubuyama Village, Aso-gun, Kumamoto Prefecture after taking off from Ubuyama temporary airfield for leisure. The aircraft was destroyed and a pilot died.</p>		
	Probable Causes	<p>In this accident, it is somewhat likely that the aircraft stalled while it was repeatedly going up, down and turning at a low AGL altitude, and it could not recover, so it collided with the ground with the nose down attitude and crashed.</p>

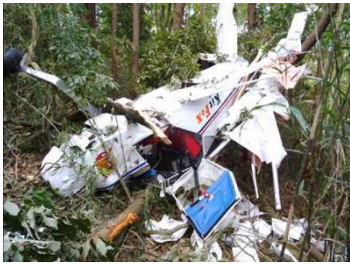
Report	https://www.mlit.go.jp/jtsb/eng-air_report/JA395A.pdf		
15	Date of Publication	Date and location	Operator	Aircraft registration number and aircraft type
	October 31, 2019	November 3, 2018 Namegata City, Ibaraki Prefecture	Privately Owned	JR1749 KITFOX Model IV -1050 (Amateur built aircraft, Two-seater)
	Summary	While approaching the Kitaura temporary airfield in Namegata City, Ibaraki Prefecture, the aircraft hit trees and crashed. One pilot and one passenger were slightly injured.		
	Probable Causes	In this accident, it is probable that because the pilot could not see the top of the trees on the approach course and made a mistake in measuring the distance with his eyes, the right wing contacted the trees during the approach and crashed into the thicket and was destroyed. It is probable that the reason why the pilot could not see the top of the trees on the approach course and made a mistake in measuring the distance with his eyes that he tried to approach by descending while making a steep turn.

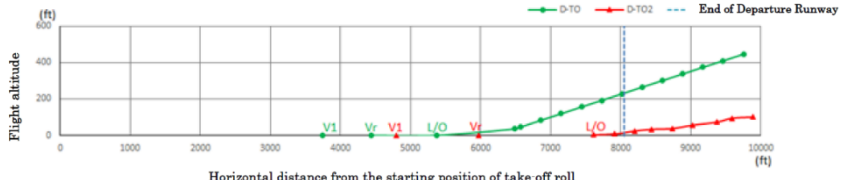
March 28, 2019	July 15, 2017, Runway 16L at Narita International Airport	Polar Air Cargo Worldwide Inc.	N852GT Boeing 747-8F (Large aeroplane)
	Summary	<p>The aircraft as the company's scheduled flight 213, lifted off after performing its take-off roll all the way of the vicinity of the end of runway when taking off from runway 16L at Narita International Airport, resulting in a case equivalent to runway overrun.</p> <p>The captain and the first officer (FO) were on board the aircraft, but nobody suffered injuries and the aircraft had no damage.</p>		
	Probable Causes	<p>It is probable that in this serious incident, the aircraft commenced a take-off roll by using the take-off thrust lower than the thrust required for the aircraft to take off, causing it to take a longer take-off roll distance to lift off; and its lifting off in the vicinity of the end of departure runway resulted in a case equivalent to runway overrun. It is probable that the aircraft commenced a take-off roll by using the take-off thrust lower than the thrust required for the aircraft to take off, because the captain did not correctly change the FMC settings for the take-off thrust at the time of take-off from the runway different from what the captain and the FO had assumed, the captain did not correctly change the FMC settings for the take-off thrust, in addition, the captain and the FO did not ensure to verify the take-off thrust by the time when they commenced the take-off.</p>

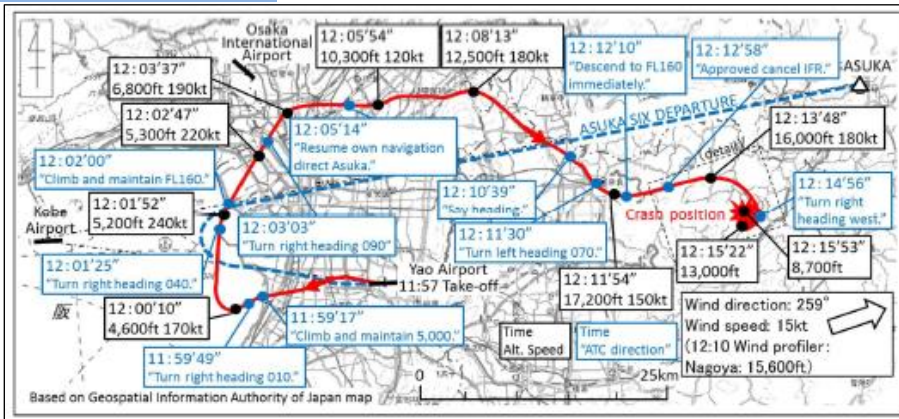
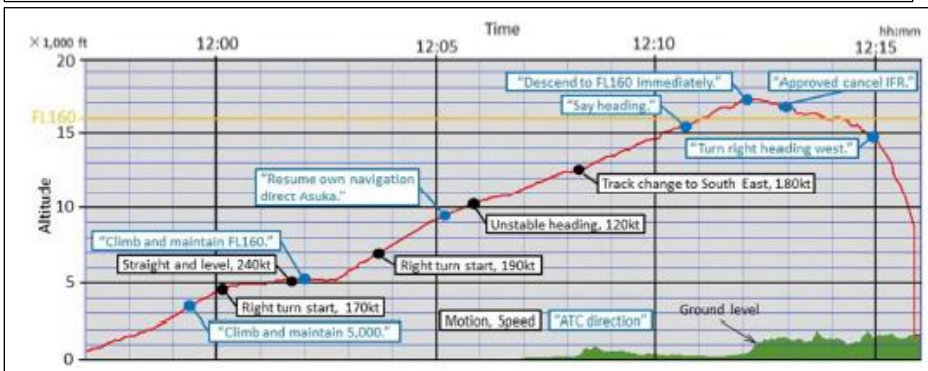
History of the flight

Further instructions due to failure to properly deal with control instructions

- neglected the responses in air traffic control, deviated from the instructed altitude
- delayed in read-back
- not able to fly IFR in accordance with the instruction from the controller about the heading and the altitude.

the left wing was broken → the fuel was discharged (ignited) → the right wing was broken → crashed

Probable Causes: In the accident, it is highly probable that the Aircraft lost control during flight, nose-dived while turning, and disintegrated in mid-air, resulting in the crash.

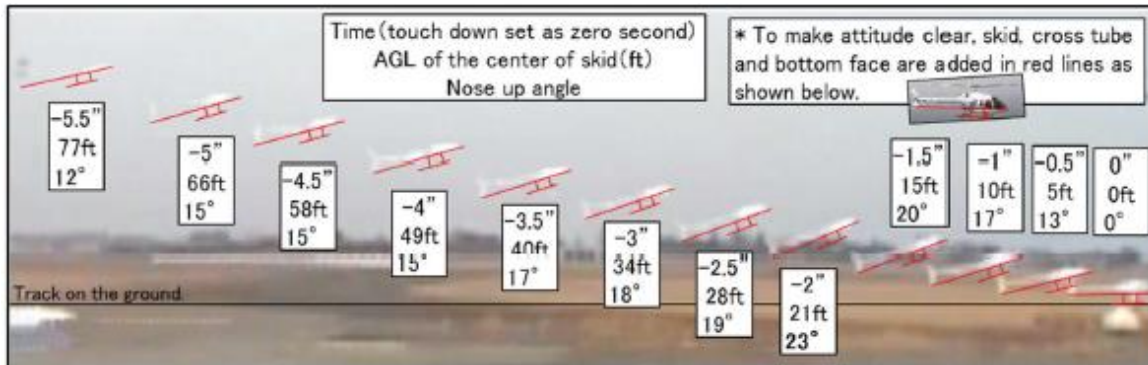
Damage to Aircraft

Deformed cross tube

Damaged antenna mounting

Probable causes: In this accident, it is highly probable that the helicopter experienced hard landing without stopping its descent speed and damaged the air frame, when the helicopter was executing autorotation Full Landing, because of the delayed commencement of deceleration and improperly subsequent maneuvering.

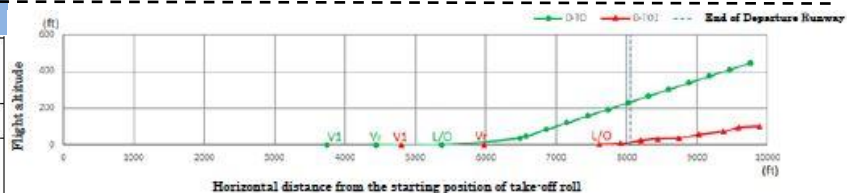
QAR Records and the Estimated Values by the Manufacturer

Horizontal distance from the starting position of take-off roll to the position of lifting off	Flight attitude at the end of departure runway
QAR Records	7,720ft	16ft
Estimated Values by the Manufacturer	5,370ft	230ft

Probable causes (excerpt): It is probable that in this serious incident, the aircraft commenced a take off roll by using the take off thrust lower than the thrust required for the aircraft to take off, causing it to take a longer take off roll distance to lift off; and its lifting off in the vicinity of the end of departure runway resulted in a case equivalent to runway overrun.

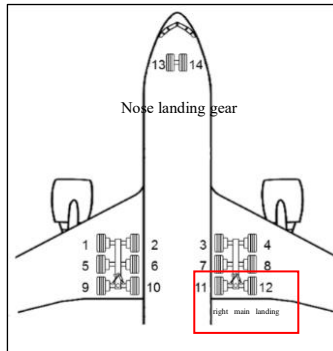
Damage to Aircraft

(Slightly damage) •The R-MLG AFT Axle was fractured. •The R-MLG Truck beam was damaged. •The R-MLG Steering system was damaged. •Hydraulic hoses of Brake and the Steering system were cut. •Hydraulic system fluid leaked. •Brake components were damaged. •Electric cables and junction box of the R-MLG were damaged.

Situation of main damages to aircraft (The R-MLG AFT Axle was fractured)

- The entire fractured surface of the front side of the pivot discolored black due to the corrosion.
- It was confirmed that a partially black-discolored portion due to corrosion and a grey new metal surface were confirmed on the fractured surface of the aft side of the pivot.

The forward fractured surface had an initiating region of corrosion on the lower side of the pivot bore, then was generating SCC and finally was fractured due to repetitively imposed loads.

The fillet seal was damaged due to the rotation of the bushings, which allowed water to penetrate between the pivot bore and the bushings.

The aft fractured surface was caused by SCC initiated by the corrosion generated on the lubrication passage, which then led to progressing cracking due to repetitively imposed loads.

Probable causes: It is certain that the aircraft had the right main landing gear aft axle fractured when landing in the serious incident, and subsequently, it was forced to halt on taxiway and could not continue taxiing. It is highly probable that the fractured axle was attributed to the SCC originated from the corrosion generating on the pivot bore and ongoing operations of the aircraft thereafter with cracking occurred. It is highly probable that the corrosion generated on the pivot bore was contributed by water penetration caused by the torn fillet seal due to rotation of the bushings and corrosion inhibitor that was not applied.
