Japan Transport Safety Board
Annual Report 2022
【March 2022】

ANNUAL REPORT 2022

Japan Transport Safety Board

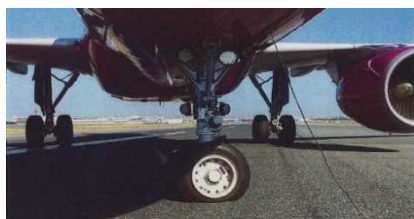
Consequently, the aircraft was unable to continue taxiing. (See Photo 1)

Photo 1. Serious incident aircraft
(at the time of the serious incident)

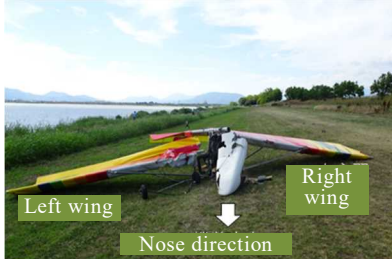
Report	https://www.mlit.go.jp/jtsb/aircraft/rep-acci/AA2021-3-2-JE0205.pdf (In Japanese only)			
7	Date of publication	Date and location	Operator	Aircraft registration number and aircraft type
	April 22, 2021	June 9, 2020 In Shiroishi Town, Kishima District, Saga Prefecture	Privately owned	JR0862 Sanyo Tekko EX-03C PUFFIN-LT447 (Single-seat ultralight plane))
	Summary	<p>The aircraft crashed at Kita-Ariake temporary airfield during the jump flight.</p> <p>Only a pilot was on board and died.</p> <p>The aircraft got heavily damaged with no fire.</p>

Probable causes	<p>It is probable that this accident occurred because the propeller blade got damaged after starting the takeoff run, subsequently some scattered fragments collided with the rear strut of the left wing, then the strut buckled and also the left-wing front joint was separated, which caused the aircraft to crash.</p> <p>Regarding the damaged propeller blade, there may be a possibility of external damage due to a collision with foreign matter or potential internal damage, and influence in association with the processing to change the propeller diameter, however, none of them were identified.</p> <p>Regarding the separation of the left-wing front joint, it is probable that an inappropriate assembly and maintenance of the aircraft as well as the buckled strut were involved.</p>

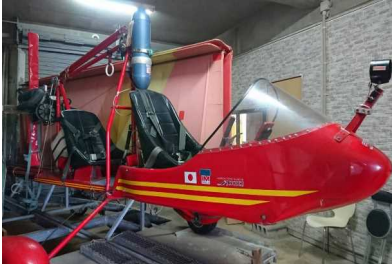
mainly responsible for maneuvering the aircraft. PM is an abbreviation of Pilot Monitoring mainly responsible for monitoring flight status of the aircraft and cross-checking of PF's maneuvering and undertakes other nonoperational tasks.		
	Report	https://www.mlit.go.jp/jtsb/eng-air_report/JA01JC.pdf		
10	Date of publication	Date and location	Operator	Aircraft registration number and aircraft type
	July 29, 2021	January 3, 2020 In Miyako Island, Okinawa Prefecture	Privately owned	JR0251 Maxair Drifter XP-R503L (Two-seat ultralight plane)
	Summary	When the aircraft conducted a forced landing on the road in the vicinity of Gusukubenagama, Miyako Island, Okinawa Prefecture, its left wing collided with trees at the side of the road, and then fell to the ground. The airframe got heavily damaged and the passenger got severely injured.

Probable causes	During the flight, the engine speed did not increase, and the thrust required for continuous flying was not achieved. For that reason, it is probable that the aircraft started to descend, consequently colliding with trees before reaching the destination for the forced landing, fell to the ground and the airframe got damaged, and thereby the passenger got severely injured.

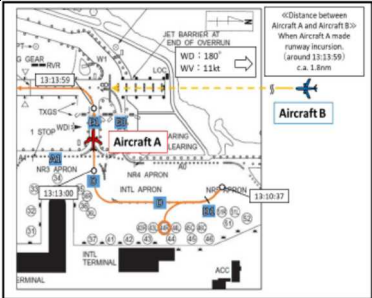
Probable causes	<p>It is highly probable that this serious incident occurred because aircraft A entered the runway despite of being instructed to hold short of runway 18, when aircraft B, which were cleared to land by the tower, attempted to land at the same runway.</p> <p>Regarding the fact that aircraft A entered the runway, it is probable that when the PIC A received the ATC instruction, he mistook the tower's instruction to hold short of runway as the instruction to line up and wait, and his misunderstanding was not corrected.</p> <p>It is probable that the reason why the PIC A's misunderstanding was not corrected is because the PIC A and the FO A did not cross-check the ATC clearance, as specified in the company A's manual.</p>

Safety Actions	<p>Measures Asiana Airlines, Inc. took to prevent the recurrence of similar accidents</p> <ul style="list-style-type: none"> · Updating the Airport Information and notifying all the flight crew for flight safety. · Changed in Standard Callouts*1 during taxi. · Company campaign for the prevention of runway/taxiway incursion.

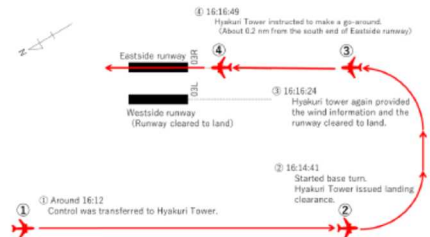
Probable causes	<p>In this serious incident, it is highly probable that because the captain of the aircraft misidentified the runway cleared to land, he made an approach for the different runway where an inspection vehicle was running.</p> <p>It is somewhat likely that the captain as the PF*1 did not thoroughly perform the visual recognition of runway, and in addition, the FO as the PM*1 did not adequately monitor the flight status of the aircraft, which may be involved in the runway misidentification made by the captain of the aircraft.</p> <p>*1 "PF" and "PM" are the terms used to identify pilots by their different roles in aircraft operated by two persons. PF is an abbreviation of Pilot Flying and is mainly responsible for maneuvering the aircraft. PM is an abbreviation of Pilot Monitoring mainly responsible for monitoring flight status of the aircraft and cross-checking of PF's maneuvering and undertakes other nonoperational tasks.</p>

Safety Actions	<p>Preventive actions that the Company took in the wake of this serious incident</p> <p>(1) Made known the serious incident in details to flight crew.</p> <p>(2) Added the condition in which the PIC flying to Hyakuri Airfield is required to have flight experience with the flight time of 500 hours or more as the PIC*1.</p> <p>*1 "PIC" stands for Pilot in Command who is the pilot responsible for the operation and safety of an aircraft. In aircraft operated by several pilots qualified as PIC, from whom one PIC is appointed.</p>		
	Report	<p>https://www.mlit.go.jp/jtsb/eng-air_report/HL8052.pdf</p>		
7	Date of publication	Date and location	Operator	Aircraft registration number and aircraft type
	April 22, 2021	June 15, 2019 At Tokyo International Airport	Skymark Airlines Inc. (Aircraft A)	JA73AB Boeing 737-800 (Large aeroplane)
			All Nippon Airways Co., Ltd. (Aircraft B)	JA885A Boeing 787-9 (Large aeroplane)

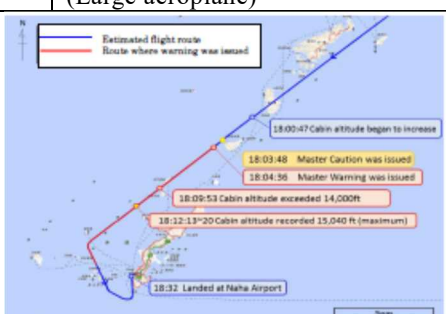
Probable causes	<p>The JTSD concludes that the probable cause of this serious incident was the shutdown of both PACKs of the Aircraft during the flight at FL400, which resulted in loss of cabin pressurization. Concerning the shutdown of both PACKs, it is highly</p>

probable that the flight crew member was going to operate the switches of fuel recirculation system but erroneously pushed both PACK switches to position "OFF" without noticing.		
	Safety Actions	<p>Safety actions taken by the Company after the serious incident</p> <p>The following safety actions were taken for all crew members who operate the same type of aircraft.</p> <ol style="list-style-type: none"> (1) Strict adherence to checklists and procedures during all phases of flight, especially in climb out and cruise, as was identified in this incident. (2) It was informed that it is important for a PIC to emphasis on Crew Resource Management (CRM^{*1}) and crew communication is vital and will be briefed and emphasized during all phases of flight. (3) Review of fuel recirculation procedures on aircraft with manual fuel recirculation action, such as N829RA, crew shall do a thorough review of the fuel recirculation system to include limitations of such actions. (4) Re-emphasis the challenge and response items to various phases of the checklist to ensure proper cockpit switchology. <p>*1 "CRM" refers to the effective use of all available resources: human resources, hardware and information, in order to accomplish safe and efficient operations. (AIM-JAPAN)</p>

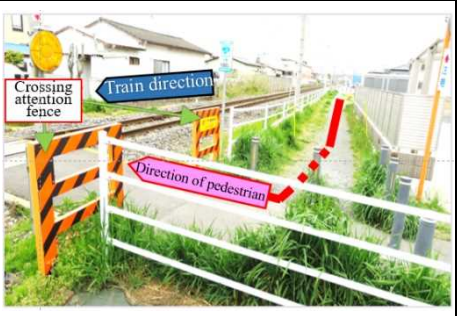
Probable causes	<p>The JTSB concludes that the probable cause of this accident was that the pedestrian entered No.1 Shimoura level crossing, the class 3 level crossing equipped with the road warning device but without the crossing gate, in the status that the road warning device was operating and responded to the approaching train.</p> <p>It could not be determined why the pedestrian entered the level crossing because the pedestrian was dead, although it is likely that the pedestrian did not hear the rumbling sound of the road warning device and that the pedestrian overlooked the red flashing lamps of the road warning device.</p>		
	Safety actions	<p>Proposed a discussion to Higashi-Matsushima City regarding abolition or upgrading the level crossing, given that the accident occurred. However, since the discussion with the city did not progress, the level crossing was constructed for upgrading to class 1 level crossing, considering safety as the first priority.</p> <p>(1) Measures taken by the Company</p> <ol style="list-style-type: none"> 1. Applied yellow paint to the edge end of the level crossing on May 11. 2. Taken the awareness-raising activities regarding level crossing accidents at Higashi-Yamato station and Yamoto station on May 13. (jointly with the cities and Ishinomaki Police Station). 3. Changed the red flashing lamps of the level crossing to omnidirectional red flashing lamps on May 13. 4. Applied a paint to the halt line of the level crossing on May 14. 5. Upgraded the level crossing to class 1 level crossing, and started to operate it from November 21. <p>(2) Measures taken by the City</p> <ol style="list-style-type: none"> 1. Taken public-relations activities at Higashi-Yamato station and Yamoto station on May 13 jointly with Ishimaki Police Station, Ishinomaki district safe driving manager society, the Company, and the traffic safety association, and the disaster prevention section, the general affairs department of Higashi-Matsushima City. 2. Leveled crushed stones as safety measure for pedestrians for non-statutory public properties owned and managed by Higashi-Matsushima City on July 22. 3. Confirming the on-site status such as the paint of the edge ends and halt lines of No.1 Shimoura level crossing once a month by the construction section, the construction department of Higashi-Matsushima City.
