## Chapter 3 Aircraft accident and serious incident investigations

### Aircraft accident investigation reports published in 2023

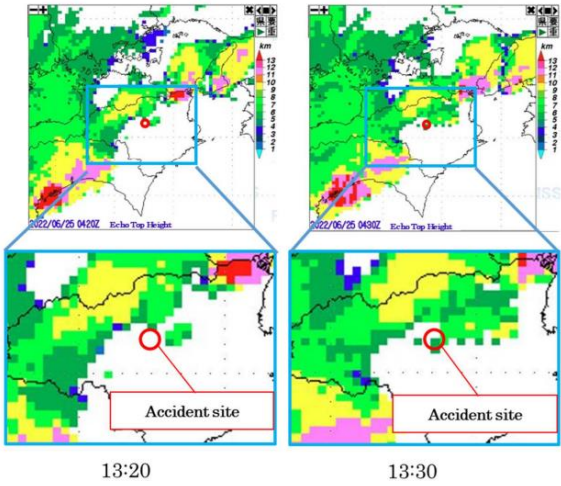
16	Date of publication	Date and location	Operator	Aircraft registration number and aircraft type
	October 26, 2023	June 25, 2022 At FL170 over Yoshinogawa City, Tokushima Prefecture	ANA WINGS Co., Ltd.	JA854A Bombardier DHC-8-402 (Large aeroplane)
	Summary	The aircraft, as a scheduled flight 1626 of All Nippon Airways Co., Ltd., as the joint undertaking for transport, was flying from Kumamoto Airport to Osaka International Airport, the aircraft was shaken, causing a cabin crew member to sustain an injury.

Probable Causes	<p>The probable cause of this accident was that while the Belt Sign was off, the aircraft encountered an airflow disturbance due to convective clouds*1 and was violently shaken, while working in the galley in the aft side of the aircraft, resulting in getting out of balance to fall down on the floor and most likely sustaining the injury.</p> <p>It is possible that the aircraft encountered airflow turbulence caused by convective clouds because of inadequate maneuvering to avoid them, and besides because it was difficult to detect developing convective clouds from onboard weather radar, the aircraft was likely not to be able to maintain an adequate distance from them.</p>

Safety Actions	<p>It is desirable for the Company to make known the overview of this accident to all flight crew members in order to let them reconfirm how to avoid echoes*2 and how to operate the Belt Sign.</p> <p>*2 “Echoes” refer to the reflective waves captured on the radar as radio waves emitted from a metrological radar are reflected by raindrop and ice particle, etc. The reflective waves allow to observe the distribution of precipitation area and the intensity, and this precipitation area may be also called “Echoes.”</p>

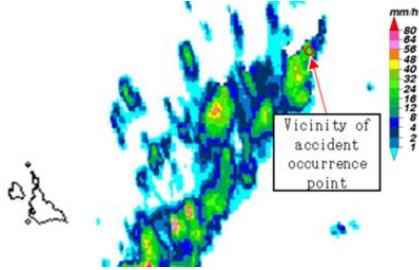
17	Date of publication	Date and location	Operator	Aircraft registration number and aircraft type
	October 26, 2023	July 16, 2022 Approximately 120 km southwest of Naha Airport, around FL260	Solaseed Air Inc.	JA807X Boeing 737-800 (Large aeroplane)
	Summary	The aircraft, as a scheduled flight 41 of the Company, was flying from Naha Airport to New Ishigaki Airport, the aircraft was shaken, causing a cabin crew member to sustain an injury.		
	Probable Causes	<p>The probable cause of this accident was that when the aircraft passed over the developing convective clouds*1, occurred the shaking as if to hold the body down, due to which cabin crew fell down in a position like sitting sideways with left leg down, resulting in the injury in the left foot. It is highly probable that the reason why the aircraft passed over the developing convective clouds is because as it was unable to anticipate the possibility that the clouds seen below would rapidly develop, the aircraft passed over.</p>

Safety Actions	In order to avoid a cumulonimbus, it is probably necessary to select the flight route based on the meteorological information and analysis obtained before flight, grasp the change in the weather conditions during flight and clouds conditions by visual sighting but also using the airborne radar, and reconfirm how to select a safer avoidance method. (See “3. ANALYSIS” on the Investigation Report.)		
Report	<a href="https://www.mlit.go.jp/jtsb/aircraft/rep-acci/AA2023-7-3-JA807X.pdf">https://www.mlit.go.jp/jtsb/aircraft/rep-acci/AA2023-7-3-JA807X.pdf</a> (Japanese) <a href="https://www.mlit.go.jp/jtsb/eng-air_report/JA807X.pdf">https://www.mlit.go.jp/jtsb/eng-air_report/JA807X.pdf</a> (English)
