ANNUAL REPORT 2024

JAPAN TRANSPORT SAFETY BOARD

March, 2024

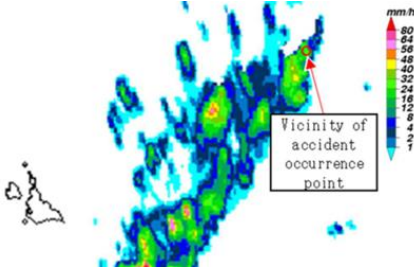
17	Date of publication	Date and location	Operator	Aircraft registration number and aircraft type
	October 26, 2023	July 16, 2022 Approximately 120 km southwest of Naha Airport, around FL260	Solaseed Air Inc.	JA807X Boeing 737-800 (Large aeroplane)
	Summary	The aircraft, as a scheduled flight 41 of the Company, was flying from Naha Airport to New Ishigaki Airport, the aircraft was shaken, causing a cabin crew member to sustain an injury.		
	Probable Causes	<p>The probable cause of this accident was that when the aircraft passed over the developing convective clouds*1, occurred the shaking as if to hold the body down, due to which cabin crew fell down in a position like sitting sideways with left leg down, resulting in the injury in the left foot. It is highly probable that the reason why the aircraft passed over the developing convective clouds is because as it was unable to anticipate the possibility that the clouds seen below would rapidly develop, the aircraft passed over.</p>

<p>*1 “Convective Clouds” refer to clouds that are formed when updraft develops vertically.</p>

Safety Actions	In order to avoid a cumulonimbus, it is probably necessary to select the flight route based on the meteorological information and analysis obtained before flight, grasp the change in the weather conditions during flight and clouds conditions by visual sighting but also using the airborne radar, and reconfirm how to select a safer avoidance method. (See “3. ANALYSIS” on the Investigation Report.)		
Report	https://www.mlit.go.jp/jtsb/aircraft/rep-acci/AA2023-7-3-JA807X.pdf (Japanese) https://www.mlit.go.jp/jtsb/eng-air_report/JA807X.pdf (English)

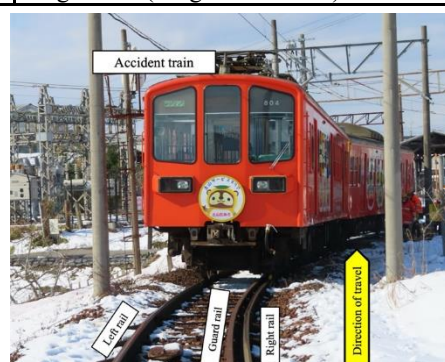
1	Date of publication	Date and accident type	Railway operator	Line section (location)
	January 19, 2023	February 7, 2022 Train derailment	OHMI Railway Co., Ltd.	In the premises of Takamiya Station, Toga Line (Shiga Prefecture)
	Summary	<p>The driver of the train stopped the train due to feeling an impact while passing through a right-hand curve with a radius of 160 m at the premises of Takamiya Station.</p> <p>When the driver checked the train after stopping, he discovered that the lead axle of the lead bogie of the lead vehicle, the lead axle of the rear bogie of the lead vehicle, and the lead axle of the lead bogie of the rear vehicle had been derailed.</p> <p>About 100 passengers and one driver were onboard the train, and there were no injuries.</p>

<p>Probable causes</p>	<p>It is probable that the right wheels of the lead axle of the lead bogie of the lead vehicle, the rear bogie of the lead vehicle, and the lead bogie of the rear vehicle fell into the gauge due to the gauge widening significantly while the train was passing through a right-hand curve with a radius of 160 m.</p> <p>It is more likely that the gauge widened significantly due to a large amount of static irregularity of gauge along this curve, and that a series of defective sleepers and poor rail fastening status resulted in lateral movement of the rails and rail tilt due to lateral force when the train was running, which caused the gauge to widen dynamically.</p> <p>It is probable that the static irregularity of gauge was large due to the standard value for maintenance for irregularity of gauge being larger than the appropriate value.</p> <p>The series of defective sleepers and poor rail fastening status is more likely because inspection methods and judgment criteria were not clarified, preventing proper maintenance from being performed.</p> <p>It is more likely that this accident may have occurred because the slack^{*1} on this curve was relatively large, which resulted in a smaller margin for derailment by gauge widening, and there were places where the guard rail^{*2} was not fastened to the sleepers, causing rail tilt^{*3}, etc. to occur from inward lateral force from the right wheel, etc., which dynamically increased the flangeway width, causing the derailment prevention function not to work sufficiently. Another factor probable to be involved was that the countermeasures implemented in response to the Japan Transport Safety Board UN-I-SAN No. 43, dated June 28, 2018, “Opinions Related to the Prevention of Train Derailment Accidents Caused by Gauge Widening^{*4},” were insufficient.</p> <p>*1 “Slack” means the amount to widen the gauge beyond the predetermined size in order to drive smoothly along a curve.</p> <p>*2 “Guard rails” are rails installed on the insides of the gauges of the inner rails to prevent derailment.</p> <p>*3 “Rail tilt” refers to a phenomenon where a rail is tilted due to the load exerted on it by wheels.</p> <p>*4 “Gauge widening” means a state where the gauge has widened due to damage to the rail fastening device from lateral force (force where the wheels press on the rail in the lateral direction) or due to increased rail wear. When the gauge spreads beyond a certain point, it creates a state where either the left or right wheel cannot be supported by the rail head, resulting in derailment. In this context, gauge widening due to lateral force in conjunction with the train running means “dynamic gauge widening.”</p>

<p>Safety actions</p>	<p>(1) Steady implementation of track maintenance</p> <p>(i) About the standard value for maintenance for track irregularity It would be preferable to revise the standard value for maintenance for irregularity of gauge to make it the appropriate value and to have a clear deadline set for performing track maintenance as action to be taken when track irregularity reaches the standard value for maintenance.</p> <p>(ii) About sleeper inspection The inspection methods and judgment criteria manual for sleeper inspection need to be enhanced, and track maintenance needs to be performed along with this. It is also necessary to perform maintenance in a planned manner for locations that require it, regardless of which type of sleepers are installed there.</p> <p>(iii) About rail fastening status inspection and maintenance When inspecting track members, such as during a sleeper inspection, and when conducting a permanent way inspection tour, etc., it’s necessary to check for things like wooden sleeper corrosion, floating dog spikes, cracked PC sleepers, and broken fastening devices, and replace or add dog spikes, adjust fastening torque, replace plate springs, replace sleepers, install gauge ties, etc. according to the status. In addition, because the danger of derailment by gauge widening increases in particular when these issues occur in a series or when it happens on a sharp curve with a large amount of slack, care must be taken to prioritize maintenance in these status. In addition, when it comes to managing sleepers, rail fasteners, etc., on curves, in general, more attention tends to be paid to the outer rail side where it’s easy for large amounts of lateral force to occur, but because lateral force also occurs on the inner rail side in the direction in which the curve turning lateral force^{*5}, etc., pushes the rails toward the outside, it needs to be managed with attention equal to that devoted to the</p>

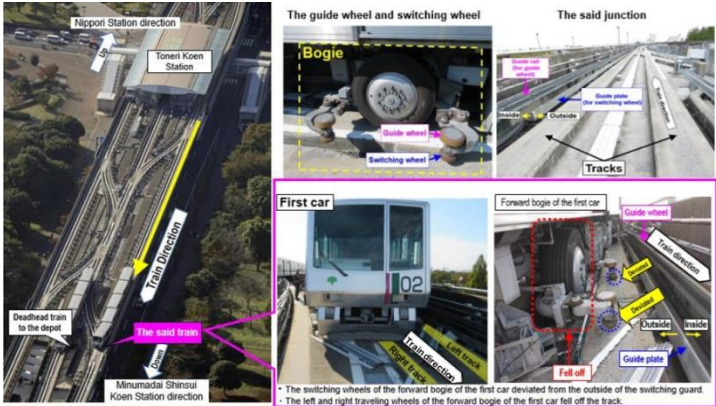
2	Date of publication	Date and accident type	Railway operator	Line section (location)
	February 16, 2023	October 7, 2021 Train derailment	Bureau of Transportation Tokyo Metropolitan Government	In the premises of Toneri-Koen Station on the Nippori-Toneri Liner (Tokyo Metropolitan)
	Summary	<p>The train departed Toneri-Koen Station on schedule. Shortly after, the dispatcher in the command center felt the earthquake tremor and pressed the button to stop all train departures, halting all trains at the stations. Immediately afterward, the Early Earthquake Warning System*1 confirmed the earthquake originating in the northwestern part of Chiba Prefecture, and the dispatcher pressed the emergency stop button, stopping all moving trains. As a result, this train stopped at the switch on the premises of Toneri-Koen Station. Upon inspection by staff on site, it was found that the front wheels of the first car (hereinafter, cars are counted from the front, and front, back, left, and right are based on the train’s direction) had derailed to the right side of the track.</p> <p>There were 29 passengers on the train, and eight of them were injured.</p> <p>*1. The Early Earthquake Warning System alerts the dispatcher when forecast information from a disaster-prevention technology company (ANET) predicts an earthquake with a seismic intensity of 4 or higher on the Japanese scale of 7 along the Nippori-Toneri Liner. When this system activates, it performs an emergency stop of all trains.</p> <p>It is probable that this accident was caused by the train derailing due to the seismic motion from the earthquake in the northwestern part of Chiba Prefecture. It is probable that the derailment process was as follows: the seismic motion caused the train</p> <div data-bbox="703 1122 1422 1525">

Probable causes	<p>It is probable that this accident was caused by the train derailing due to the seismic motion from the earthquake in the northwestern part of Chiba Prefecture. It is probable that the derailment process was as follows: the seismic motion caused the train</p>

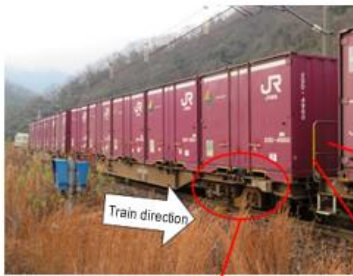
3	Date of publication	Date and accident type	Railway operator	Line section (location)
	March 30, 2023	December 28, 2021 Train derailment	Japan Freight Railway Company	Between Seno Station and Hachihommatsu Station on the Sanyo Line (Hiroshima Prefecture)
	Summary	<p>Due to the snowfall in Shiga Prefecture the previous day, the train departed Hiroshima Freight Terminal 22 hours and 22 minutes behind schedule. After passing through Seno Station, the lead locomotive was set to notch 13, and the auxiliary locomotive at the rear was set to notch 12, running at approximately 52 km/h. The driver of the lead locomotive observed a sudden drop and rise in the brake pipe pressure*¹, and the brakes activated, stopping the train.</p> <p>Upon inspection, as directed by the transport dispatcher, the driver found that the front bogie of the 12th car (cars are counted from the front, including locomotives, with directions based on the train’s direction of travel) had derailed to the left.</p> <div style="display: flex; justify-content: space-around;">

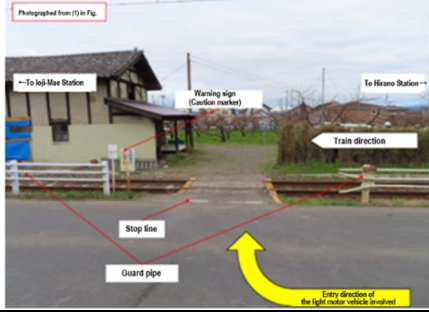
4	Date of publication	Date and accident type	Railway operator	Line section (location)
	March 30, 2023	April 5, 2022 Level crossing accident	Fukushima Transportation, Inc.	Between Hirano Station and Iojimae Station on the Iizaka Line (Fukushima Prefecture) 6k961m crossing (Class 4 level crossing without crossing gate nor road warning device)
	Summary	<p>While the train ran approximately 50 km/h between Hirano Station and Iojimae Station, the driver recognized a light vehicle entering the crossing (Class 4 level crossing) from the left. The driver immediately sounded the horn and applied the emergency brake, but the train collided with the light vehicle.</p> <p>The driver of the light vehicle involved in this accident was killed, and the passenger was seriously injured.</p>

Probable causes	<p>It is certain that this accident occurred because the light vehicle entered the 6k961m crossing (Class 4 level crossing without gates or road warning devices) while the train was approaching, resulting in a collision.</p> <p>It is probable that the light vehicle driver did not notice the approaching train, but the details could not be clarified as the driver was deceased.</p>

Safety actions	<p>Class 4 level crossings, which lack crossing gates and road warning devices, should be abolished or equipped with proper safety equipment.</p> <p>Railway operators and stakeholders such as orchard owners need to proceed with discussions to reach an agreement on abolishing or equipping this crossing with safety equipment and implementing safety measures.</p> <p>Until these measures are implemented, it is desirable to restrict passage through the crossing only when necessary.</p> <p>Furthermore, since the company has many other Class 4 level crossings, it is recommended that railway operators, landowners, municipalities, and residents conduct discussions to abolish or equip these crossings with safety equipment.</p>		
	Report	https://www.mlit.go.jp/jtsb/railway/rep-acci/RA2023-3-2.pdf (Japanese)

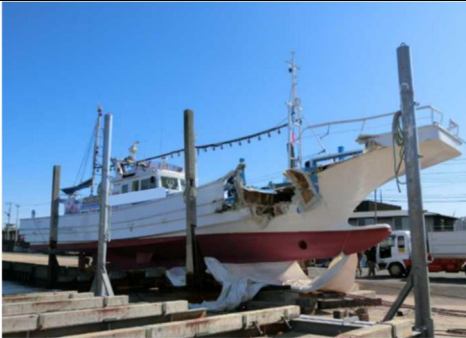
1	Date of publication	Date and location	Vessel type and name, accident type
	January 19, 2023	February 16, 2020 Kashima Port, Ibaraki Prefecture	Recreational fishing vessel No.27 SAKURAIMARU Contact (with breakwater)
	Summary	<p>With the master and one deckhand, one passenger, and 20 anglers on board, the vessel was heading southwest towards Kashima Port, Ibaraki Prefecture, when it contacted with the northern breakwater at the Second Ship Basin of Kashima Port.</p> <p>As a result, 14 anglers, the master, and the deckhand were injured, and the vessel sustained a rupture on the starboard bow. Additionally, the breakwater sustained damage and scuff marks at its tip.</p>

Probable causes	<p>It is probable that this accident occurred when the vessel proceeded southwest at approximately 16 knots towards the Second Ship Basin of Kashima Port. With a blind spot ahead, the master noticed the vessel heading towards the breakwater about 230 meters from the breakwater extending northeast from the opening of the area surrounded by the northern breakwater at the entrance of the Second Ship Basin when the bow of the ship dropped due to the waves and the blind spot disappeared. Upon noticing, he turned the helm to the left to avoid the breakwater, navigating remarkably close to its tip. Due to the influence of the waves, the vessel veered to the right again towards the breakwater, unable to avoid it at a speed of about 16 knots, and collided with the breakwater.</p> <p>The master navigated remarkably close to the breakwater because he usually took a route near it. It is probable that he believed the vessel would clear the breakwater as the heading line on the radar screen pointed to the left, based on his experience.</p>

Safety actions	<p>The following measures are necessary to prevent the recurrence of similar accidents:</p> <ol style="list-style-type: none"> (1) Masters should consider the usual wave conditions in the surrounding sea area and the effects of composite waves generated from reflective waves off nearby structures when navigating past obstacles such as breakwaters, ensuring a safe distance from such obstacles and paying careful attention to the chosen navigation route. (2) Masters should decelerate as much as possible when entering the port, considering the channel's wave conditions. (3) Masters should station deckhands at the bow for lookout duties when entering the port. (4) Masters operating vessels with blind spots should use navigational instruments such as radar and GPS plotters to verify the vessel's position. (5) Shipowners should prioritize visibility from the bow as much as possible in designing and constructing new vessels.

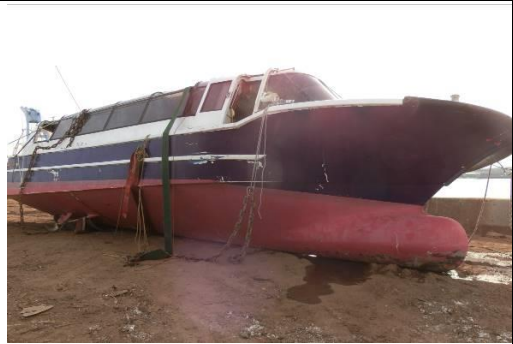
2	Date of publication	Date and location	Vessel type and name, accident type
	January 19, 2023	November 19, 2020 Off northwest of Wasa Island, Sakaide City, Kagawa Prefecture	Passenger ship SHRIMP OF ART Grounding

3	Summary	<p>The vessel, which had the master, one deckhand, and 60 passengers on board, ran aground on a drying rock^{*1} while navigating off the northwest coast of Wasa Island, Sakaide City, Kagawa Prefecture.</p> <p>The vessel sank, injuring four passengers, after suffering a breach in the outer bottom plate and flooding.</p> <p>*1. The “drying rock” is a rock that submerges at high tide and becomes exposed at low tide.</p>

Probable causes	<p>It is highly probable that this accident occurred off the western coast of Wasa Island when the ship was heading north-northwest towards the Seto Ohashi Bridge. Hearing a passenger teacher explaining the eastern side of Iguro Island to students, the master decided it would be better for the passengers to view the eastern side of Iguro Island. The master checked visually and confirmed that there were no other vessels between the third and fourth bridge piers from the Iguro Island side, concluding that it would be safe to pass between them. However, the master did not notice the presence of a drying rock called Osowai, located to the south of the passage between the piers, approximately 200 cm above the minimum water level, and the ship ran aground on it.</p> <p>It is probable that the master’s failure to notice the drying rock is attributed to the fact that when he glanced at the GPS plotter^{*2} screen to confirm the route, he did not enlarge the screen from the 300-meter scale, making the drying rock appear small on display. Additionally, the rock was submerged during the accident and not visible to the naked eye.</p> <p>Despite not usually navigating this area with the vessel, the master had sailed several times a year and believed he was familiar with the rocks and other hazards. Therefore, he did not conduct a waterway survey before departure, contributing to his failure to notice the drying rock.</p> <p>The ship owner had not equipped the vessel with charts marked with standard routes, hazard lines, and other necessary information as specified in the safety management regulations, nor had the safety manager conducted regular safety education on the safety management regulations and related laws. It is probable that this lack of preparation contributed to the master’s failure to conduct a waterway survey before departure.</p> <p>*2. The “GPS plotter” is a device that displays the ship’s position on a map on the screen using information obtained from satellites via the Global Positioning System (GPS) and can plot the ship’s track.</p>

Safety actions	<p>The following measures are necessary to prevent the recurrence of similar accidents:</p> <ol style="list-style-type: none"> (1) Masters should conduct a waterway survey of the planned navigation area using charts, nautical reference maps, fishing facility information, and navigational notices before departure and plan the voyage while identifying obstacles that may hinder navigation. (2) Masters should be aware that in some areas, charts, and the information from electronic navigational reference maps on GPS plotters alone may not provide detailed information on obstacles such as drying rocks or the area’s actual coastline features. (3) If a waterway survey of the planned navigation area has not been conducted in advance, masters should not change the planned route impulsively. (4) Masters should appropriately use detailed displays on GPS plotters and other devices to verify the ship’s position and determine the conditions of the maritime area. (5) Domestic irregular route passenger transport operators must keep charts marked with hazard lines as specified in the reported safety management regulations on board. (6) Safety managers must regularly conduct safety education on safety management regulations and related laws for employees of their company.

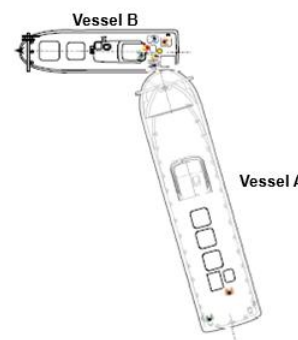
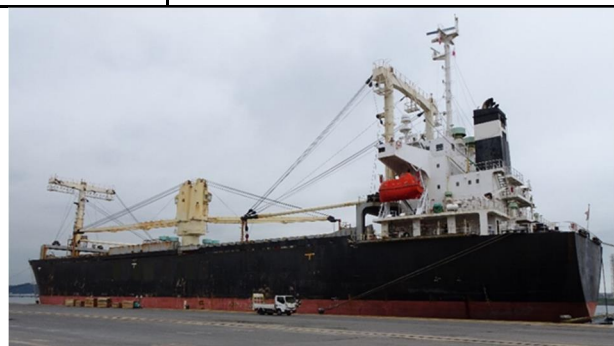
March 30, 2023	June 19, 2020 Honmoku Pier A5 Wharf, Yokohama District, Keihin Port	Cargo ship TIMU (Panamanian-flagged) Casualties
	Summary	<p>With a master and 17 crew members, the vessel was moored at Honmoku Pier A5 Wharf. Three stevedores were handling used trucks and other cargo on the second deck of the No. 2 hold, and three welders were attaching D-rings for cargo securing on the same deck. During these operations, two welders were struck by falling used trucks being handled by a crane, resulting in death and injury.</p>	
	Probable causes	<p>It is probable that this accident occurred while the vessel was moored at the pier. Welders were working near the cargo unloading area in the No. 2 hold (hereinafter referred to as “the unloading area”). As the cargo (hereinafter referred to as “the cargo”) approached the</p>

<p>unloading area, the chain sling (hereinafter referred to as “the chain sling”) holding the front gooseneck part of a semi-trailer (hereinafter referred to as “the front part”) broke, causing the trucks to tilt to the port side and fall, hitting two welders.</p> <p>The chain sling in question likely had an insufficient maximum working load*1 for the maximum working load needed to lift the cargo on the effective side of an asymmetric lift. Additionally, if lateral loads were applied to the chain links on the front part, the links would be subjected to bending stresses exceeding the specified breaking stress for Grade 80 chains under ASTM standards. This could have led to the chain sling breaking under a load smaller than its breaking load*2.</p> <p>The stevedoring company did not call the two welders to the pre-operation meeting on the day of the loading/unloading work. They were unaware of the details of the loading/unloading operation. Additionally, the hold supervisor was late in noticing the approaching cargo and failed to communicate this, leading the welders to continue their work facing portside, unaware of the cargo approaching from the starboard side.</p> <p>The work supervisor, finding it difficult to see inside the No. 2 hold surrounded by hatch coaming, believed that loudly communicating the approach of the cargo to the hold supervisor would lead to the evacuation of workers from the unloading area. Despite loudly informing the workers inside the hold, the hold supervisor more likely did not receive the message, and the cargo approached the unloading area.</p> <p>The hold supervisor conversed with the hold workers about tasks, as there was a delay before the cargo would be lifted from the pier. Additionally, he did not hear the loud warning from the work supervisor about the approaching cargo. Consequently, it is probable that the hold supervisor noticed the cargo’s approach late and failed to evacuate workers from the unloading area in time.</p> <p>*1 The “maximum working load” refers to the maximum mass applied to a single chain sling during use. *2 The “breaking load” refers to the maximum load a single chain sling can withstand during a tensile test.</p>

Safety actions	<p>The following measures are suggested to prevent the recurrence of similar accidents:</p> <ul style="list-style-type: none"> • The stevedoring company should select slinging gear with sufficient capacity relative to the weight of the cargo, ensuring that the gear can handle the total weight of the cargo, especially on the effective side in asymmetric lifts. • When using slinging gear to lift cargo with rectangular sections like H-beams by looping under the cargo, the stevedoring company should account for the fact that concentrated loads at the ends of the rectangular sections can cause localized high stress. To distribute the stress, materials such as reinforced fabric rubber pads with adequate elasticity, hardness, tear resistance, and abrasion resistance should be used between the slinging gear and cargo. • Before starting loading/unloading operations, the stevedoring company should hold a meeting with the work supervisors and workers at the worksite to explain the following points: <ol style="list-style-type: none"> ① Work plan (schedule) ② Work procedures ③ Work methods ④ Confirmation of communication methods • Communication between workers during loading/unloading operations should be ensured using portable radios and visual signals such as hand gestures and flags. • The work supervisor should confirm that there are no workers in the cargo’s path before instructing the crane operator to move the cargo.

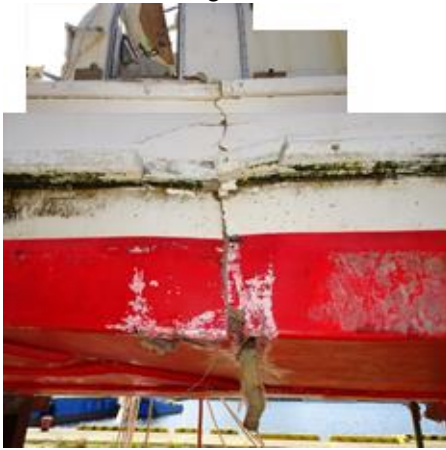
5	Date of publication	Date and location	Vessel type and name, accident type
	April 27, 2023	February 29, 2020 Off the northern coast of Katsumoto Port, Iki City, Nagasaki Prefecture	Fishing vessel TAKAHISAMARU (Vessel A) Recreational fishing vessel

SHINEIMARU (Vessel B) Collision
Summary	<p>With a master and one deckhand on board, Vessel A was heading north towards the fishing grounds off the coast north of Katsumoto Port, Iki City, Nagasaki Prefecture. Meanwhile, Vessel B, with only the master and five anglers on board, was drifting for recreational fishing purposes off the coast north of the same port when the two vessels collided, causing the capsizing of Vessel B.</p> <p>As a result of this collision, two anglers on Vessel B died, and three anglers and the master were injured. Additionally, the portside midsection of Vessel B sustained cracks and other damages (total loss), while Vessel A sustained cracks in the bow's outer plate.</p>	
Probable causes	<p>It is probable that this accident occurred off the coast north of Katsumoto Port, with Vessel A heading north towards the fishing grounds. The deckhand on Vessel A relied on radar for lookout, which was set in a way that could not detect Vessel B due to a blind spot ahead. Meanwhile, Vessel B, drifting with the bow facing west for recreational fishing, had the master focused on the GPS plotter*¹ and considering changes to the return route, believing no other vessels were approaching. This led to both vessels not noticing each other and the subsequent collision.</p> <p>The deckhand on Vessel A relied on radar for lookout because, typically, when detecting radar targets or recognizing multiple vessels outside the blind spot, they would look out of the left and right windows or sway the bow left and right to visually confirm the presence of other vessels within the blind spot. However, it is probable that just before the accident, no radar targets appeared, and no other vessels were seen outside the blind spot, leading the deckhand to believe no vessels obstructed their course and to continue using the radar to supplement the lookout for the blind spot ahead.</p> <p>It is probable that the deckhand on Vessel A could not detect Vessel B on the radar because the left radar, set to a short pulse width, was not adjusted for sensitivity, and the right radar was set to a long pulse width. This configuration made both radars unable to detect Vessel B as the distance decreased to approximately 1.2 miles.</p> <p>It is probable that the master of Vessel B believed no vessels were approaching because, after helping to retrieve fish on the portside midsection of the upper deck, he looked around the starboard side while returning to the wheelhouse and did not notice any approaching vessels.</p> <p>*1. The "GPS plotter" is a device that displays the ship's position on a map on the screen using information obtained from satellites via the Global Positioning System (GPS) and can plot the ship's track.</p>

Safety actions	<p>The following measures should be taken to prevent the recurrence of similar accidents and mitigate damage:</p> <ol style="list-style-type: none"> (1) Navigators should correctly understand their radar's performance, functions, and operation methods and adjust the range, pulse width, sensitivity, rain/snow clutter suppression, and sea clutter suppression levels according to the distance, terrain, weather, and sea conditions. (2) Navigators of vessels with blind spots due to the ship's structure should not rely solely on radar for lookout. They should use visual methods such as swaying the bow left and right to supplement the radar and maintain a proper lookout using all available means, including radar. (3) Shipowners should ensure that the visibility from the bow is maximized as much as possible when designing and constructing new vessels or modifying existing ones. (4) Navigators of drifting vessels should maintain a proper lookout in all directions to detect approaching vessels early. Upon recognizing an approaching vessel, they should issue a warning early and take measures to avoid a collision, such as starting the engine and moving the vessel. (5) Crew members of recreational fishing vessels should, even when they notice that their

<p>vessel is approaching another vessel and cannot avoid a collision, alert anglers as early as possible using the onboard microphone or other means to ensure they take actions to minimize damage, such as bracing for impact, avoiding injury, or jumping into the water to avoid being trapped inside the vessel in the event of a collision.</p> <p>(6) High-sided vessels with a small crew should equip ladders or other means to rescue anyone who falls overboard effectively.</p>	
	Report	https://www.mlit.go.jp/jtsb/ship/rep-acci/2023/MA2023-4-2_2020tk0002.pdf (Japanese)

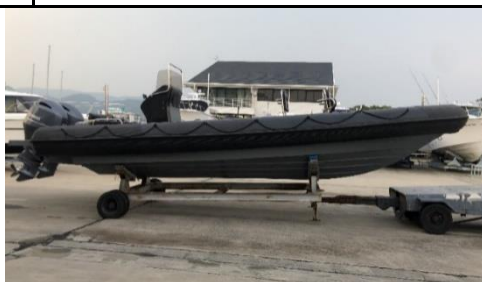
7	Date of publication	Date and location	Vessel type and name, accident type
	June 29, 2023	May 20, 2021 Off the southeast of Ohara Fishing Port, Isumi City, Chiba Prefecture	Recreational fishing vessel AMAMASAMARU (Vessel A) Recreational fishing vessel

HANABUSAMARU (Vessel B) Collision
	Summary	<p>Vessel A was heading south towards the fishing grounds, and Vessel B was drifting for recreational fishing when the two vessels collided.</p> <p>As a result, one angler on Vessel B died, and the aft deck extension sustained damage, while Vessel A sustained scrapes on the bow's outer plate.</p>	
	Probable causes	<p>It is probable that this accident occurred southeast of Ohara Fishing Port when Vessel A was heading south at approximately 13 knots under autopilot, moving to a different fishing spot. Meanwhile, Vessel B was drifting for recreational fishing. The master of Vessel A, believing no vessels were obstructing his course, continued navigating while organizing fishing gear in the wheelhouse's aft area, failing to notice Vessel B drifting ahead. Meanwhile, the master of Vessel B was focused on the anglers on the starboard deck, the GPS plotter, and the fish finder for vessel position adjustments, delaying his recognition of Vessel A's approach and leading to the collision.</p> <p>The master of Vessel A more likely thought no vessels were obstructing his course and continued navigating while organizing fishing gear in the wheelhouse's aft area because he was more concerned with the positions of four other recreational fishing vessels drifting and fishing from the port beam to the port bow rather than the bow itself, only glancing at the bow momentarily.</p> <p>The master of Vessel B continued drifting without noticing Vessel A's approach. It is probable that he was accustomed to other vessels avoiding his drifting vessel and believed they would do the same during this incident, leading to a decreased awareness of his surroundings.</p>

Safety actions	<p>The following measures should be considered to prevent the recurrence of similar accidents:</p> <ul style="list-style-type: none"> • Masters or other watchkeepers should constantly watch out while navigating and avoid being distracted by specific tasks, focusing on steering. • Masters or other watchkeepers should maintain a constant lookout while drifting and, upon recognizing approaching vessels, should not assume that the navigating vessels will avoid them, taking necessary measures to avoid collisions. • Masters or other watchkeepers should confirm the approach of other vessels by switching radar ranges appropriately in addition to visual observation. 	
	Report	https://www.mlit.go.jp/jtsb/ship/rep-acci/2023/MA2023-6-1_2021tk0005.pdf (Japanese)	 
8	Date of publication	Date and location	Vessel type and name, accident type
	June 29, 2023	June 5, 2022 Off the northern coast of Jino Island, Wakayama City, Wakayama Prefecture	Recreational fishing vessel No.2 EBISUMARU Fatality
