3. Case Studies of accidents

Case 1

Injuries suffered by passengers and cabin attendants from the shaking of the aircraft encountering turbulence during its descent in convective clouds

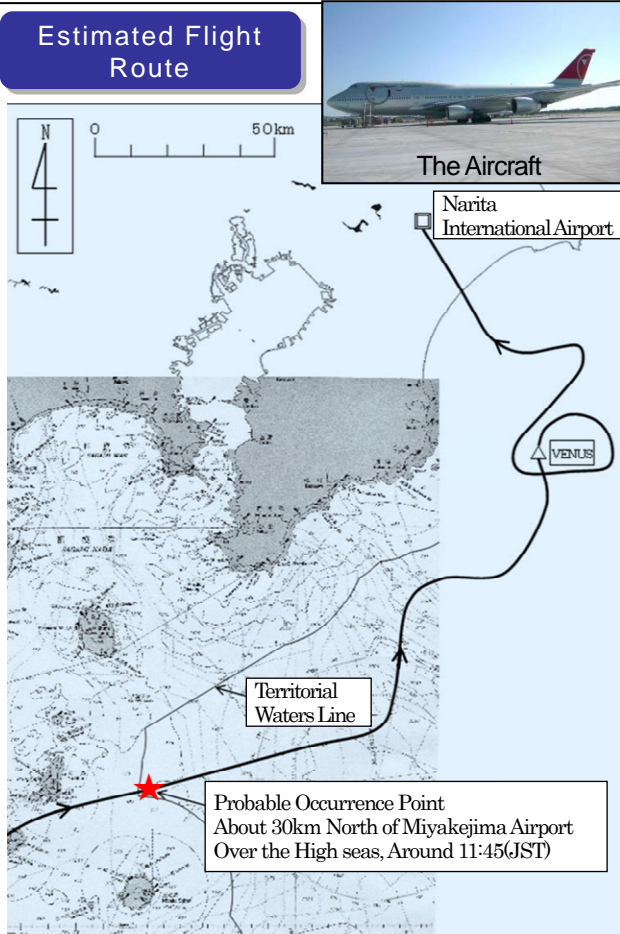
Summary : On Friday February 20, 2009, a Boeing 747-400, operated by Company A, took off from Manila (Ninoy Aquino) International Airport (Republic of the Philippines) bound for Narita International Airport (Japan) as the company's scheduled Flight. Around 11:45 Japan Standard Time (JST: UTC+9hr, unless otherwise stated, all times are indicated in JST on a 24-hour clock), the aircraft was hit by turbulence when it was flying at an altitude of about 30,300 ft about 174 km south-southwest of Narita International Airport (about 30 km north of Miyakejima Airport). Four passengers sustained serious injuries while 27 other passengers and seven flight attendants (FA) sustained minor injuries. There were 422 people on board, consisting of the pilot in command (PIC), 13 other crewmembers and 408 passengers. The aircraft interior was partially damaged.

The wind velocity began to change and dropped to approximately 100kt from approximately 150kt when the aircraft was descending by approximately 500ft from an altitude of approximately 30,700ft. At around that time, the bumpiness became intensified with altitude fluctuations.

When the Aircraft was descending at an altitude of about 30,300 ft, the vertical acceleration changed: from +1.36G to -0.52G, then to +1.70G. At that time, the pitch angle of the Aircraft decreased by about 0.5 degree in the nose-down direction and after the decrease, quickly increased by about two degrees in the nose-up direction.

Probable Causes: It is considered highly probable that this accident occurred when the Aircraft pitched greatly upon encountering a turbulence during its descent through a turbulent airspace of convective clouds near the front and below the jet stream, causing serious injuries to four passengers in the aft cabin section: who were not seated; who were not being buckled up; or if done so, who did it in an inappropriate manner.
