Case 3

Injuries suffered by FAs from the shaking of the aircraft encountering turbulence after entering cumulonimbus clouds that suddenly developed

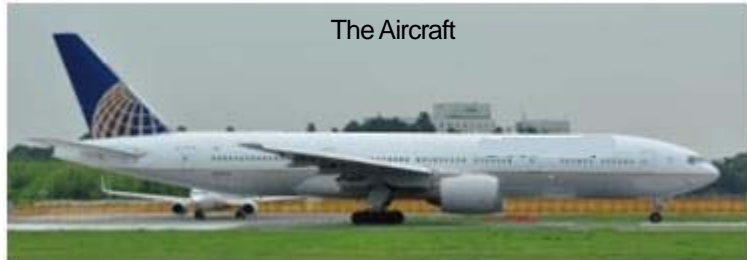
The Aircraft

The aircraft encountered a moderate turbulence when it entered some clouds while going around. Serious and slight injuries were suffered by four FAs working in the rear galley of the aircraft as a result of the severe shaking of the aircraft.

In the rear galley where the four injured FAs were working
