# JTSTB Digests

JTSTB (Japan Transport Safety Board)

(Issued in January, 2015)

## Digest of Aircraft Accident Analyses For Prevention of Accidents due to the Shaking of the Aircraft

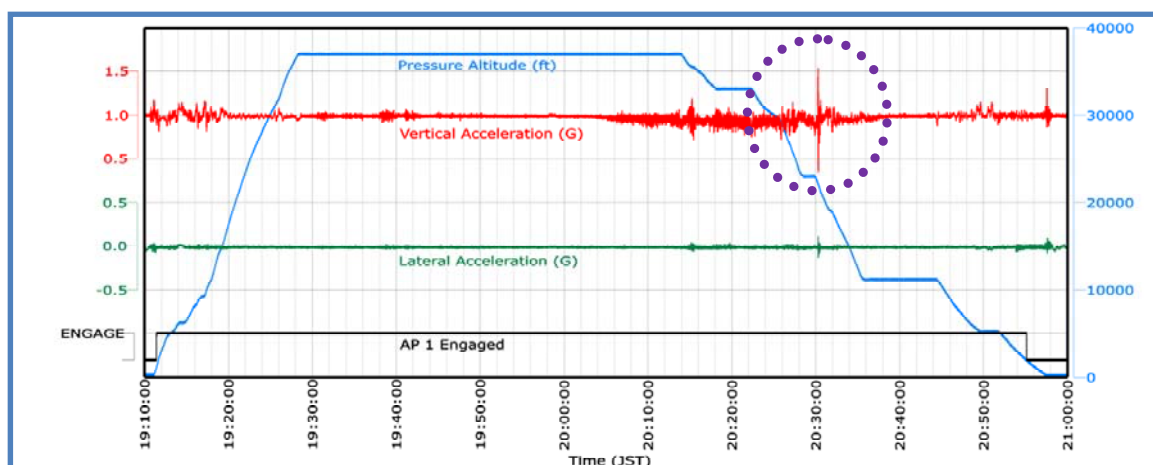
Figure 1 Example of Recording by DFDR (Digital Flight Data Recorder) (a large change in vertical acceleration (G) can be seen in aircraft shaking accidents)

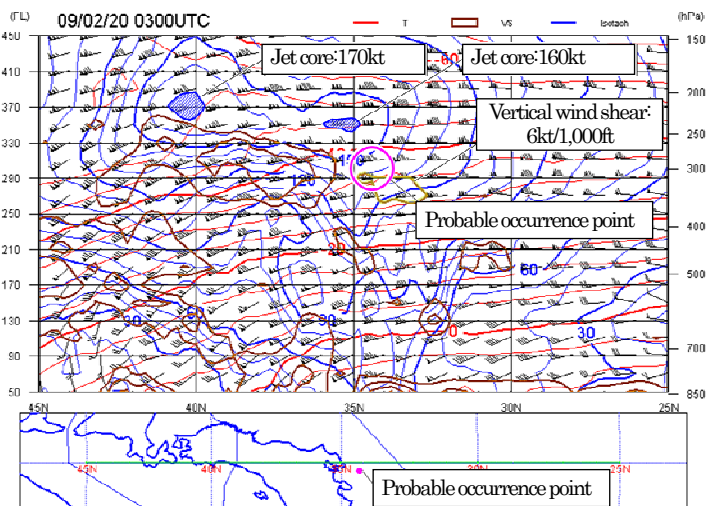
Hourly Analysis Chart

Because warm and damp winds were blowing from the south into the low pressure near the Tokai region, generating unstable atmospheric condition. As a result, it is considered highly probable that clumpy convective clouds were developing there.

It is highly probable that clumpy convective clouds developed from the waters off the Tokai region to the Kanto region.

A vertical wind shear of 6kt/1,000 ft was observed amid jet stream near Latitude 35° N at an altitude of 26,000 to 30,000 ft. Therefore, it is considered highly probable that turbulent air was generated in the airspace near the place where the accident occurred.

1200JST 20 FEB 2009(Longitude 140°E) Some information was overlaid onto the JMA document.

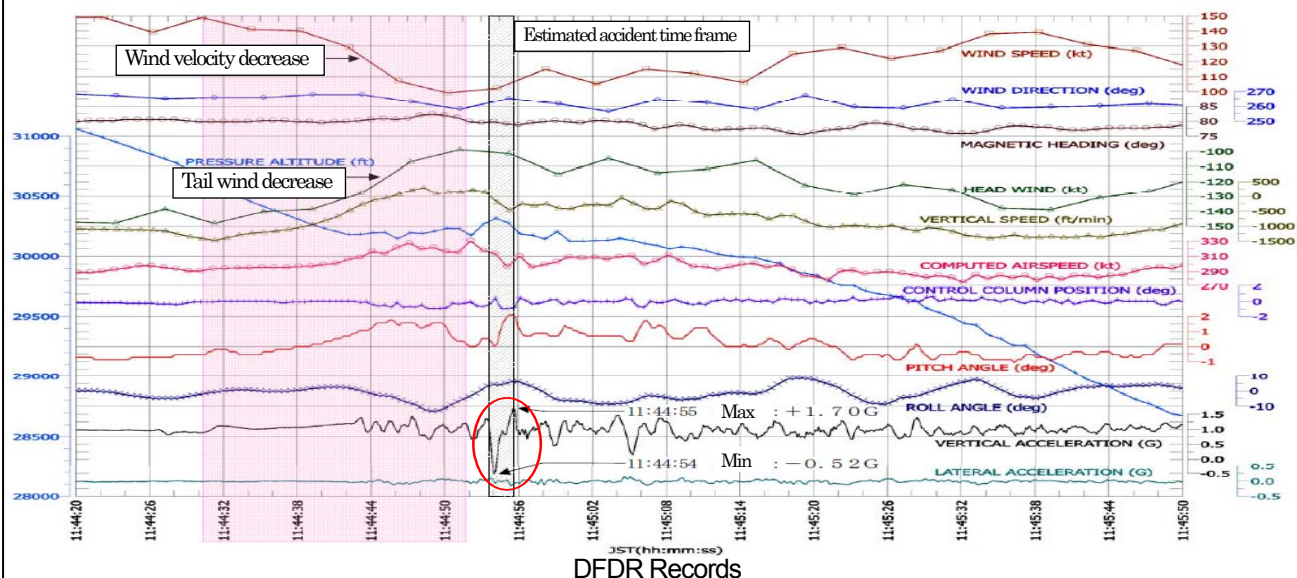
The wind velocity was 130 to 140kt in the vicinity of the airspace where the accident occurred. But the wind velocity that the Aircraft actually flew varied by about 50kt from about 150 kt to about 100kt. Therefore, it is considered highly probable that the Aircraft was influenced by the sudden large wind velocity change near the airspace where the accident occurred.

**Probable Causes:** It is considered highly probable that this accident occurred when the Aircraft pitched greatly upon encountering a turbulence during its descent through a turbulent airspace of convective clouds near the front and below the jet stream, causing serious injuries to four passengers in the aft cabin section: who were not seated; who were not being buckled up; or if done so, who did it in an inappropriate manner.

It is considered somewhat likely that the following factors contributed to the serious injuries of aft cabin passengers: safety of passengers was not fully confirmed in the aft cabin section during the time frame between the seat belt sign illumination and the abrupt big aircraft pitching; and the aft cabin was exposed to a stronger negative vertical acceleration compared to the forward.

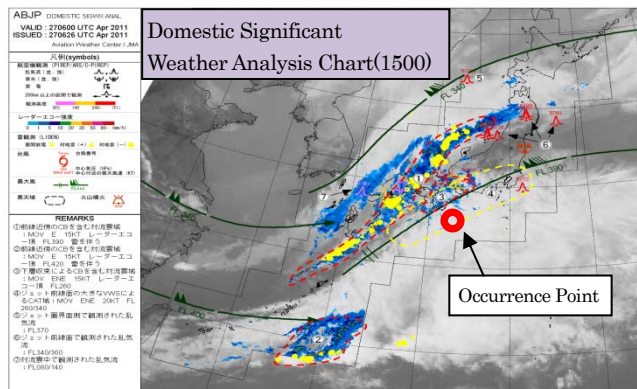
A radar echo area which developed along the forefront of the cold front extending from the low spread like a belt and was advancing to the east at 15kt. The area of strong radar echo intensity and high top radar echo altitudes were observed along the area off the coast of Shikoku, Chugoku Region and off the coast of Hokuriku. However, there were very few echoes present with 5mm/h or less in the airspace where the accident occurred, and their tops were as low as 2 to 4km high.

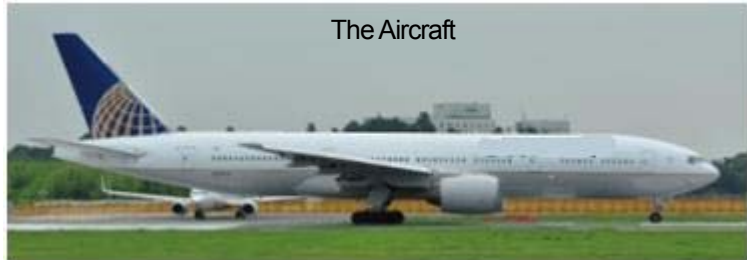
#### The Aircraft

The aircraft encountered a moderate turbulence when it entered some clouds while going around. Serious and slight injuries were suffered by four FAs working in the rear galley of the aircraft as a result of the severe shaking of the aircraft.

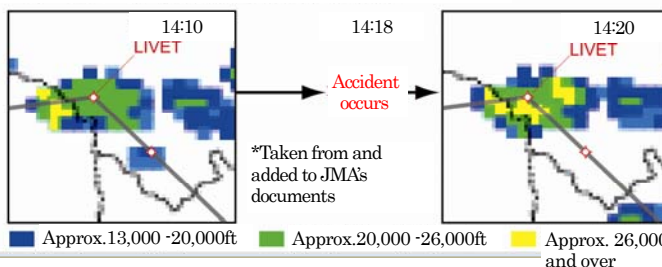
Weather Radar Imagery (Top height: indicates cloud height)

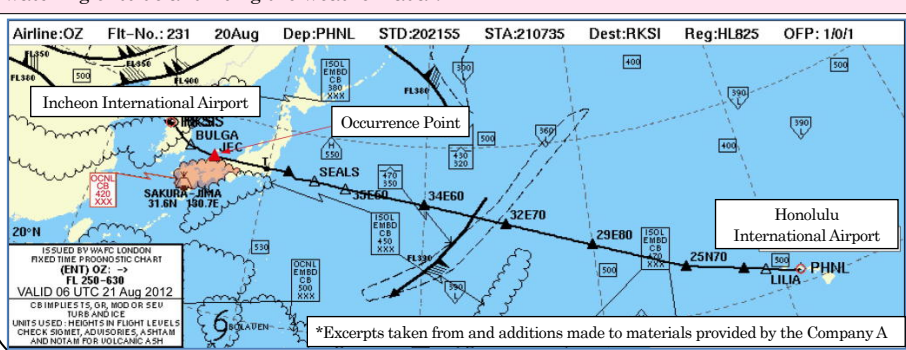
According to the statements of the PIC, although it was forecast in the pre-flight weather briefing that there would be a cloud top height of 42,000ft around the flight route, no significant weather conditions such as clouds was forecast on the flight route including the accident point; however there was a possibility that the nearby clouds expanded to the site of the accident.

The Significant Weather Prognostic Chart for International Aviation issued by the London WAFC and confirmed by the PIC in the pre-flight briefing.

It was necessary for the PIC and the Route Captain to continually obtain the most current weather information from the Operation Control Center and other organizations during flight and also to pay close attention to the weather conditions on the flight route by watching outside and using the weather radar.

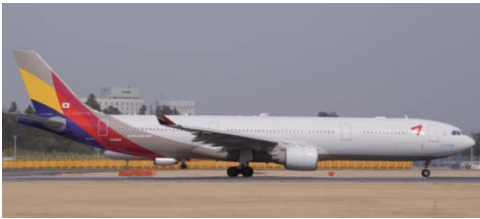
The aircraft

**Probable Causes** : It is highly probable that in this accident, serious injury was sustained by a passenger walking in the rear aisle due to the severe shaking of the Aircraft, and that serious injury was sustained by another passenger seated nearby when the passenger removed the seat belt in order to help the injured passenger, the Aircraft shook severely again at that moment.
