JTSTB Digests

JTSTB (Japan Transport Safety Board)

(Issued in February 2017)

Digest of Aircraft Accident Analyses For prevention of Accidents Involving Private Small Aircraft and Gliders

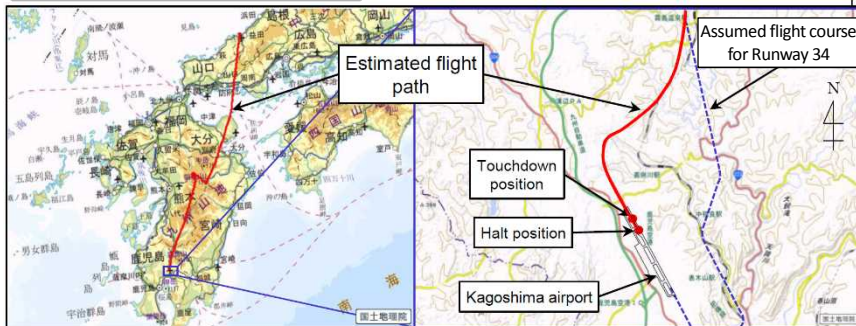
Estimated Flight Route

Summary: A privately owned Cessna 172RG took off from Iwami Airport for a familiarization flight, and made a belly-landing at Kagoshima Airport on Sunday, April 26, 2015. The Aircraft sustained damage.
