JTTSB (Japan Transport Safety Board) DIGESTS

Digest of Aircraft Accident Analyses

Injuries suffered in Use of Evacuation Slides during an Emergency Evacuation

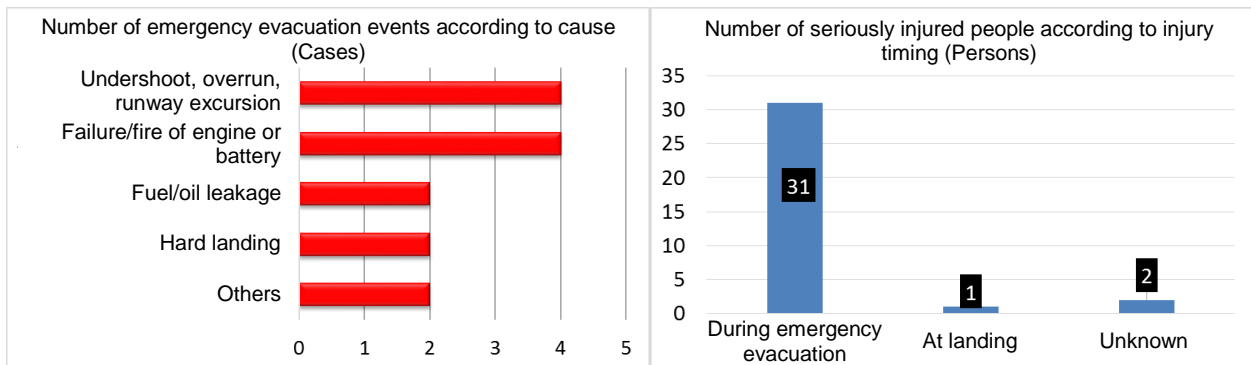
Fig. 1

According to the 14 cases of the accident investigation reports issued by JTSB and its predecessors (Table 1), emergency evacuation procedures were conducted not only in cases that a normal landing was not possible, such as an undershoot, overrun and runway excursion, but in cases that a fire occurred (Fig. 1). In most of such cases, passengers suffered injuries during evacuation (Fig. 2).
