## Case 2

### A crew member who was engaged in cargo unloading entered a cargo tank and died of suffocation caused by oxygen deficiency

Outline: At around 13:55, March 10, 2010, while the Vessel (same as the vessel in Case 1) was unloading about 380 tons of chemical liquid cargo containing tert-butyl alcohol (TBA) at the consignee's No. 2 pier (the Pier) in Kawasaki Section of Keihin Port, the chief officer who was engaged in cargo unloading entered portside No.2 cargo tank (the Tank), and died of suffocation caused by oxygen deficiency.

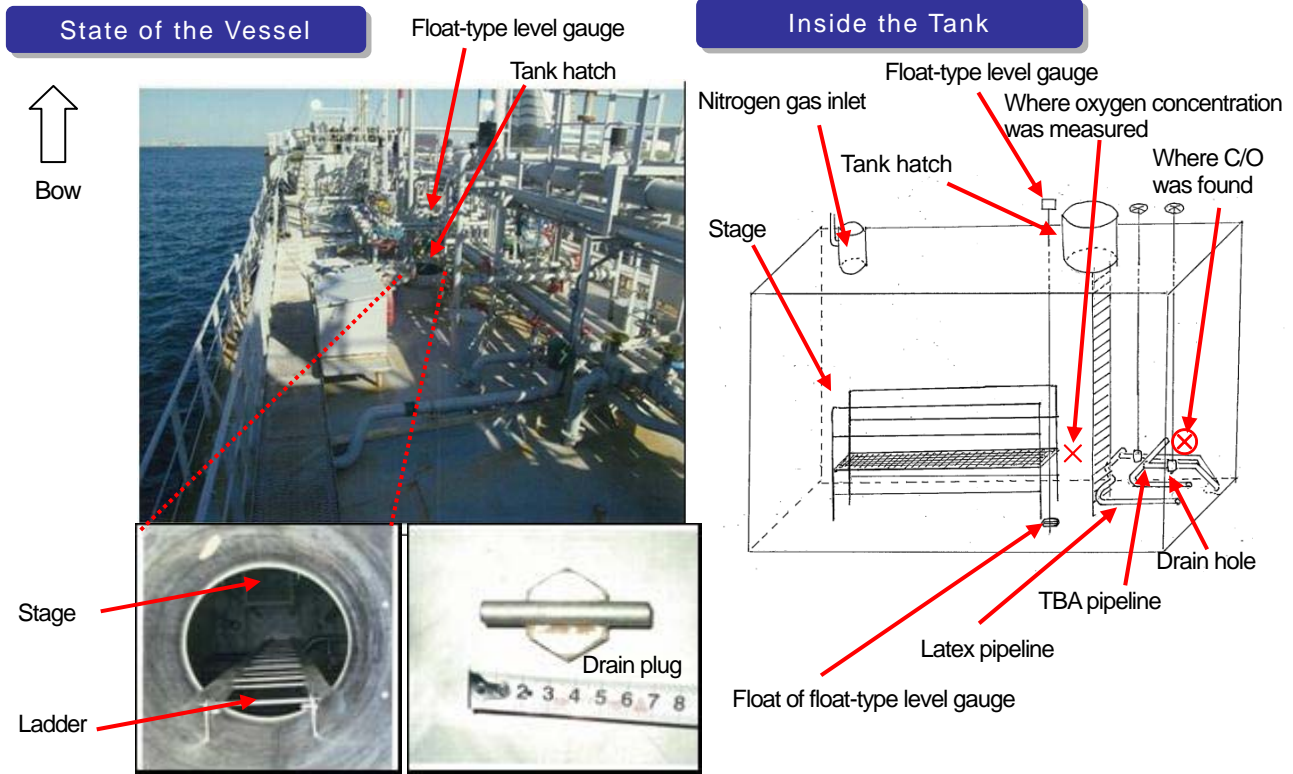
Upon checking inside the Tank from the upper surface of the opened hatch to see why it became unable to unload TBA inside the Tank, C/O found that a drain plug was placed on the stage of the Tank, and was not restored in the proper position.

According to the findings that the drain plug was not restored in the drain hole of the cargo pipe inside the Tank, it is considered probable that air was absorbed through the drain hole while unloading, and it became unable to transfer TBA.

In order to restore the drain plug, C/O ran for getting a gas mask without measuring oxygen concentration inside the Tank, and entered the Tank after wearing the gas mask.

C/O entered the Tank wearing the gas mask without measuring oxygen concentration.

According to the findings that although the gas concentration inside the Tank was 16% at around 14:23, C/O stopped moving at around 13:55 soon after picking up the drain plug and fixing it in the drain hole by screwing it three times, it is considered somewhat likely that the gas concentration near the drain hole was not so high as to cause instant death, but to the extent of causing the loss of consciousness in a short time (10% or less).

Accordingly, vessel owners are required to provide the crew of chemical tankers with safety education about the possibility that a state of oxygen deficiency will be caused depending on the nature of cargo to handle, as well as the method of cargo handling, and further to instruct them never to fail to measure oxygen concentration before entering a cargo tank which is feared to turn into a state of oxygen deficiency.

Furthermore, considering that crew members other than C/O and 1/E were unaware when the accident occurred that nitrogen gas was injected into the cargo tank while unloading work was going on, and even C/O may have forgotten it, it is earnestly recommended that stevedores working on the shore side should notify the crew of a chemical tanker properly before injecting gas into a cargo tank to lower oxygen concentration.
