**AIRCRAFT SERIOUS INCIDENT  
INVESTIGATION REPORT**

**KAWASAKI HEAVY INDUSTRIES, LTD.  
7033**

**June 30, 2022**

RUNNING OFF THE SIDE OF A RUNWAY  
KAWASAKI HEAVY INDUSTRIES, LTD.  
P-1 FIXED WING PATROL AIRCRAFT, 7033  
GIFU AIRFIELD  
AT ABOUT 16:00, SEPTEMBER 7, 2021

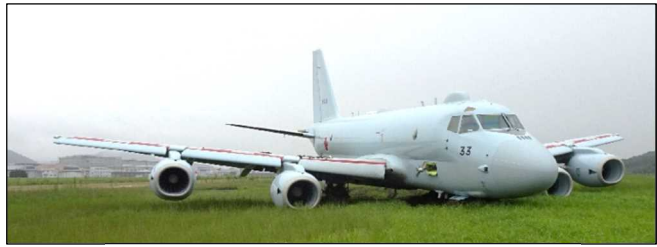
Figure 1: Serious Incident Aircraft

After landing on Runway 28 (runway direction: 281°) at Gifu Airfield at about 15:59JST (JST: UTC+9 hours; unless otherwise noted, all times are indicated in JST in this report on a 24-hour clock), the Aircraft came to stop in the grassy area located on the right side (north side) of the runway and was disabled to perform taxiing. The crew members disembarked the Aircraft by themselves, and no one was injured.

<b>2.2 Injuries to Persons</b>	None																																		
<b>2.3 Damage to the Aircraft</b>	<p>Minor damage</p> <ol style="list-style-type: none"> <li>1. Nose landing gear doors: Partial fracture of its components</li> <li>2. Tires: Damaged</li> <li>3. Fuselage and main wings: Scratch marks and dents</li> <li>4. No. 2 and No.3 engines: Partial deformation of its fan blades</li> </ol>																																		
<b>2.4 Personnel Information</b>	<p>At the time of the occurrence of the serious incident, the Aircraft was performing a test flight by the crew members who held the following competence certificate on qualifications while obtaining the permission in compliance with Article 28, paragraph (3) of Civil Aeronautics Act (Permission for the acts outside of the scope of service).</p> <p>(1) Captain: Age 40</p> <table border="0" style="width: 100%;"> <tr> <td style="padding-left: 20px;">Pilot certificate (Ministry of Defense)</td> <td style="text-align: right;">March 25, 2005</td> </tr> <tr> <td style="padding-left: 20px;">Type rating for P-1</td> <td style="text-align: right;">September 12, 2014</td> </tr> <tr> <td style="padding-left: 20px;">Aviation medical examination certificate (Ministry of Defense)</td> <td></td> </tr> <tr> <td style="padding-left: 40px;">Validity</td> <td style="text-align: right;">September 7, 2022</td> </tr> <tr> <td style="padding-left: 20px;">Total flight time</td> <td style="text-align: right;">5,468 hours 24 minutes</td> </tr> <tr> <td style="padding-left: 40px;">Flight time in the last 30 days</td> <td style="text-align: right;">15 hours 06 minutes</td> </tr> <tr> <td style="padding-left: 20px;">Flight time on the type of aircraft</td> <td style="text-align: right;">1,409 hours 36 minutes</td> </tr> <tr> <td style="padding-left: 40px;">Flight time in the last 30 days</td> <td style="text-align: right;">12 hours 48 minutes</td> </tr> </table> <p>(2) First Officer: Age 41</p> <table border="0" style="width: 100%;"> <tr> <td style="padding-left: 20px;">Pilot certificate (Ministry of Defense)</td> <td style="text-align: right;">July 18, 2003</td> </tr> <tr> <td style="padding-left: 20px;">Type rating for P-1</td> <td style="text-align: right;">February 7, 2018</td> </tr> <tr> <td style="padding-left: 20px;">Aviation medical examination certificate (Ministry of Defense)</td> <td></td> </tr> <tr> <td style="padding-left: 40px;">Validity</td> <td style="text-align: right;">August 1, 2022</td> </tr> <tr> <td style="padding-left: 20px;">Total flight time</td> <td style="text-align: right;">5,745 hours 36 minutes</td> </tr> <tr> <td style="padding-left: 40px;">Flight time in the last 30 days</td> <td style="text-align: right;">23 hours 00 minute</td> </tr> <tr> <td style="padding-left: 20px;">Flight time on the same type of aircraft</td> <td></td> </tr> <tr> <td style="padding-left: 40px;">Flight time in the last 30 days</td> <td style="text-align: right;">1,340 hours 54 minutes</td> </tr> <tr> <td style="padding-left: 40px;">Flight time in the last 30 days</td> <td style="text-align: right;">22 hours 24 minutes</td> </tr> </table> <p>(3) Flight Engineer: Age 51</p>	Pilot certificate (Ministry of Defense)	March 25, 2005	Type rating for P-1	September 12, 2014	Aviation medical examination certificate (Ministry of Defense)		Validity	September 7, 2022	Total flight time	5,468 hours 24 minutes	Flight time in the last 30 days	15 hours 06 minutes	Flight time on the type of aircraft	1,409 hours 36 minutes	Flight time in the last 30 days	12 hours 48 minutes	Pilot certificate (Ministry of Defense)	July 18, 2003	Type rating for P-1	February 7, 2018	Aviation medical examination certificate (Ministry of Defense)		Validity	August 1, 2022	Total flight time	5,745 hours 36 minutes	Flight time in the last 30 days	23 hours 00 minute	Flight time on the same type of aircraft		Flight time in the last 30 days	1,340 hours 54 minutes	Flight time in the last 30 days	22 hours 24 minutes

The JTTSB concludes that the partial fracture of the nose landing gear doors most likely occurred because the doors made contact with the ground when the nose landing gear sank in the grassy area. In addition, it is highly probable that the Aircraft rolled up soil and pebbles in the grassy area after running off the side of the runway, which caused many scratch marks and dents on the fuselage and main wings as well as deformation of the engine blades.

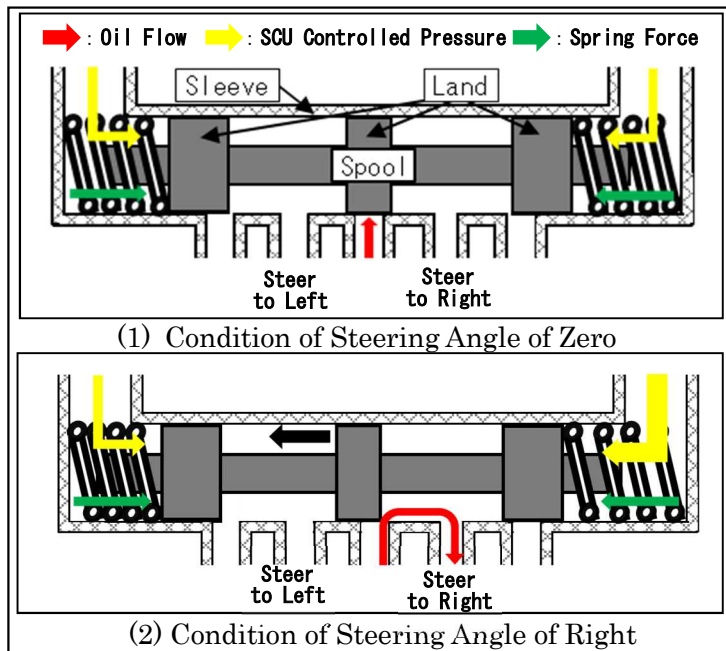
Figure 4: Status of SCV main stage (conceptual)

Foreign materials such as aluminum alloy, low alloy steel, copper alloy, cress and others were found in hydraulic oil in the SCV and S-ACT in the detailed examination of the steering systems component. Among these objects, the copper alloy was the material not used for steering systems accessories.

The size of found foreign materials was larger than the filtration grain size of the filter installed in SCV.

The observation with an optical microscope found several scratch marks on the spool (material: stainless steel 440 C) in the SCV, however, it was not able to identify the material which had made the scratches because they were too small.
