AI2008-1

AIRCRAFT SERIOUS INCIDENT INVESTIGATION REPORT

**TRANSMILE AIR SERVICES (Malaysia)
McDonnell Douglas MD-11F, 9M-TGS
OVER THE SEA 30km SOUTHWEST OF CAPE ASHIZURI, KOCHI
PREFECTURE (Japan)
JANUARY 10, 2007**

**Aircraft and Railway Accidents Investigation Commission
Ministry of Land, Infrastructure and Transport**

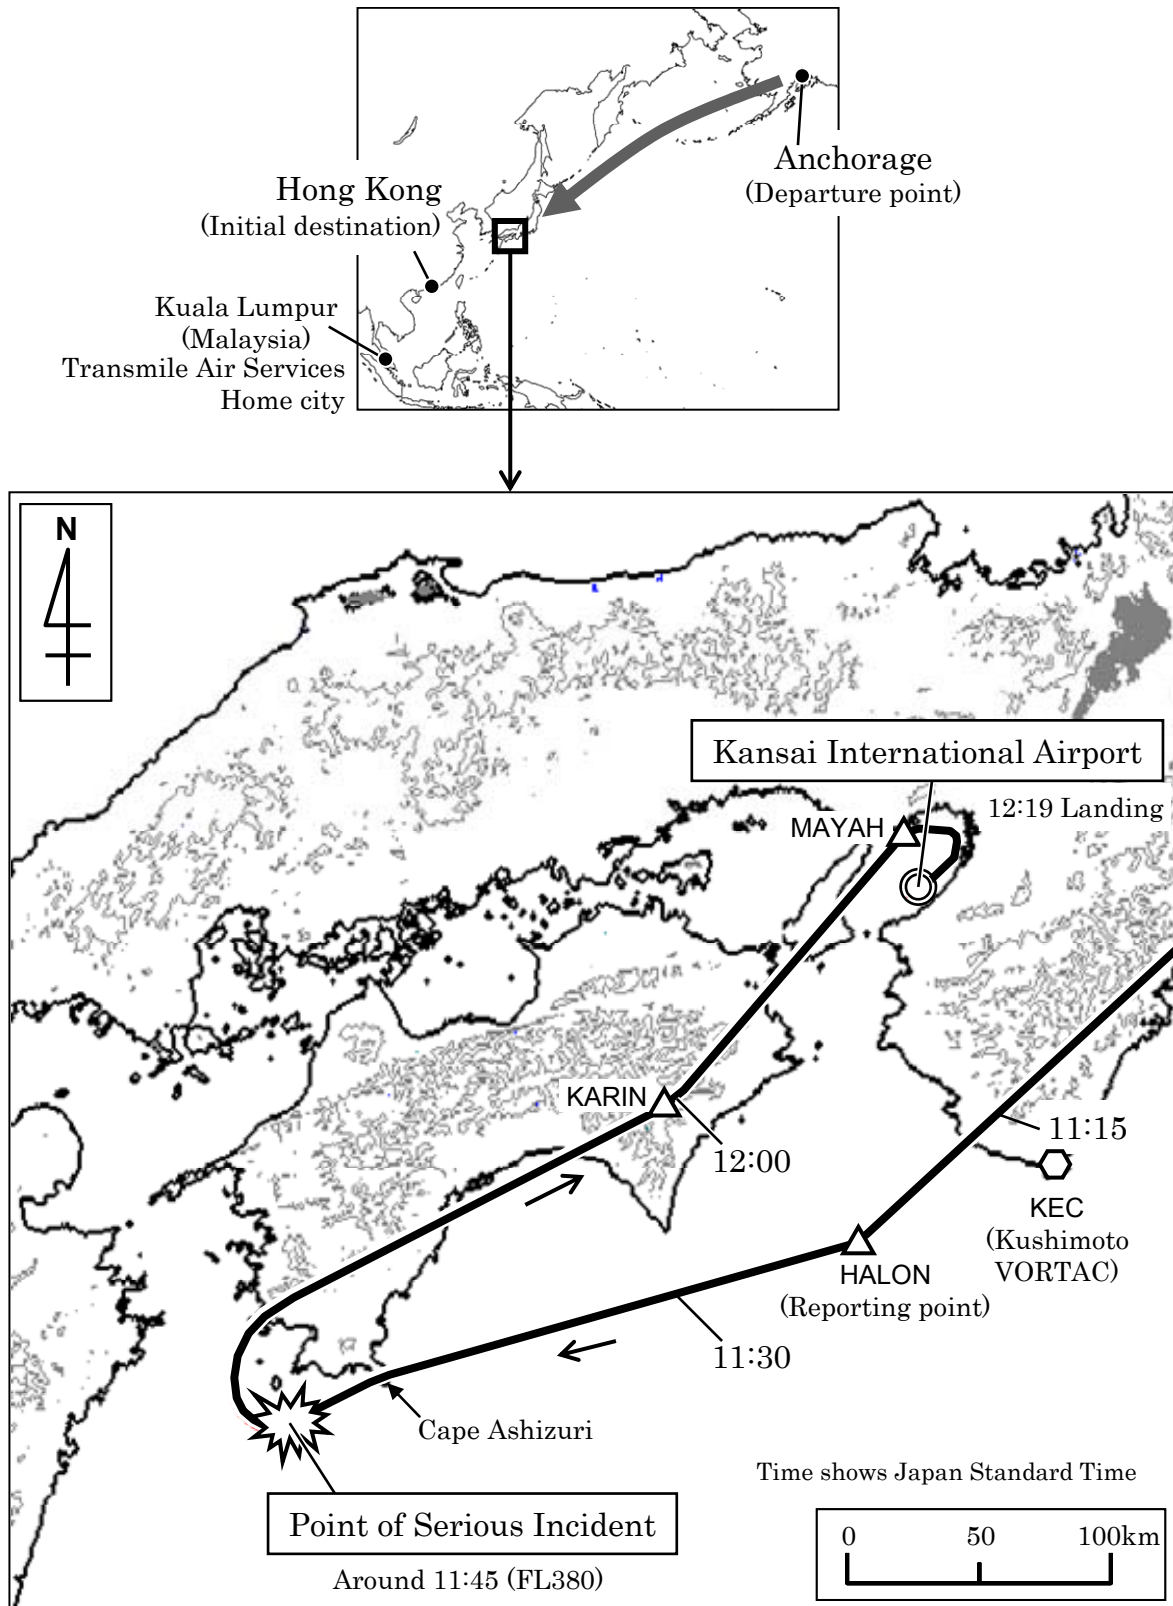
Figure 1 Estimated Flight Route

The aircraft was in level flight on air route A1 at FL 380 to the southwest. At around 11h46m, over the sea approximately 47 km to the southwest of Cape Ashizuri, the aircraft made a right turn, passed KARIN (PRP: Position Reporting Point), and MAYAH (PRP), and landed at the airport. (See Figure 1)

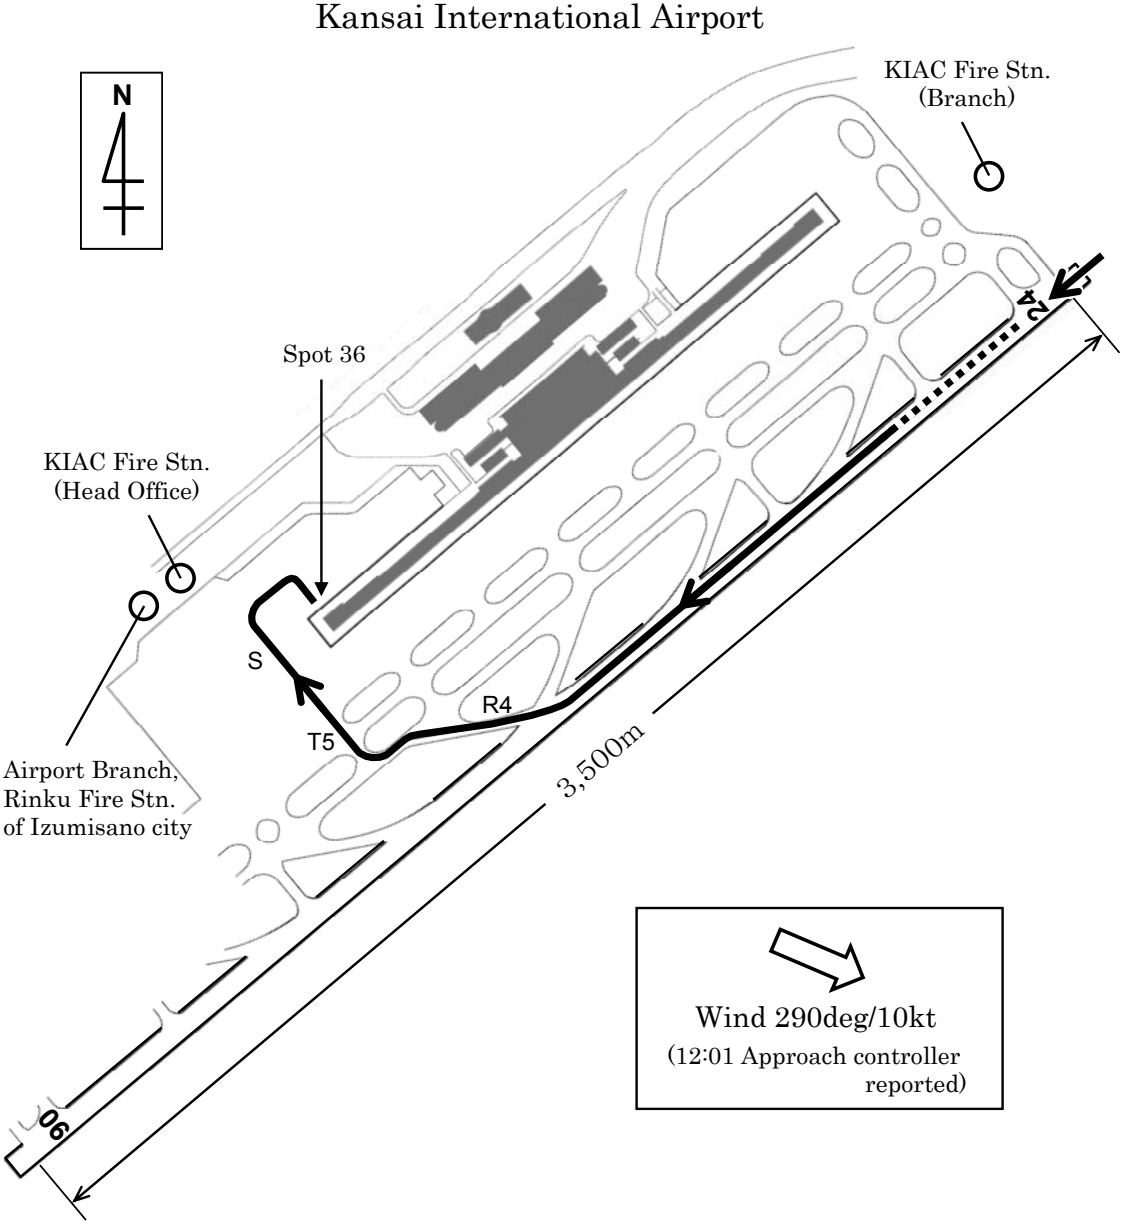
Figure 4 Taxing Route

The aircraft parked at Spot 36 at 12:24, and SIC was carried to a hospital by an ambulance. (See Figure 4)
