**AIRCRAFT ACCIDENT  
INVESTIGATION REPORT**

**TIGERAIR TAIWAN  
B 5 0 0 1**

**CABIN CREW MEMBER INJURY BY THE AIRCRAFT SHAKING**

**AIRBUS A320-232, REGISTERED B50001**

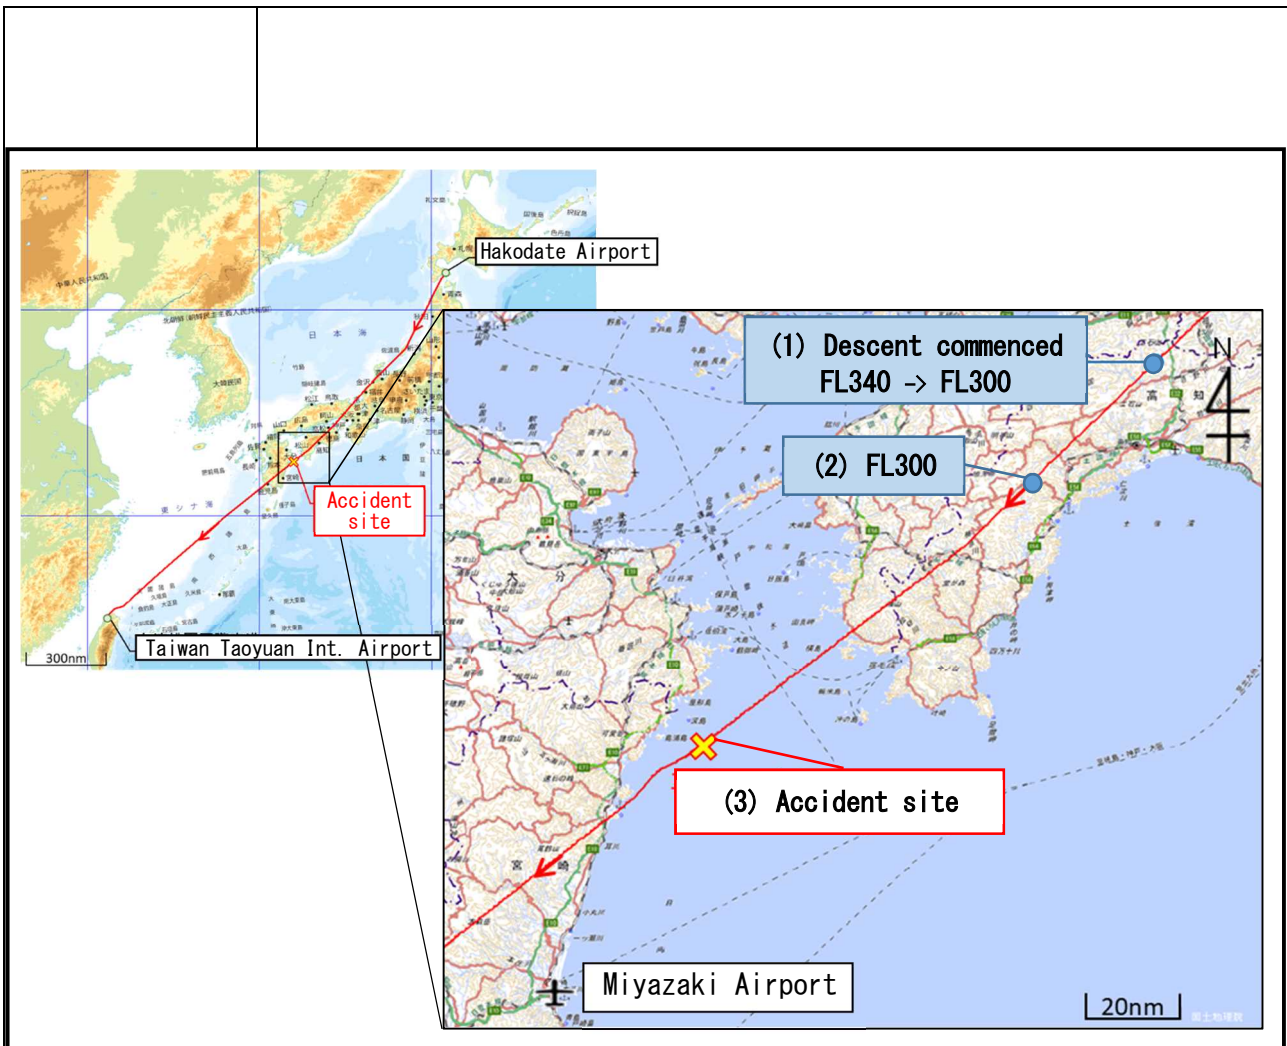
Figure 3 Estimated flight route

After having confirmed with Fukuoka Area Control Center that no Pilot Report (PIREP) was issued at FL300, the aircraft flying at FL340 commenced descending to FL300 at 15:54 due to the strong headwind at the said altitude and the performance of the aircraft of being unable to climb to FL360 or higher resulting from the aircraft weight (see Figure 3 (1)).

The aircraft reached FL300 at 15:59 and entered level flight (see Figure 3 (2)). The airstream began to be aggravated at 16:08 and the FO illuminated seatbelt sign. The aircraft was flying in thin and misty clouds. Besides, no echo was displayed on airborne weather radar of the aircraft. As the aircraft began to shake fiercely about 16:09, the FO decelerated to the recommended speed for passing through turbulence with autopilot system (hereinafter referred to as “the Autopilot”) being engaged. The airstream was further aggravated, and the FO rang seatbelt chime twice to let cabin crew be seated in accordance with FOM\*5. The turbulence was further worsened, and when the aircraft steeply climbed, the FO moved control column (hereinafter referred to as “the sidestick”) forward, which disengaged the Autopilot with the sound of Autopilot disengagement, and Autopilot disengagement was displayed on flight mode annunciator. Although flight crew recognized that the Autopilot was disengaged, the situation was such that manual control by the FO was not performed, the vertical speed of the aircraft increased to 9,300 ft/min maximum, the pressure altitude rose to 31,200 ft, and the roll angle leaned 15° to the right (see Figure 9). Then, the FO transferred the control to the PIC. Although the PIC attempted to stabilize the aircraft attitude, the aircraft subsequently climbed to 33,200 ft (about 16:12:38).

The accident occurred at FL300 over approximately 100 km north-northeast of Miyazaki Airport (32°38'01 N, 131°58'20 E) about 16:12 on December 25, 2019 (see Figure 3(3)).

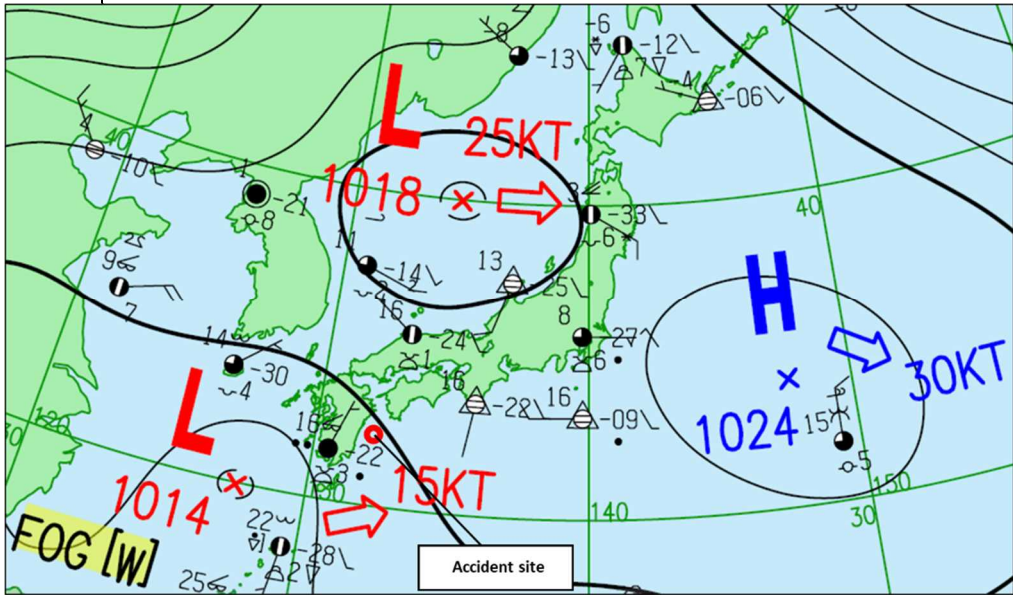
Figure 4 Excerpt from the Asia Pacific Surface Analysis Chart as of 15:00 on December 25, 2019

<b>2.6 Meteorological Information</b>	<p>(1) General weather forecasts</p> <p>The Asia Pacific Surface Analysis Chart (Figure 4) as of 15:00 on December 25, 2019, showed that low pressure, which generated in the west of Kyushu, was developing and moving to the east.</p>

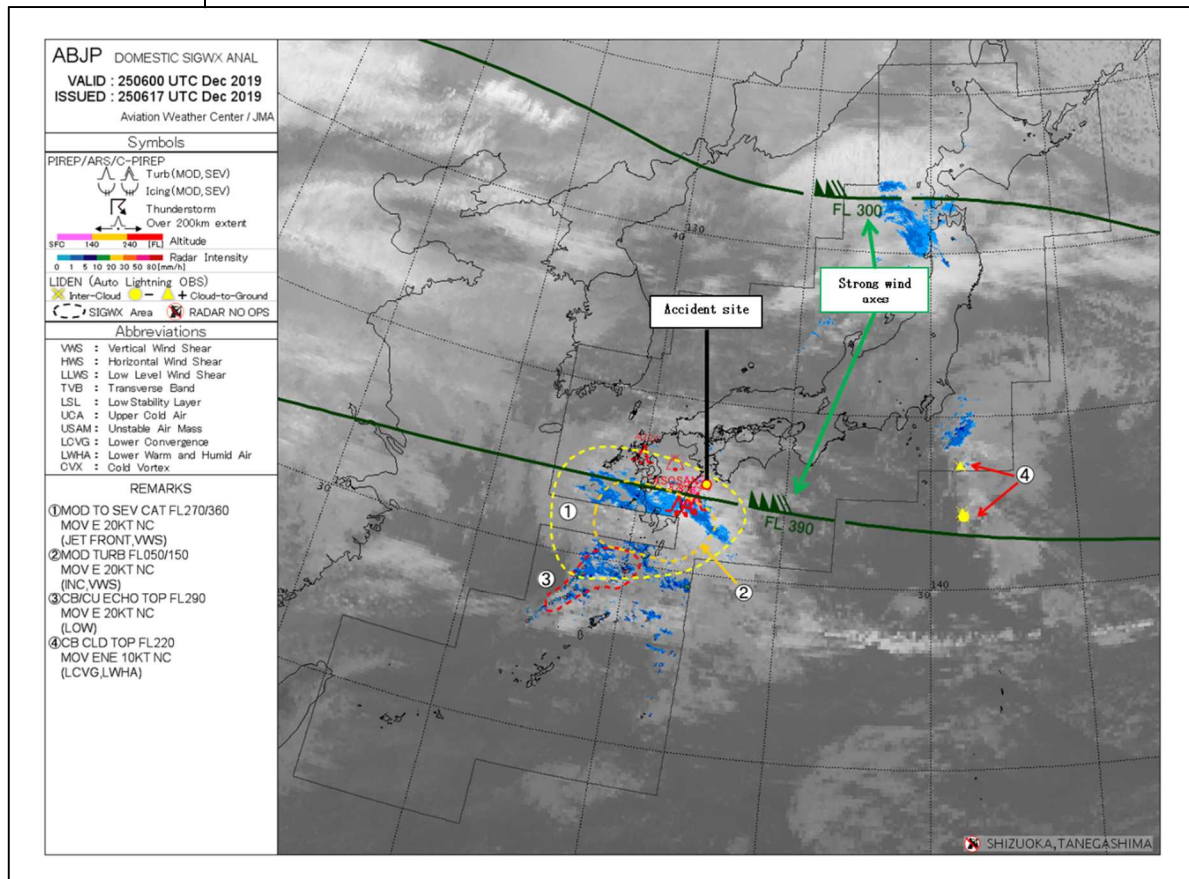
Figure 5 Significant Weather Analysis Chart as of 15:00 on December 25, 2019

Significant Weather Analysis Chart (Figure 5) as of 15:00 on December 25, 2019, showed two strong wind axes in the vicinity of Japan accompanying a jet stream. The southern strong wind axis out of the two was reaching the east of Japan from the west of Kyushu via the vicinity of the accident site and through the south of Shikoku.

Moderate to severe clear air turbulence area existed at FL270 through FL360 in the southern strong wind axis over Kyushu and was moving to the east at 20 kt (area of circled “1” in Figure 5).

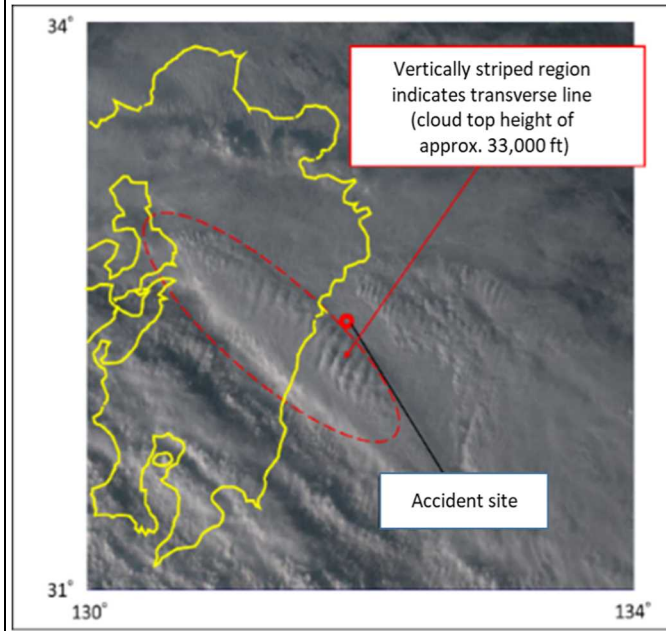
Figure 6 Satellite Image Excerpt as of 16:00 on December 25, 2019 (partially modified)

Satellite image (visualized image in color covering the areas of Japan and from 130° through 134° E to 31° through 34° N) (Figure 6) as of 16:00 on December 25, 2019, showed the high clouds with cloud top height of 33,000 ft along the southern jet stream shown in the Significant Weather Analysis Chart, the shape of which formed a transverse line\*7 indicating disturbance of the atmosphere, that reached the south of Shikoku from the west of Kyushu via the accident site.

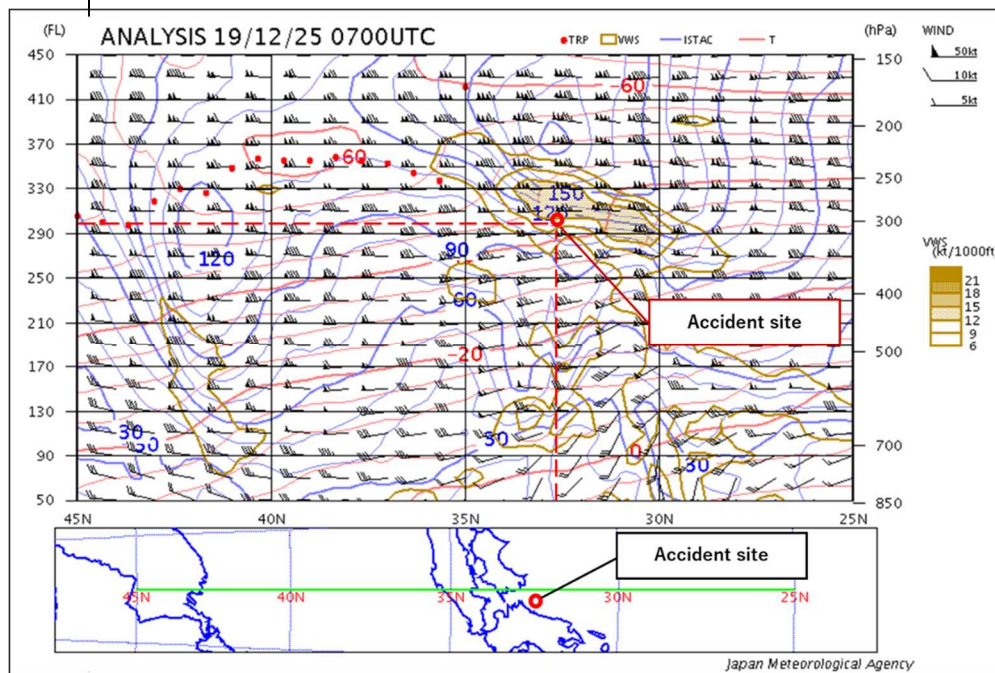
Figure 7 Hourly atmosphere analysis chart (sectional view: 132.5° E) as of 16:00 on December 25, 2019

Hourly atmosphere analysis chart (sectional view: 132.5° E) (Figure 7) as of 16:00 on December 25, 2019, showed Vertical Wind Shear (VWS) area, which indicated disturbance of the atmosphere, at an altitude near 33,000 ft where the transverse line generated, and in the skies below the southern strong wind axis. The VWS area at 15 through 18 kt/1,000 ft was shown in the vicinity of the accident site.

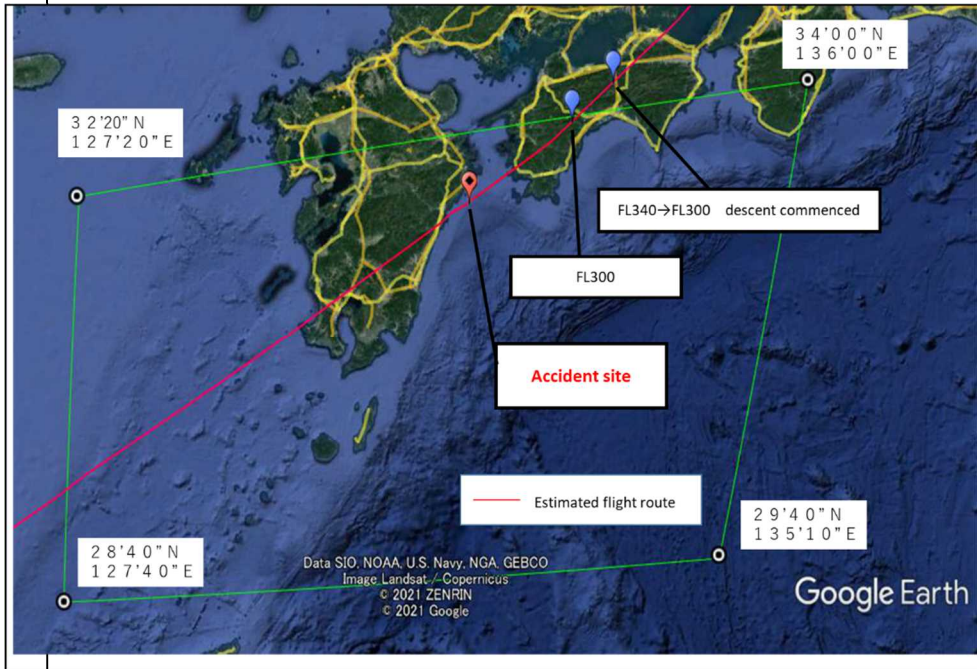
Figure 8 SIGMET released at 14:00 on December 25, 2019

During the period from 14:00 until 18:00, severe turbulence was predicted at FL270 through FL350 in the area of 28°40" N, 127° 40" E, 32°20" N, 127°20" E, 34°00" N, 136°00" E, 29°40" N, 135°10" E, and 28°40" N, 127°40" E (see Figure 8), which would move to the east at 20 kt for further development.

Since SIGMET is the information on significant changes in weather conditions pertaining to safety of the flight, it is probable to be useful to prevent recurrence of similar accidents that the OCC has system in place to obtain SIGMET information in a timely manner and provide it with flight crew as appropriately.
