**AIRCRAFT ACCIDENT
INVESTIGATION REPORT**

**ENGINE FIRE DURING TAKE-OFF ROLL
KOREAN AIR LINES CO., LTD.
BOEING 777-300, HL7534**

**ON RUNWAY 34R
AT TOKYO INTERNATIONAL AIRPORT
AT AROUND 12:38 JST, MAY 27, 2016**

July 6, 2018

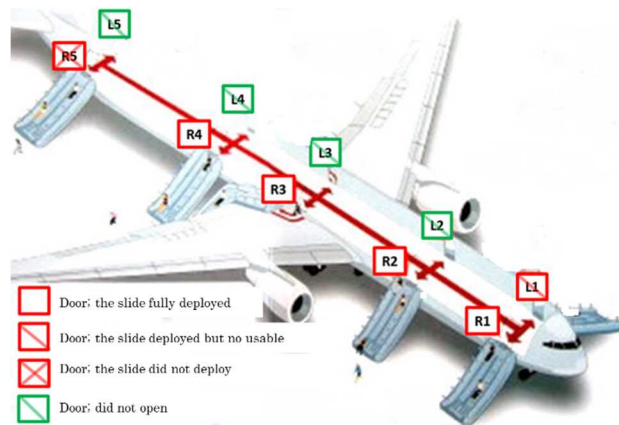
Figure 1. Door Layout for Emergency Evacuation

Because the personnel in charge of R5 operated the slide manually but it did not deploy normally, she blocked R5 and guided passengers to R4 to evacuate. Personnel in charge of R4 tried to stop passengers to evacuate because the R4 slide was blown by the wind at first, but as the slide re-positioned itself, the personnel started the evacuation using this slide. Furthermore, because R5 could not be used therefore passengers gathered to R4, the passengers in the rear were instructed to use the left side aisle to evacuate from the right front side door.

The Aircraft has the evacuation exit doors at ten locations and each door equipped with an emergency slide /raft. This system deploys a slide automatically as soon as the door opened at the emergency situation and let passengers and crew to evacuate to outside of the aircraft. (See Figure 1. Door Layout for Emergency Evacuation.)

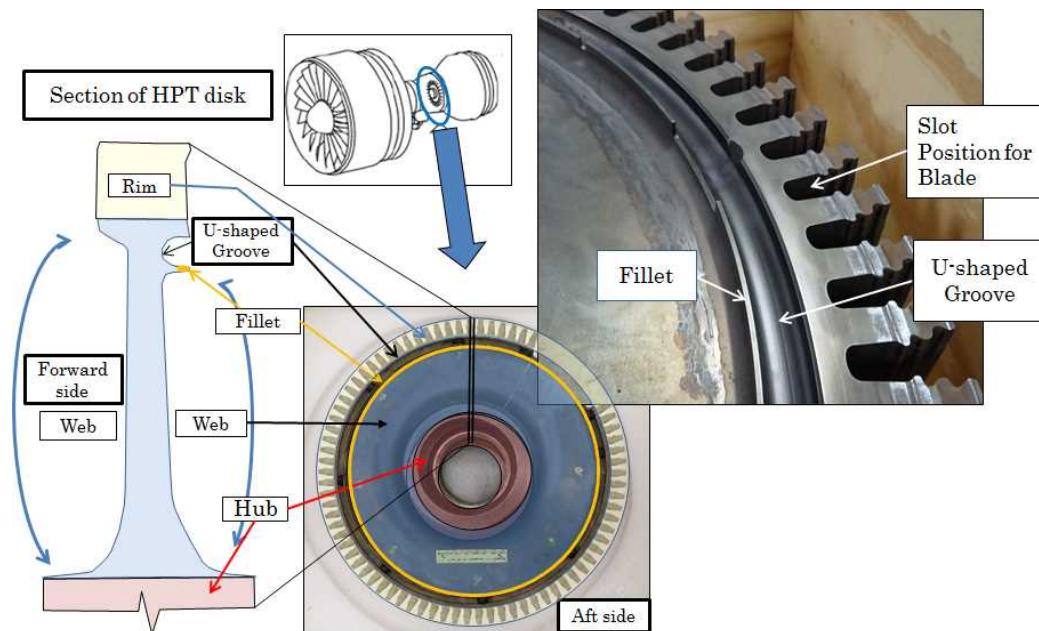
Photo 1. HPT Disk

The 1st stage HPT disk has the structure with machined grooves to install the air seal (hereinafter referred to as “U-shaped grooves”) to suppress a leak of cooling

air or the grooves to install rotor blades on the perimeter as machined. (See Photo 1. the HPT Disk)

Furthermore, since large stress would act on the HPT disk repeatedly, if mere scratch or step exceeding the manufacturing allowance exists, because of notch effect⁹, it could be an originating point for stress to concentrate or fatigue crack, the machining and inspecting at the manufacturing have being controlled strictly.

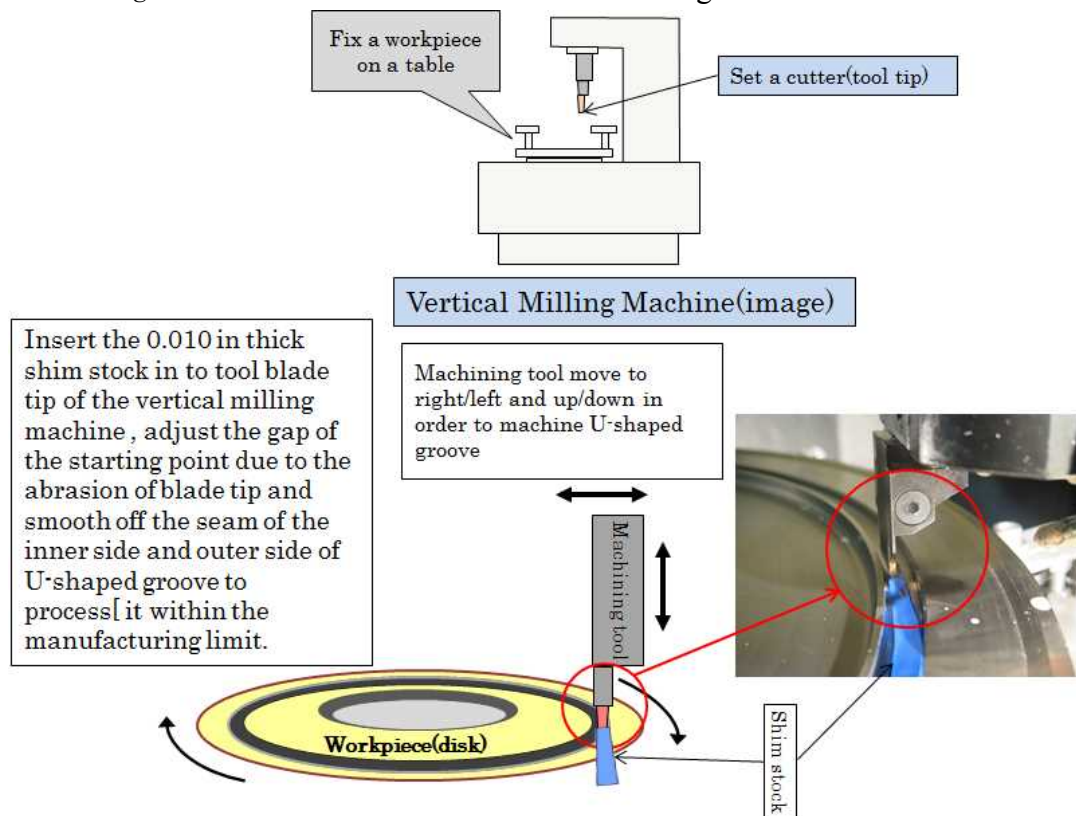
Figure 3. Processing the HPT Disk with use of a vertical milling machine

lathe for a precision finish, and sets the final processing position by adjusting the clearance between tip of machining tool and the bottom of U-shaped groove. This adjustment is to compensate the wear occurred at the tip of machining tool, and the value (Z axis; vertical feeding) of the final machining position would be displayed on the manual feeder counter for precision finishes. Inputting this value from keyboard to vertical automatic lathe, automatic machining would be executed, but the real final machining position is programmed to send the tip of machining tool at the 0.010 inches lower than this value in order to compensate the shim stock thickness.

According to the investigation by recreating the processing as the final processing position without using the 0.010 inches thick shim stock and investigating by recreating the machining by setting the condition without no gap at the bottom of U-shaped groove initiated by the tip of the machining tool had resulted in 0.010 inches deep step at the bottom of U-shaped groove. (See Figure 3. Processing the HPT Disk with use of a vertical milling machine.)

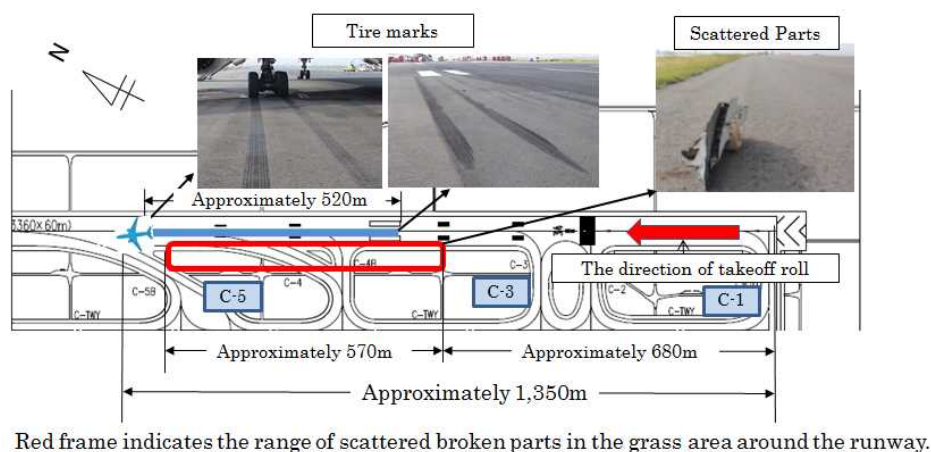
Figure 5. Tire Marks and Scattering range of Fractured Parts

The Aircraft entered to Runway 34R from the approach taxiway C1 and commenced the takeoff roll. At some time later, the Aircraft rejected the takeoff and stopped on the runway at short of Taxiway C5 with heading direction of 335 ° (magnetic direction). During this time, the Aircraft run approximately 1,350 m. tire marks due to the heavy brakes were confirmed from the stop position to approximately 520 m south along the runway centerline and at the both sides of the centerline. Besides, there were many rejected fragment and parts relating to the engine found and collected over the runway originating the point about 680 m from inside of the runway threshold to approximately 570 m north, the taxiway and the grass land of the perimeter road. (See Figure5. Tire Marks and Scattering range of fractured Parts.)

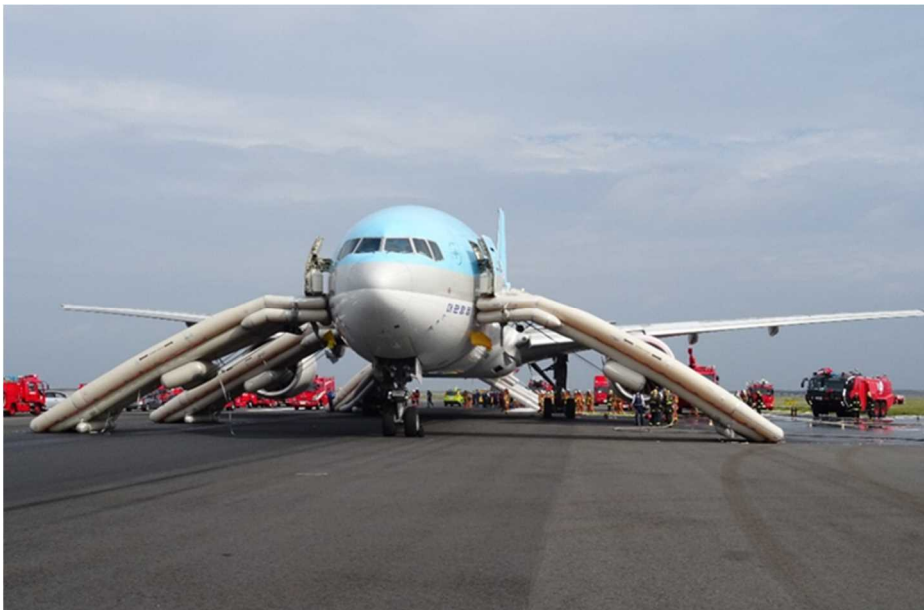
Photo 5. Emergency Evacuation Slides

According to the statements of the cabin attendants, they had deployed the doors at five locations of the right side of the Aircraft and attempted to evacuate, but the R5 door at the most rear side (hereinafter referred to as “R5 door”) was not fully deployed. For the door at the left side of the Aircraft, L1 door at the most front side had only the slide deployed, but it was not used. (See Photo 5. Emergency Evacuation Slide.) Furthermore, the situation of the emergency evacuation was recorded by the Monitoring camera at the Airport, it was confirmed that there were passengers with baggages to evacuate and no assistances at the bottom of the slide when the evacuation was started. Photo 6. shows the comparison of deploying R5 slide at the normal situation and at the accident.

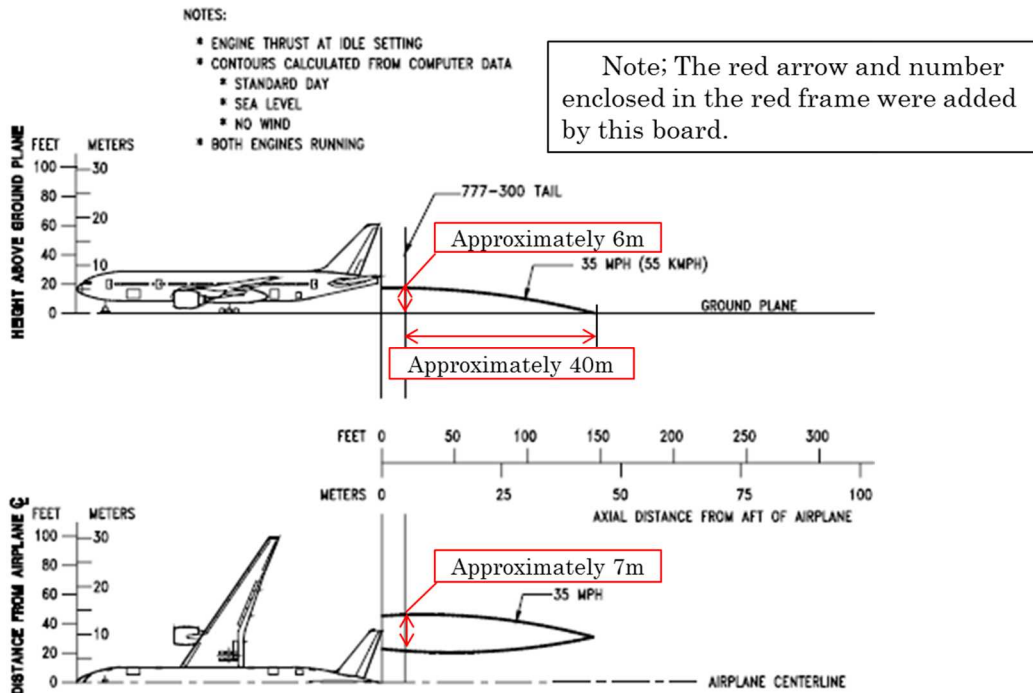
Figure 7. Predicted Engine Exhaust Velocity Contours – Idle Thrust

According to the materials concerning the engine exhaust air flow by the Aircraft manufacturer, B777-300 Engine Exhaust velocity contours at idle thrust are 55 km/h and reach approximately 40 m from the rear of the Aircraft and narrows in width. (See Figure 7. Predicted Engine Exhaust Velocity Contours – Idle Thrust.)

As described in 3.7.2, when deploying R5 slide, the No.2 engine was at idle thrust. As described in 2.14.2.4, according to the materials (Figure 7 Predicted Jet Engine Exhaust Velocity Contours – idle thrust) of the manufacturer of the Aircraft, the predicted jet engine exhaust velocity contours at idle thrust is 7 m wide at the rear end of the Aircraft, extends to the approximately 40 m ahead while being tapered at the level of approximate 6 m high and the wind velocity is about 30 kt. Calculating the resultant wind from the wind of the jet engine exhaust blow at setting of the heading at 335° as described in 2.10 with the wind direction 060° and velocity about 20 kt at the time of the accident described in 2.7, was resulting in the wind direction 007° and the velocity about 37.5 kt. The velocity is 1.5 times of the allowable limit which is 25 kt for the velocity to make a slide have normal deployment as described in 2.14.2.1. Because of this resultant wind's effect, it is somewhat likely that R5 slide which is at most rear end and the spacing to the ground is the longest, slipped under the rear end of the Aircraft by folded, deployed with its top caught by the runway therefore could not return to a normal standing position spontaneously as the effect of wind gone.

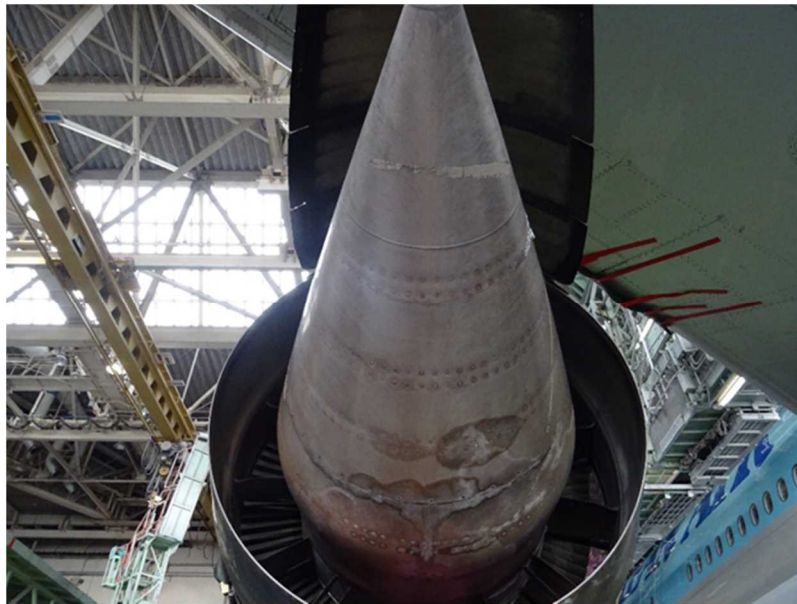
Photo #12. Tail Cone

Tail cone was still attaching to an exhaust pipe case. Nine tail cone mounting bolts at the positions (the lower side) from 4:00 to 8:00 were missing. (See Photo #12 .Tail Cone)

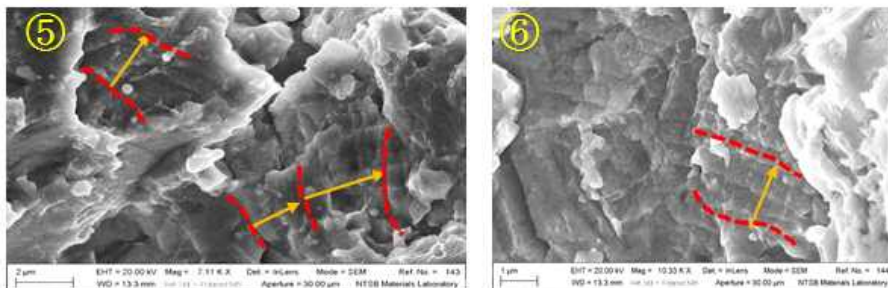
Photo ③ : Crack propagates from originating point at the aft side of the disk to the forward side. The fractured surface exhibited significant mechanical damage. The fatigue progression exhibited a bluish heat tint.

Photos ⑤ and ⑥ was the pictures enlarged and photographed parts enclosed by yellow lines shown in Photo ④ via Scanning Electron Microscope (SEM) and striation which is a characteristics of fatigue fracture surface was confirmed.
