**AIRCRAFT ACCIDENT  
INVESTIGATION REPORT**

**PRIVATELY OWNED  
JA001T**

**June 30, 2022**

<b>Company</b>	Privately owned
<b>Type, Registration Mark</b>	Cessna 525A JA001T
<b>Incident Class</b>	Damage to the airframe from a bird strike
<b>Date and Time of the Occurrence</b>	At about 08:11 Japan Standard Time (JST: UTC+9 hours), April 14, 2021
<b>Site of the Accident</b>	Approximately 2 nm west of Yao Airport at an altitude of approximately 500 ft

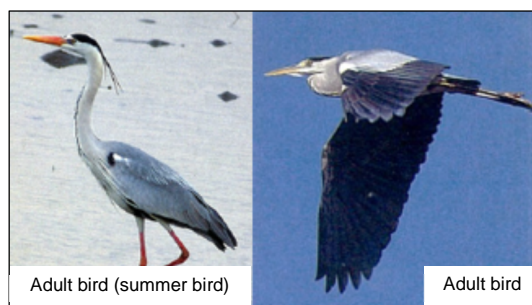
Figure 3 Gray heron

DNA testing of the bird’s feathers adhered to the horizontal stabilizer of the aircraft revealed that the species of the bird was a gray heron\*<sup>1</sup>.

The guideline for the bird strike prevention program\*<sup>2</sup> (page 8 of Appendix 1) assessed the risk of a gray heron as, “categorized as one of the most dangerous birds because of its heavy weight and a high probability of causing damage to aircraft, if collided, although frequency of collision with aircraft is low.” In the surrounding areas of the airport including the accident site, rivers and ponds that could be feeding areas and tumulus and green parks that could be breeding grounds for gray herons were scattered.
