**AIRCRAFT SERIOUS INCIDENT  
INVESTIGATION REPORT**

**JAPAN AIRLINES INTERNATIONAL CO., LTD.  
J A 0 0 2 D**

**ENGINE FIRE DURING TAKE OFF CLIMB  
JAPAN AIRLINES INTERNATIONAL CO., LTD.  
MCDONNELL DOUGLAS MD-90-30, JA002D  
AN ALTITUDE OF ABOUT 5,500 FEET, ABOUT 11 KILOMETERS  
WEST OF SENDAI AIRPORT, JAPAN  
AUGUST 15, 2010**

June 8, 2012

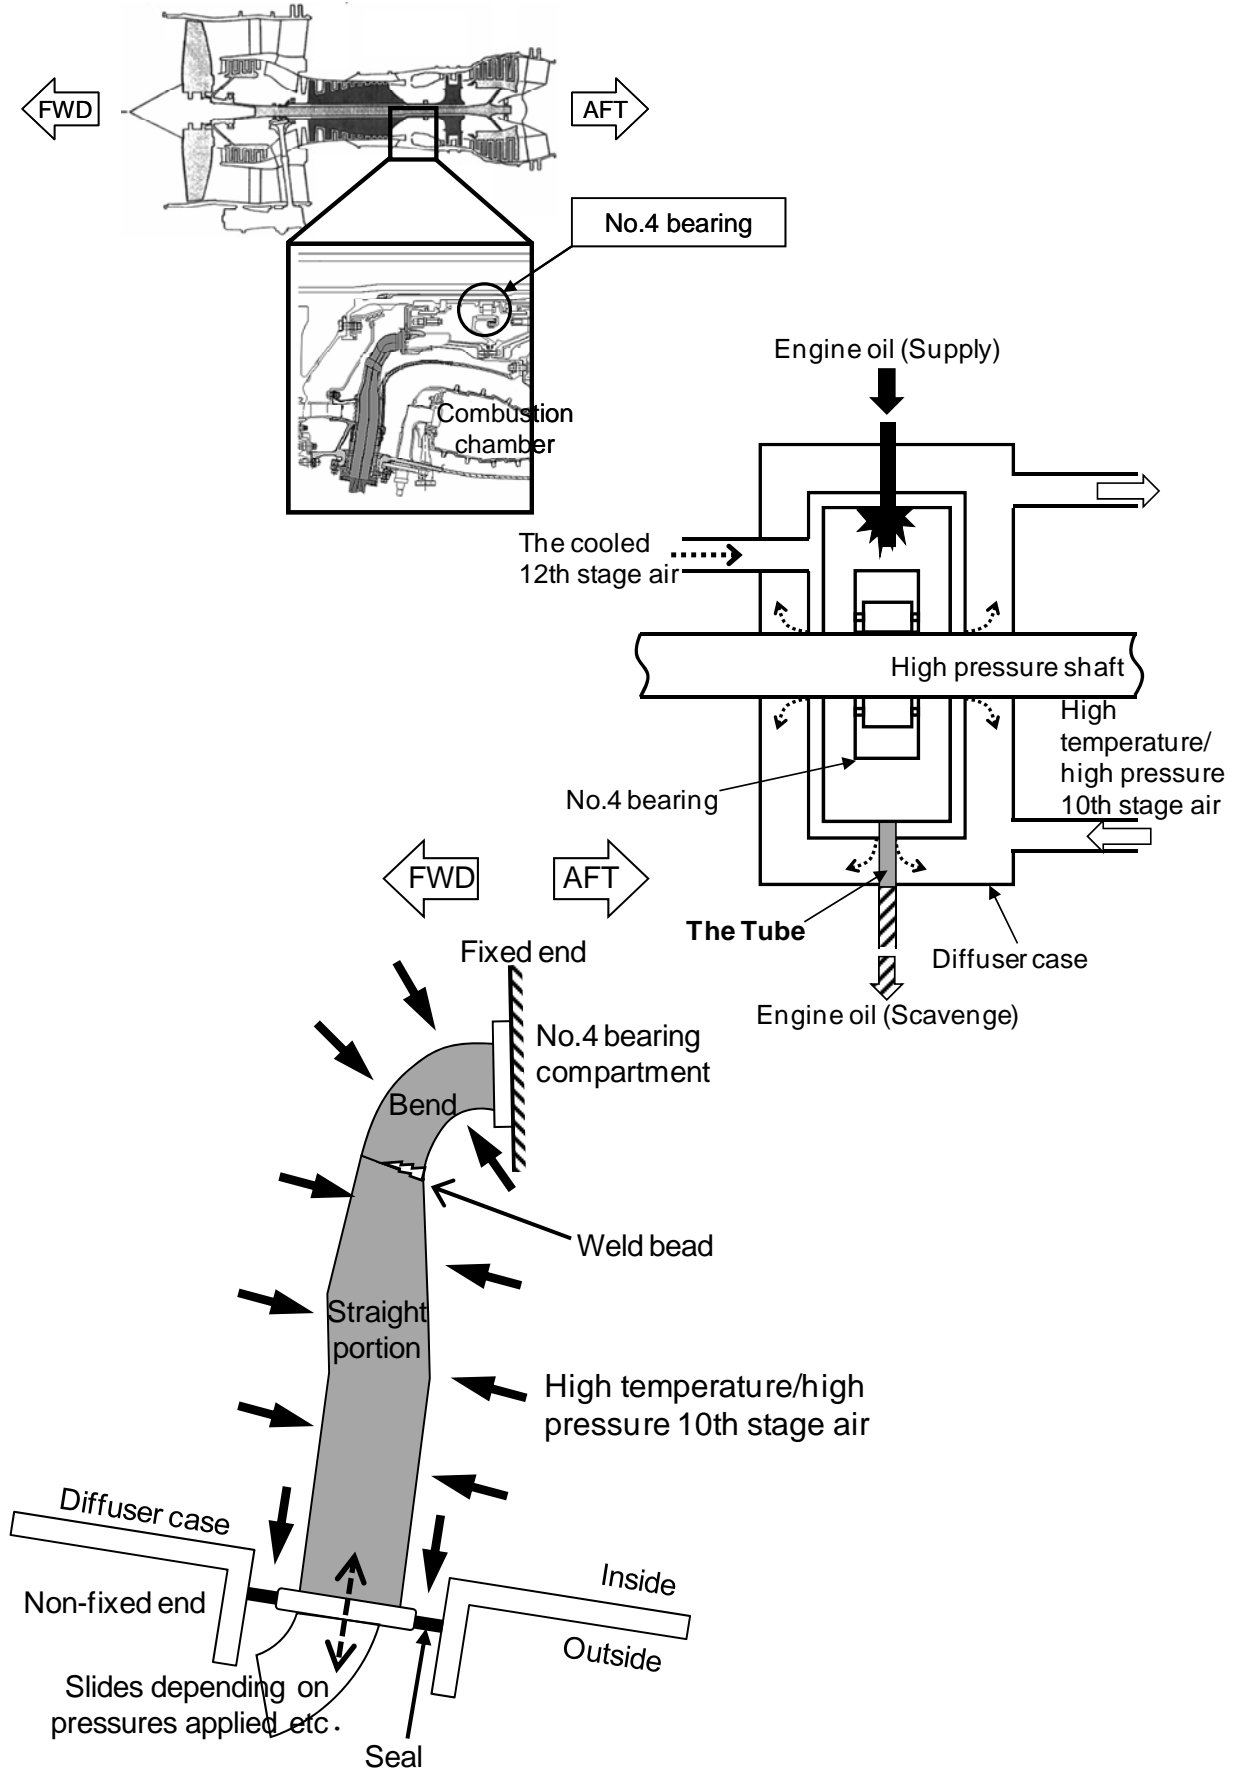
Figure 4 The Tube

It is highly probable that the repeated stress associated with engine operations generated the crack origins in the No.4 Scavenge Tube and the fatigue crack grew into the fracture of the tube.

The engine manufacturer considers that the possible assembly stress caused by assembling the Tube and the external pipe is partly responsible for the fracture of the Tube, and it has temporarily revised the engine manual as follows:

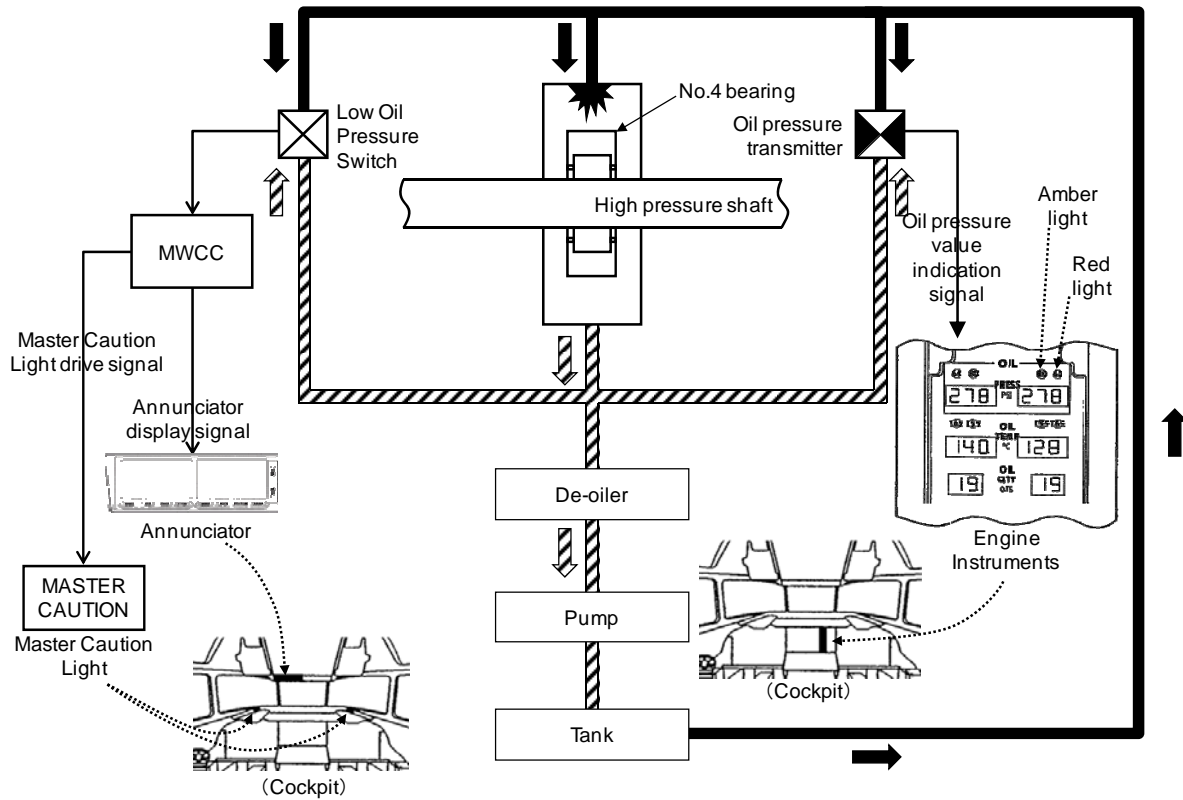
Figure 5 Engine Oil System Diagram (The relevant part)

It is probable that this serious incident occurred as follows: The Aircraft No. 4 Bearing Scavenge Tube of the right engine fractured during takeoff, resulted in the Tube breaking loose from the Diffuser Case letting the engine oil blow out through an opening where it broke loose, and subsequently the oil contact with the engine high temperature section developed into an engine fire.

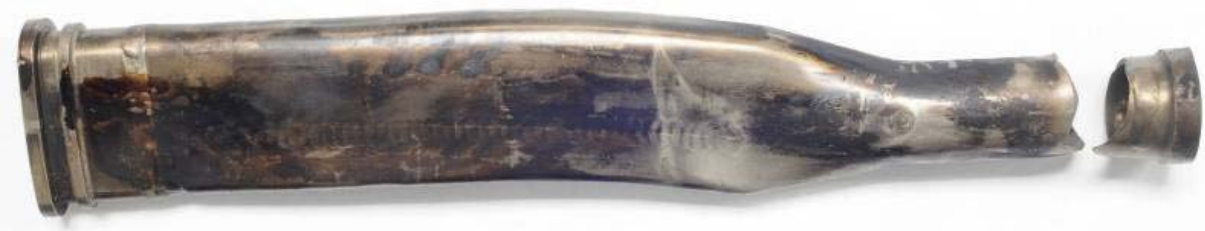
Photo 5 Cracks in the Tube

Overall images of the Tube (the heat shield being removed)
