**AIRCRAFT ACCIDENT
INVESTIGATION REPORT**

J A 0 0 7 P

AIRCRAFT DAMAGE DURING TAKEOFF RUN FROM WATER, A PRIVATELY OWNED CESSNA T206H (AMPHIBIAN), JA007P LAKE SHINJI, TAMAYU TOWN, MATSUE CITY, SHIMANE PREFECTURE, JAPAN AT AROUND 11:23 JST, APRIL 15, 2017

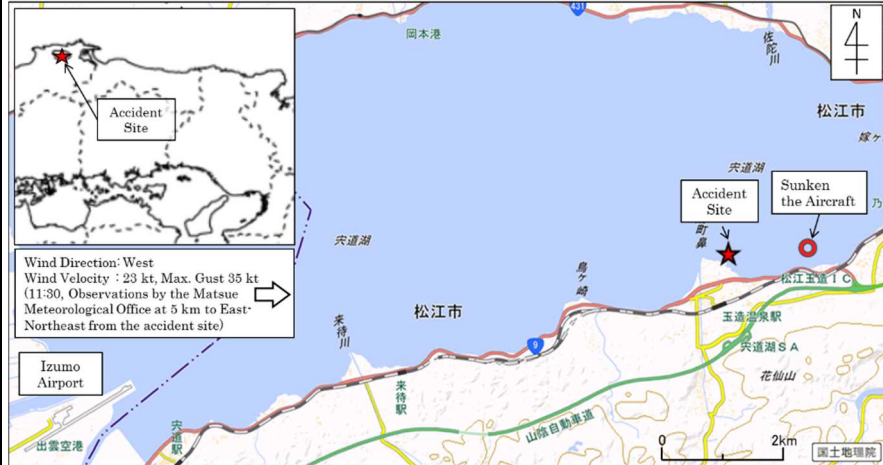
Fig. 1 Area Map of Accident Site

Time	Wind Direction	Average Wind Velocity	Maximum Instantaneous Velocity	10:00	West-Southwest	8 kt	16 kt	30	West	11 kt	16 kt	11:00	West	14 kt	28 kt	10	West	18 kt	30 kt	20	West	20 kt	32 kt	30	West	23 kt	35 kt
Time	Wind Direction	Average Wind Velocity	Maximum Instantaneous Velocity																										
10:00	West-Southwest	8 kt	16 kt																										
30	West	11 kt	16 kt																										
11:00	West	14 kt	28 kt																										
10	West	18 kt	30 kt																										
20	West	20 kt	32 kt																										
30	West	23 kt	35 kt																										
2.7 Accident Site	<p>The accident site was at Lake Shinji in Tamayu Town, Matsue City, Tottori Prefecture. The Aircraft commenced takeoff run from water heading to northwest at about 100 m offshore of the coast</p>

line. The Aircraft collided with wave when it entered the north-side water area of the cape (Yumachi-Hana), stopped, was drifted downwind (to east side) for about 1,500 m, and was sunk as the float separated while drifting.
