**AIRCRAFT SERIOUS INCIDENT  
INVESTIGATION REPORT**

**J A 0 1 E P**

## OCCURRENCE OF SMOKE IN THE AIRCRAFT PRIVATELY OWNED BEECHCRAFT B200, JA01EP AROUND 10:10 JST, APRIL 6, 2017 OVER KOMATSU CITY, ISHIKAWA PREFECTURE, JAPAN AT AN ALTITUDE OF APPROXIMATELY 20,000 FT

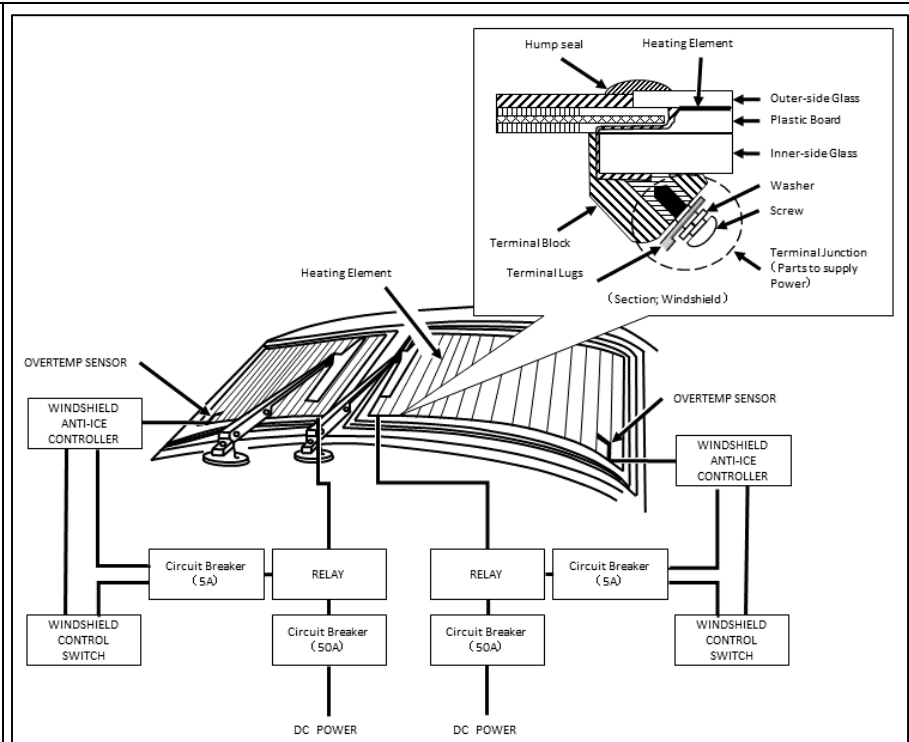
Figure 2 Schematic Diagram of Windshield Heater

<b>2.7 Additional information</b>	<p>(1) Outline of the windshield heater</p> <p>There are two windshield heater systems corresponding to two windshields (L/H and R/H), each heater is controlled by windshield control switch in the cockpit, and heats the heating elements embedded in the windshield to prevent icings on the windshield. Windshield anti-ice controller regulates power supply to the element depending on the temperature of the windshield.</p> <p>Power circuit used for the heating element is protected with 50 amp circuit breaker.</p> <p>(2) Detailed inspection of the windshield heater system</p> <p>JTSA performed following detailed inspections in order to investigate the cause of generating the smoke and the cracks of the windshield;</p>

Cracks like spider-web were found in a whole of the inner glass of right windshield. Cracks looked spreading radially from the originating point in the vicinity of the terminal block. Hump seals which was pasted to fill gaps of the outer-side windshield had no damage due to deteriorations or others.

Right windshield terminal lug was loose and there was gap of 0.05mm between the screws and the terminal lugs.
