**AIRCRAFT SERIOUS INCIDENT  
INVESTIGATION REPORT**

**J A 0 1 K Y**

**J A 2 4 7 1**

UNINTENTIONAL RELEASE OF OBJECT (TOW ROPE)  
1. JAPAN STUDENT AVIATION LEAGUE  
DIAMOND AIRCRAFT HK36TTC SUPER DIMONA, JA01KY  
(TOW PLANE) (MOTOR GLIDER)  
2. JAPAN STUDENT AVIATION LEAGUE  
ALEXANDER SCHLEICHER ASK21, JA2471  
(TOWED PLANE) (GLIDER)  
AT AN ALTITUDE OF APPROX. 150 M OVER VICINITY  
OF KOMATSU AIRPORT, ISHIKAWA PREFECTURE  
AT ABOUT 12:03 JST, SEPTEMBER 16, 2019

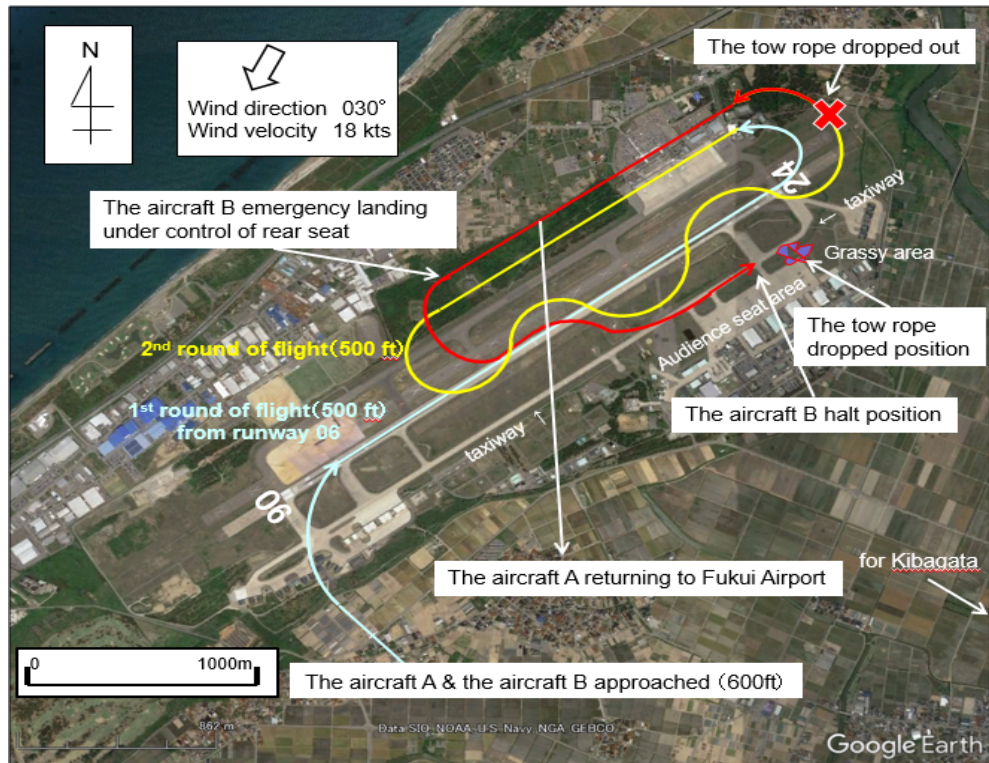
Figure 1 Estimated flight route

<p><b>2.1 History of the Flight</b></p>	<p>According to the statements of the captains of JA01KY (hereinafter referred to as “the aircraft A”) and JA2471 (hereinafter referred to as “the aircraft B”), and personnel of aerodrome control position of Komatsu Airport Control Tower (hereinafter referred to as “the Tower”) and the aircraft operator of the general incorporated association of Tokai Kansai Student Aviation League (hereinafter referred to as “the League”), the history of the flight was summarized as follows:</p> <p>The aircraft A with the captain alone onboard took off from Fukui Airport at 11:23 on September 16, 2019, to attend an event held at Komatsu Airport (hereinafter referred to as “the Airport”) towing the aircraft B where the captain and another pilot were onboard. Both captains obtained the meteorological information for the Airport prior to the flight, and confirmed that the northern wind blowing at the velocity of 16 to 18 kts in the demonstration flight airspace did not hinder the flight.</p> <p>According to the captain of the aircraft A, both aircraft planned to perform demonstration flight three times from 12:00 until 12:15, and had held short of over Kibagata in the southeast of the Airport (approximately 2.5 nm southeast of the Airport) until three minutes before the demonstration flight commenced. In the first round of the demonstration flight, both aircraft approached over runway 06 threshold at an altitude of 600 ft at 12:00 and flew straight along the runway at an altitude of 500 ft, and in the second round of the flight, performed meandering flight at the same altitude. Then, during left circling to perform the third round of the demonstration flight, the captain of the aircraft A felt impact like “boon” and confirmed that the tow rope was fractured. The captain of the aircraft A notified to the Tower that the aircraft B was going to land at the Airport and the aircraft A was returning to Fukui Airport, and landed at the airport at 12:20.</p>

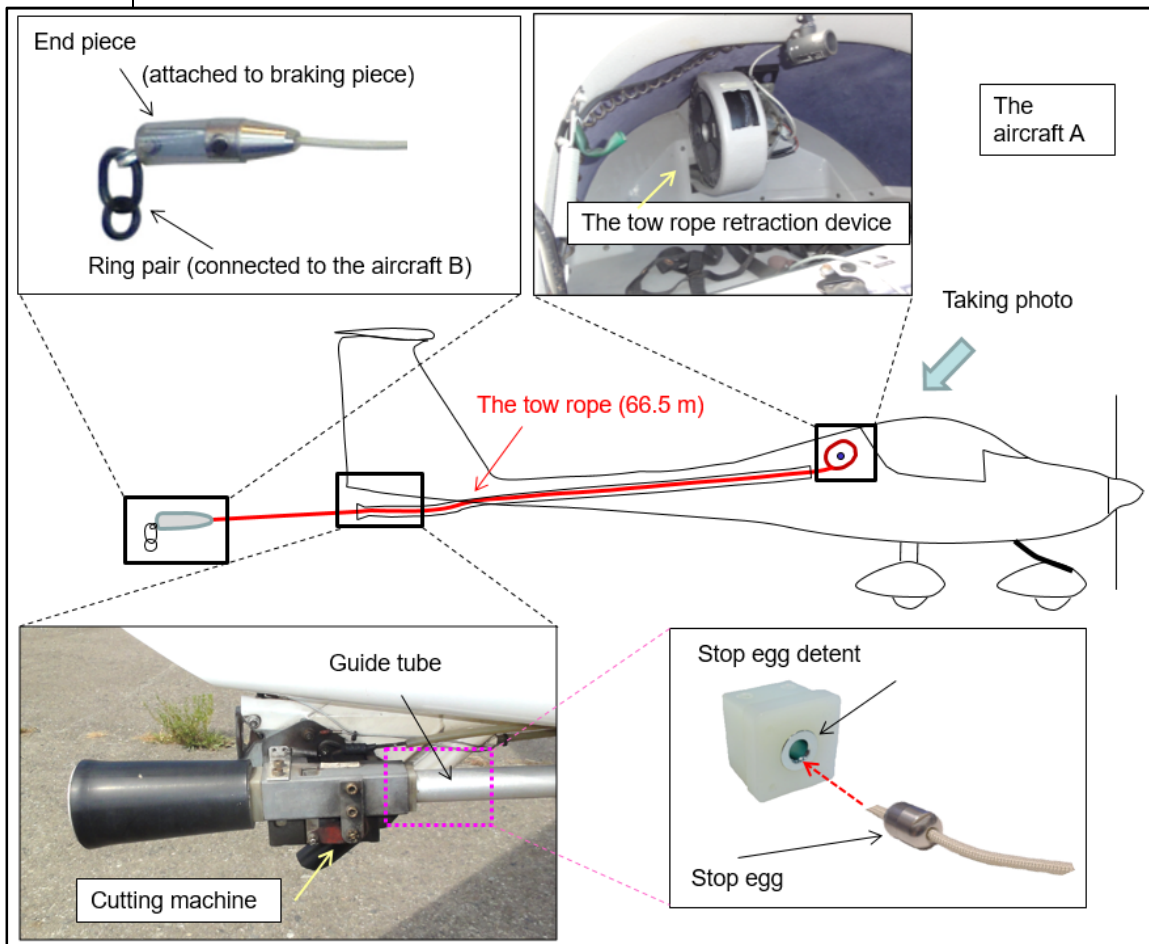
Figure 8 Installation of the tow rope

piece when an excessive tensile force (maximum load of 400 daN plus/minus 40) was applied during towing (see Figure 8).

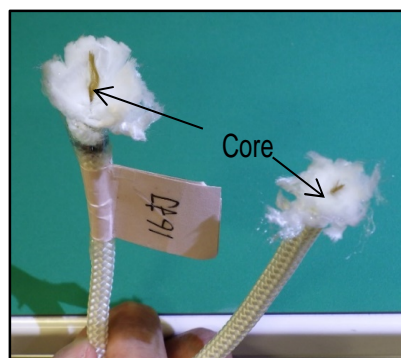
Figure10 Cross section of Rope A

Fiber identification test conducted at a testing laboratory by Attenuated Total Reflection method (ATR method) determined that the material of the domestic-manufactured tow rope used in the serious incident, both Rope B and Rope B New, was polyester. On the other hand, the test result revealed that the Rope A had materials of polyester on the surface and middle layers and polyamide (nylon) only in the core (Figure 10). Besides, confirmation was made with the Design and Manufacturer of the aircraft A that a polyester make was also usable in addition to PVC and polyamide, which was reflected on the Flight manual addendum No.9 thereafter.
