**AIRCRAFT ACCIDENT
INVESTIGATION REPORT**

**Japan General Aviation Service Co., Ltd. (JGAS)
J A 0 1 T C**

Company	Japan General Aviation Service Co., Ltd. (JGAS)
Type, Registration Number	Cirrus SR20, JA01TC
Accident Class	Damage to Aircraft during Landing
Date and Time of the Occurrence	At about 11:05 Japan Standard Time (JST: UTC+9 hours), December 26, 2022
Site of the Accident	On Runway at Amakusa Airfield, Kumamoto Prefecture (32°28'50" N, 130°09'45" E)

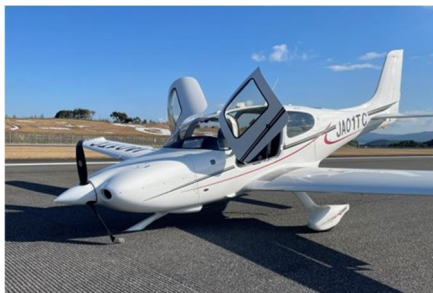
Figure 3: Damaged Area at the lower fuselage

The nose landing gear of the Aircraft was fractured and the detached one was found in the grass area on the south side of the runway. In addition, the right main landing gear tire cover was broken, struck marks were found on the lower part of fuselage and the lower surface of the left horizontal stabilizer, the bent backward and the scratched marks were found on the three propeller blades.

Besides, in the inspection of the inner fuselage, as shown in Figure 3, at the right-side central lower structure of the fuselage (Longeron), damage equivalent to major repair (separation of the adhesive surface between the fuselage outer skin and Longeron) was found.

The JTSB concludes that it is highly probable that when the aircraft touched down on the nose landing gear first, its propellers touched on the runway surface and were damaged. After that, it is highly probable that a part of the nose landing gear was broken along with the tire, and it hit the tire cover and then lower fuselage and the lower surface of the left horizontal stabilizer. Furthermore, it is highly probable that the lower structure of the right central fuselage (Longeron) was damaged when the broken nose landing gear hit the lower fuselage.
