AI2017-4

**AIRCRAFT SERIOUS INCIDENT
INVESTIGATION REPORT**

PRIVATELY OWNED CIRRUS SR22T, JA01YK INABILITY TO OPERATE DUE TO DAMAGES OF THE LANDING GEAR OF THE AIRCRAFT KAGOSHIMA AIRPORT AT ABOUT 13:20 JST, MARCH 21, 2016

July 21, 2017

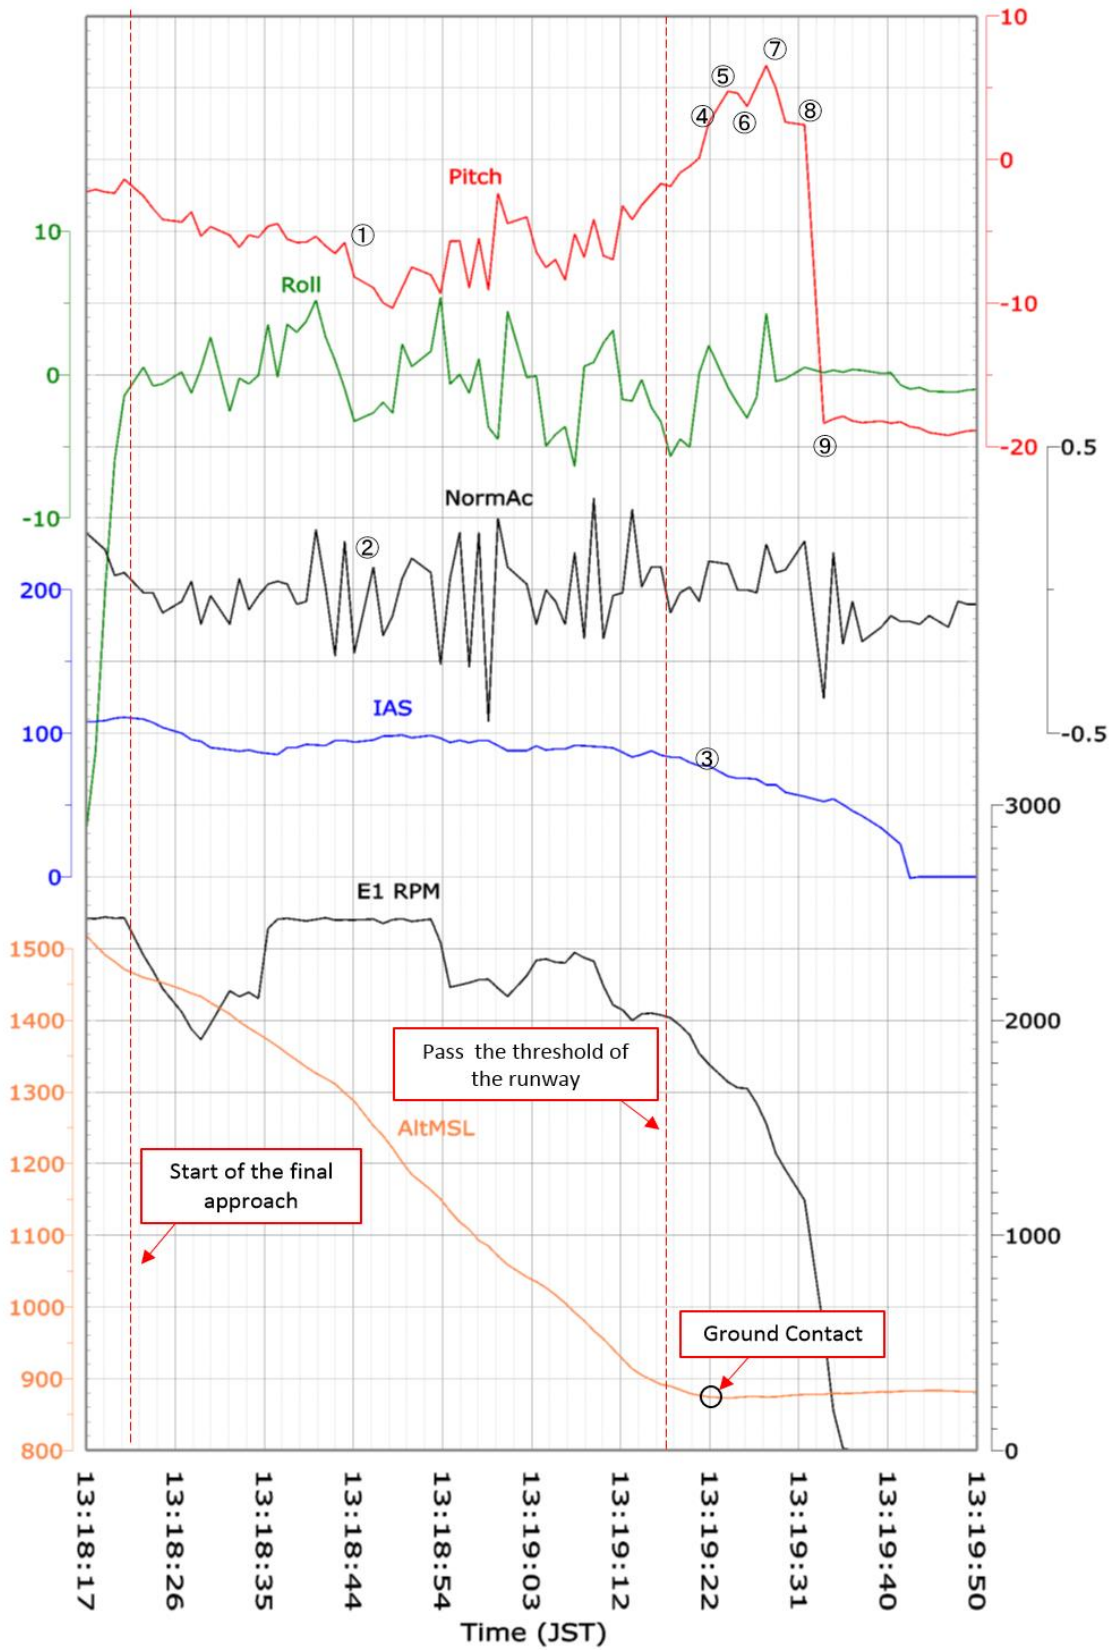
Appended Figure 2: Records of ADL

According to the records of ADL (see 2.7), the Aircraft was at the ground altitude of 620 ft and the airspeed of 110 kt at the time to complete the turning for the final approach. Then, as shown in Appended Figure 2, ① and ②, there were the fluctuation in pitch angle between about -10° and -2° from the ground altitude of 400 kt and the fluctuation in an vertical acceleration^{*4} between about -0.5 G and +0.3 G, which continued till near the runway threshold. After that, without big fluctuations in the pitch angle, the Aircraft touched down at approximately 340 m inside of the runway threshold.
