AIRCRAFT SERIOUS INCIDENT INVESTIGATION REPORT

**Nakanihon Air Service Co., Ltd.
J A 0 2 A H**

February 29, 2024

CASE WHERE A SLUNG LOAD CARRIED EXTERNAL TO AN AIRCRAFT WAS RELEASED UNINTENTIONALLY NAKANIHON AIR CO., LTD. EUROCOPTER AS 350 B3 (ROTORCRAFT), JA02AH ONO CITY, FUKUI PREFECTURE AT APPROXIMATELY 13:08 JST, OCTOBER 24, 2022

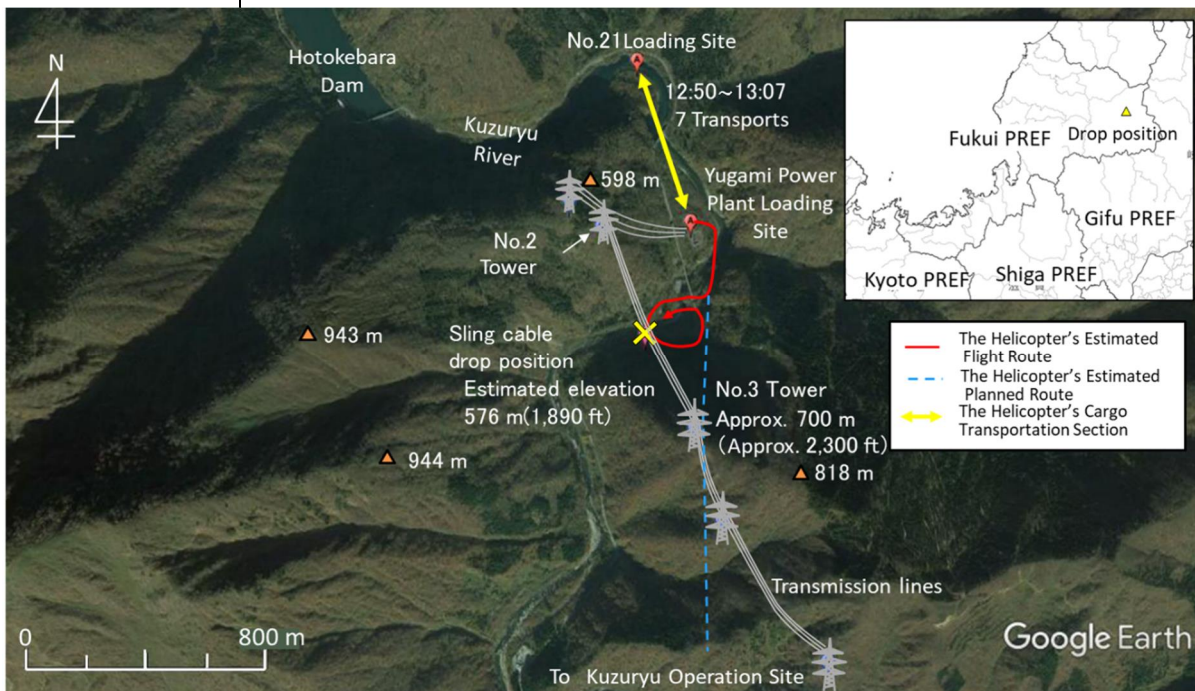
Figure 1: The Helicopter's Estimated Flight Route from the End of Cargo Transportation to the Position of the Contact with Transmission Lines

On the day of the serious incident, the captain was seated in the right pilot seat and the onboard mechanic in the left seat of cabin. After the helicopter took off from Kuzuryu Ski Resort Temporary Operation Site in Ono City, Fukui Prefecture (hereinafter referred to as “Kuzuryu Operation Site”) and carried out cargo transportation from No.21 loading site to Yugami Power Plant seven times, at around 13:08 on the way of returning to Kuzuryu Operation Site, the underslung 21 m long sling cable was broken as contacting with transmission lines, and a part of the hook and sling cable dropped. The sling cable was broken and damaged, in addition, the transmission lines were damaged and required some repair or replacement. There was neither damage to the helicopter nor to the personnel. For the transmission lines to which high voltage applied, the safety device for the electric power facility on the ground was activated at around 13:08, the high electric voltage was shut down.

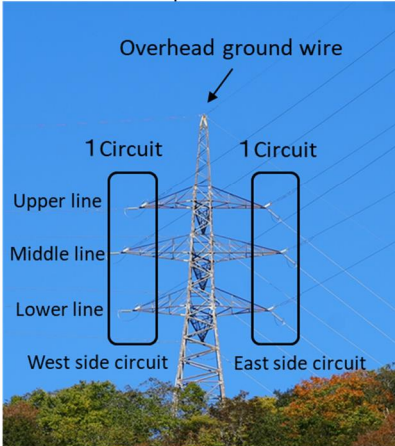
<p>Figure 4: Tower Configuration (No.2 Tower)</p> </div> <div style="text-align: center;">

<p>Figure 5: Tower Height and Spacing between Transmission Lines</p> </div> </div> <p>According to the transmission line management company, the transmission lines with which the sling cable had contacted are alternating current (AC) transmission lines (a three-phase three-wire system) where a single-circuit AC transmission line has three phases, and the power is transmitted through two circuits, one on the east side and the other on the west side, across the tower (see Figure 4). The spacing between each line on the tower is as shown in Figure 5, at the top, an</p>

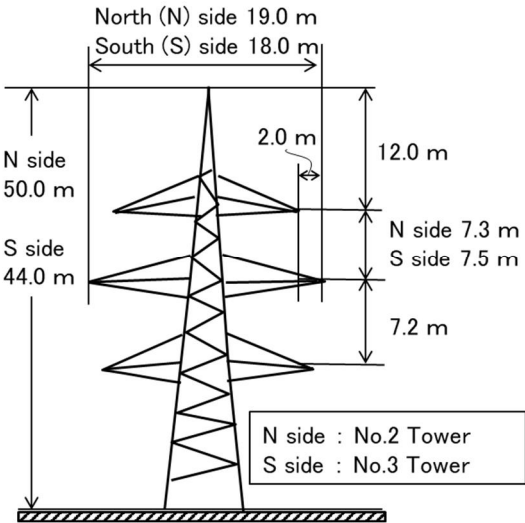
Although the spacing between the upper and middle lines is approximately 7.4 m, the spacing between the two burnt areas on the damaged sling cable was approximately 6.4 m, therefore, it is more likely that the sling cable initially contacted with the middle line, the sling cable lifted the middle line, which made the spacing between the upper and middle lines come to 6.4 m, when the burnout occurred. The sling cable was burnt probably because when the sling cable contacted with the two high-voltage transmission lines, excessive current exceeding an allowable limit value flowed in the control cable, causing short-circuit at the contact point and catching fire.

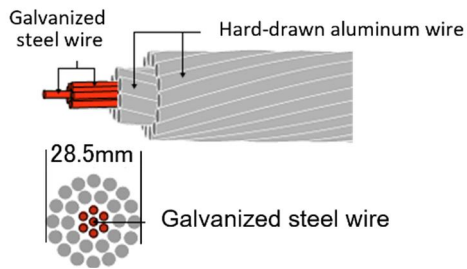
Figure 7: Overview of Transmission Lines

overhead ground wire made of aluminum-covered steel stranded wire (AC wire) with a diameter of 12 mm is strung, and for the lower transmission line, aluminum cable steel reinforced (ACSR wire) with a diameter of 28.5 mm is used (see Figure 7). Among three transmission lines on the one side of the tower, the spacing between the upper and middle lines is approximately 7.4 m. When this serious incident occurred, a voltage of 154 kV was applied on both circuits. Due to the design of transmission lines, when the spacing between the lines becomes within 1.7 m, air as an insulator causes dielectric breakdown*¹ which could allow electricity to run in the air (discharge). When discharge occurs between the lines, discharge marks is highly likely left on mutual line surfaces.
