AA2007-3

# AIRCRAFT ACCIDENT INVESTIGATION REPORT

SHIZUOKA PREFECTURAL POLICE  
AGUSTA A109K2(ROTORCRAFT), JA11PC  
SHIMIZU-KU, SHIZUOKA CITY, SHIZUOKA PREFECTURE, JAPAN  
MAY 3, 2005, AROUND 16:28 JST

April 27, 2007

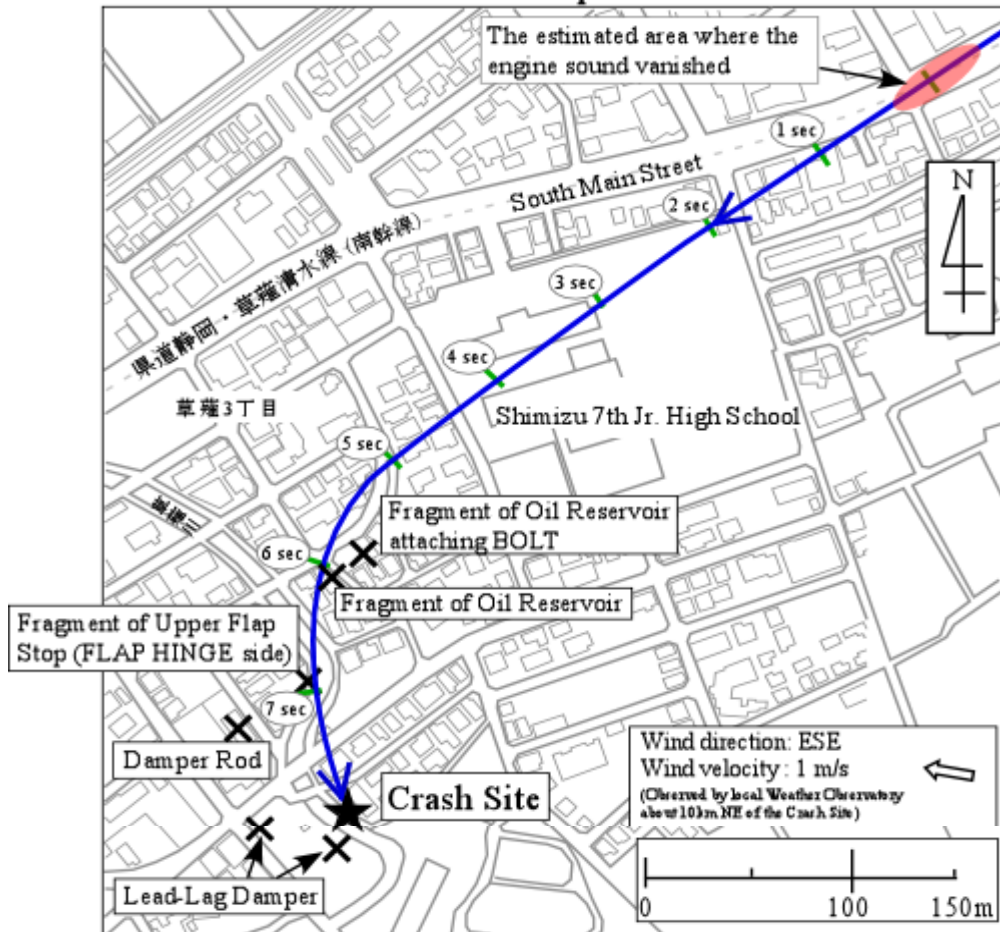
Figure 2 Estimated Flight Route and Locations where detached parts were collected

- (1) Bolt fragments (oil reservoir retaining bolt)  
Approximately 140m north.
  - (2) Two pieces of metal fragments (portions of oil reservoir)  
Approximately 125m north.
  - (3) Damper rod  
Approximately 75m northwest.
  - (4) Fragments of the flap-hinge-side upper flap stop  
Approximately 75m north-northwest.
  - (5) Two lead-lag dampers  
Approximately 15m southwest and approximately 35m west-southwest.
- (See Figure 2 and Photos 6 and 7.)
