**AIRCRAFT SERIOUS INCIDENT  
INVESTIGATION REPORT**

**ACADEMIC CORPORATE BODY HIRATAGAKUEN  
J A 1 3 5 E**

ENGINE DAMAGE  
TO  
A EUROCOPTER EC135T2 (ROTORCRAFT), JA135E  
OPERATED BY  
ACADEMIC CORPORATE BODY HIRATAGAKUEN  
OVER  
THE SEA ABOUT 6 NM (ABOUT 11 KM) NORTHWEST  
OF KERAMA ISLANDS, OKINAWA PREFECTURE  
AT  
10:20, MARCH 28, 2009

August 23, 2013

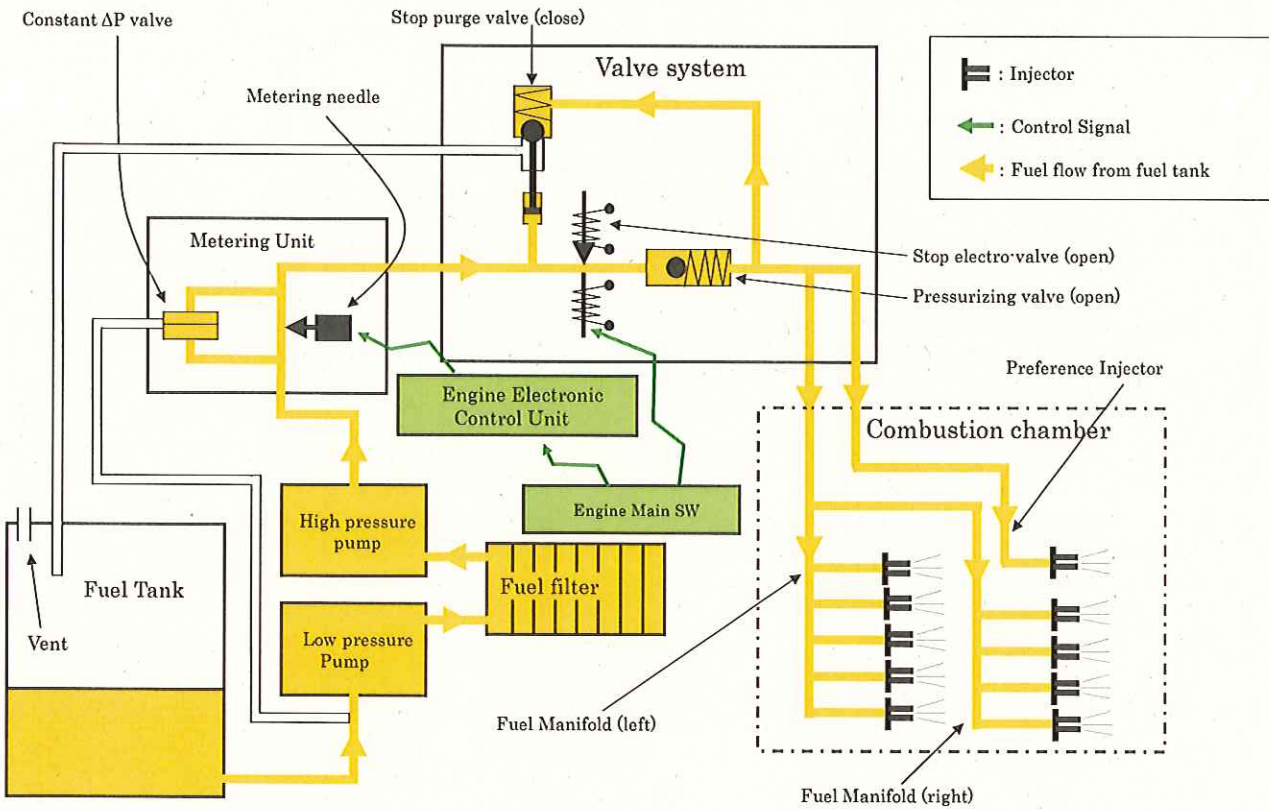
**Figure 4: Fuel Flow at the Engine Start**  
 (\*This Figure is a simplified scheme not showing all this system and function)

(See Figure 4: Fuel Flow at the Engine Start, Figure 5: Fuel Flow at the Engine Shutdown)

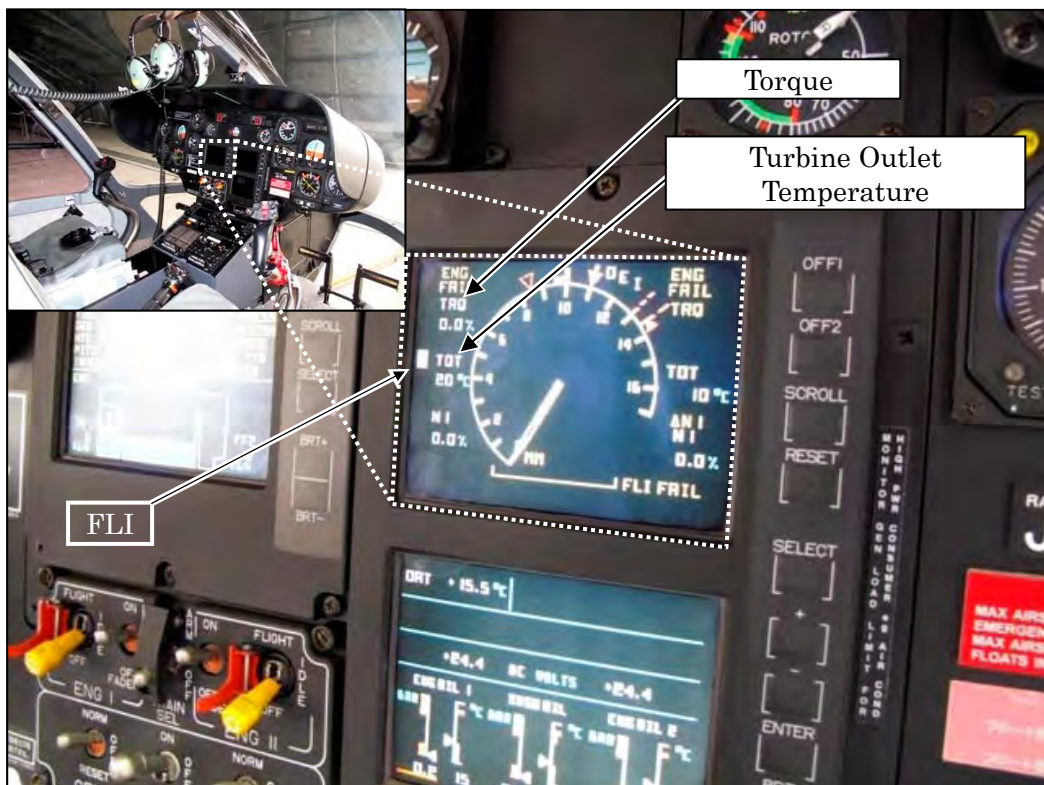
Photo 2: Display Example of ENG Instrument

Shortly after the helicopter took off from Kumejima Helipad, the mechanic found that the right engine FLI was blinking alternately for the TRQ and the TOT. When the mechanic was wondering what was going on, a similar phenomenon occurred for the left engine FLI indication. The TOT rose to show a yellow underline indicating that the value surpassed the maximum continuous power limit, he asked the PIC to reduce the engine power. The engine conditions worried the mechanic and he jotted down the engine parameters for both engines. The TRQ values for both engines were equal at 47.5 %, while the left TOT was 865 °C and the right TOT was 795 °C. The left N1 (the compressor rotating speed) was 88.9 %, while the right N1 89.6 %. The outside air temperature was 19.8 °C. There were no major differences in the values for the two engines, except for the TOTs. Sometime later, the left engine TOT quickly rose and the left engine stopped.

(See Figure 1: Estimated Flight Route, Photo 2: Display Example of Engine Instrument)

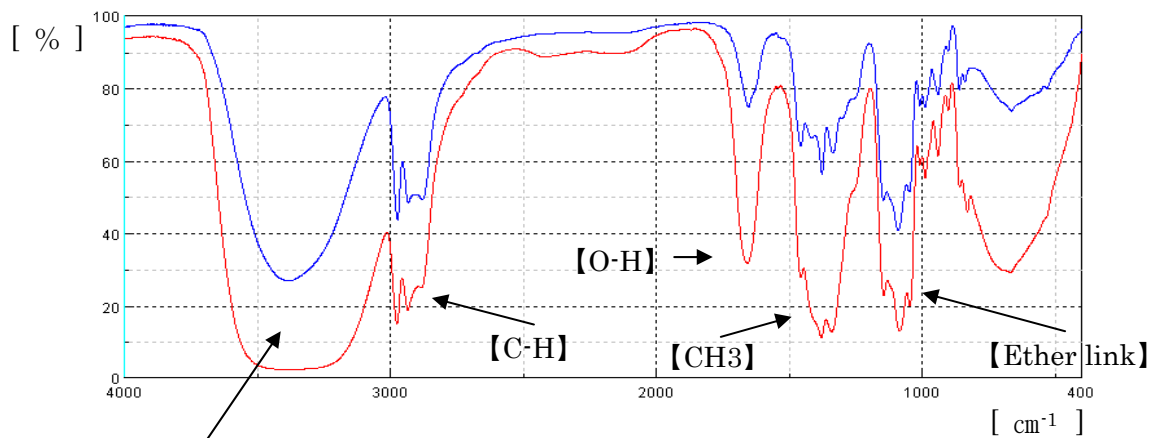
《IR absorption spectrum for the fungicide》

(See Photo 8: Fungicide Dissolution in the Fuel)

— : Fungicide  
 — : Transparent Liquid from fuel dram
