AA2019-4

**AIRCRAFT ACCIDENT
INVESTIGATION REPORT**

**VANILLA AIR INC.
JA14VA**

FLIGHT ATTENDANT INJURY
BY THE SHAKING OF THE AIRCRAFT
VANILLA AIR INC.
AIRBUS A320-214, JA14VA
AT AN ALTITUDE OF ABOUT 9,100 M (FL300)
OVER THE SEA ABOUT 45 KM EAST OF
MIYAZAKI AIRPORT, JAPAN
AT ABOUT 10:35 JST, AUGUST 27, 2018

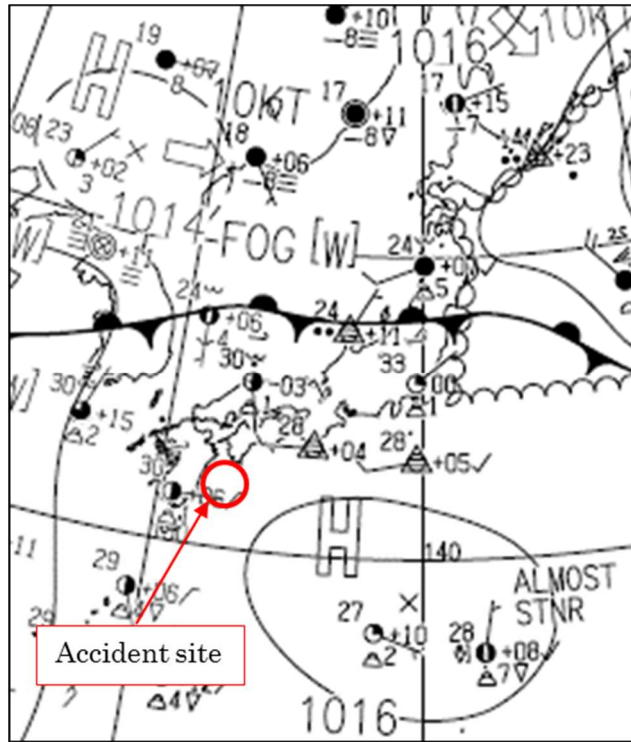
Figure 4: Asia-Pacific Surface Weather Chart (excerpt) at 09:00 JST on August 27, 2018

3.1 Involvement of Weather	None
3.2 Involvement of Pilot	None
3.3 Involvement of Aircraft	None
3.4 Analysis of Findings	<p>(1) Weather</p> <p>According to the statement of the PIC, the Asia-Pacific Surface Weather Chart, the Domestic Significant Weather Prognostic Chart, the Hourly-Analysis Chart issued by the JMA, and the QAR records, no clouds accompanying significant weather were observed and windshear was not observed in the vicinity of the accident site during the time when the accident occurred, in addition, there were no PIREPs on turbulence within one hours before as well as after the accident. As the Aircraft continued to fly in stable condition until the accident occurred, it is probable that the weather conditions were stable without atmospheric disturbances such as clear air turbulence; therefore, it was not the weather conditions that triggered the shaking of the Aircraft at the time of the accident.</p> <p>(2) Wake turbulence of the Relevant Aircraft</p> <p>About one minute 40 seconds before the accident, the Relevant Aircraft</p>

It is probable that because the winds were weak and the atmosphere was stable condition in the vicinity of the accident site, the weather conditions can be excluded from the factor that had triggered the shaking of the Aircraft that occurred only once; and the shaking of the Aircraft resulted from the Aircraft crossing through the Relevant Aircraft's wake turbulence which remained along the flight path of the Aircraft. It is also probable that the shaking of the Aircraft caused the Flight Attendant A to lose her balance, fall down and get injured in her buttock.

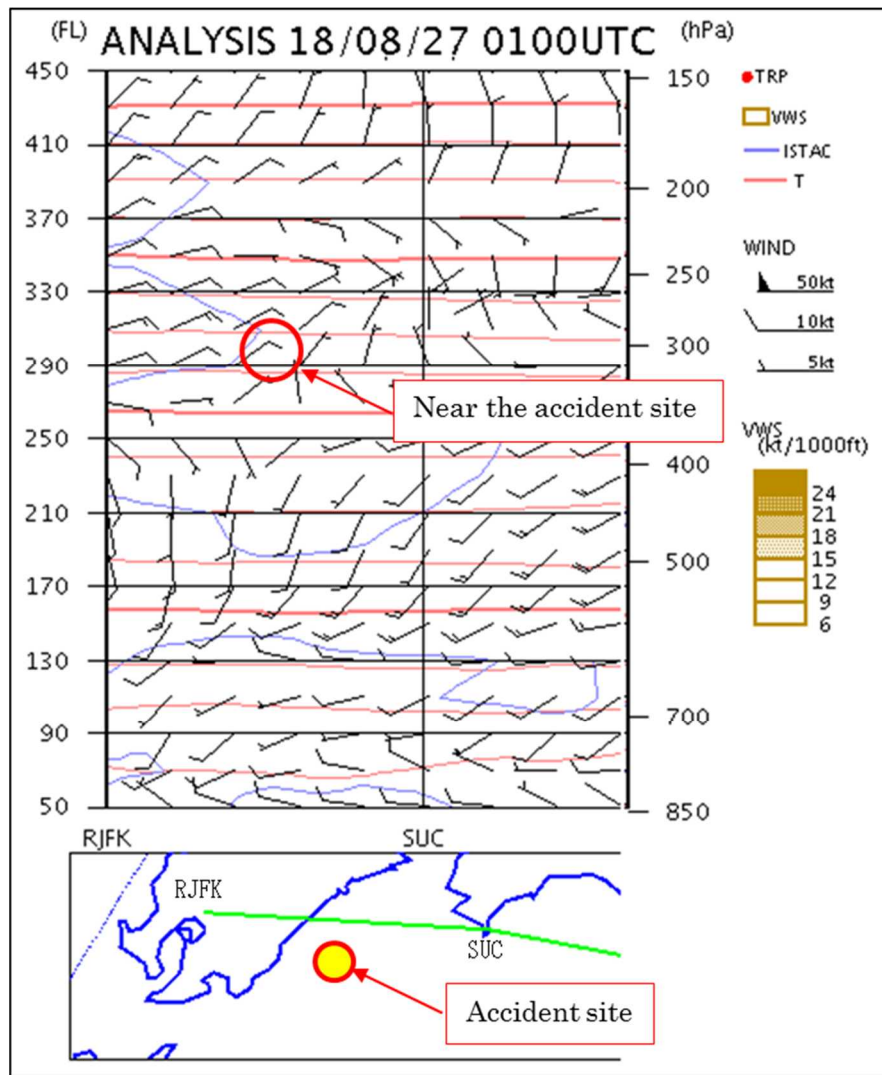
Figure 6: Hourly-Analysis Chart (excerpt / partially edited)
at 10:00 JST on August 27, 2018

2.6 Meteorological Information	<p>According to the Asia-Pacific Surface Weather Chart for 09:00 and the Domestic Significant Weather Prognostic Chart for 10:00 issued by the Japan Meteorological Agency (JMA) on August 27, 2018, The airspace in the vicinity of the accident site was covered with high pressure located in the south of Japan, and no clouds accompanying significant weather were observed.</p> <p>In addition, there were no pilot reports (PIREP) on turbulence within one hours before as well as after the accident in the vicinity of the accident site, also according to the Hourly-Analysis Chart for 10:00, the winds were weak at 5 to 10 kt, and windshear indicating a change in wind direction and wind speed was not observed in the vicinity of the accident site.</p>
