**AIRCRAFT SERIOUS INCIDENT  
INVESTIGATION REPORT**

## AIR PROXIMITY

1. KUMAMOTO PREFECTURE DISASTER PREVENTION FIRE  
FIGHTING AVIATION UNIT, EUROCOPTER AS365N3,  
JA15KM (ROTORCRAFT)

2. PRIVATELY OWNED, ROBINSON R44 II,  
JA344T (ROTORCRAFT)

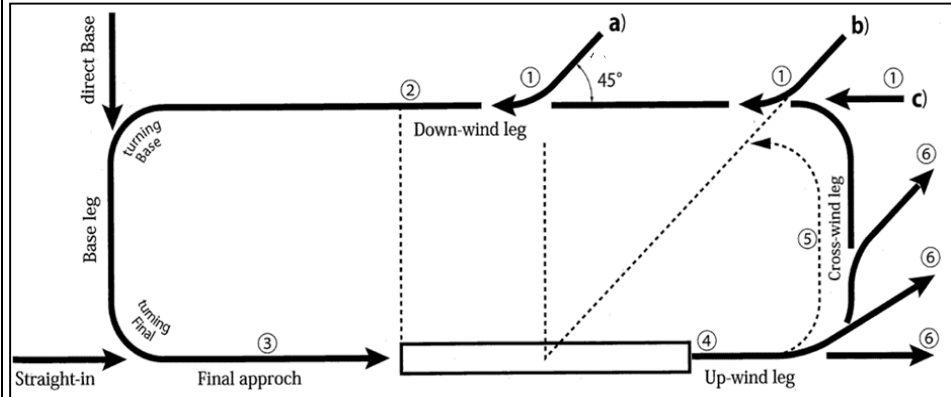
- ⑥ If breaking the traffic pattern, continue straight-out, or exit with a 45 degree turn to the left. Also, exit with a 45 degree turn to the outside from the cross wind leg.

The Helicopter-B's captain has an understanding that a range within 15 degrees each leftward and rightward of the runway centerline at the starting point of takeoff roll in case when full length of the runway is used is permissible for straight out departure.

The Air Traffic Control Division, Air Navigation Service Department of CAB commented that although concrete flight procedures and range are not specified for straight out departure, air traffic control is conducted under the recognition in general that aircraft do not make turns at least soon after takeoff, and that there is no discrimination between fix wing and rotor wing for that.
