**AIRCRAFT SERIOUS INCIDENT
INVESTIGATION REPORT**

**J-AIR CORPORATION
J A 2 0 6 J**

February 26, 2015

FIRE WITHIN THE ENGINE FIRE ZONE
J-AIR CORPORATION
BOMBARDIER CL-600-2B19, JA206J
ON THE TAXIWAY A4 AT OSAKA INTERNATIONAL AIRPORT
AT AROUND 12:15 JST, MAY 6, 2013

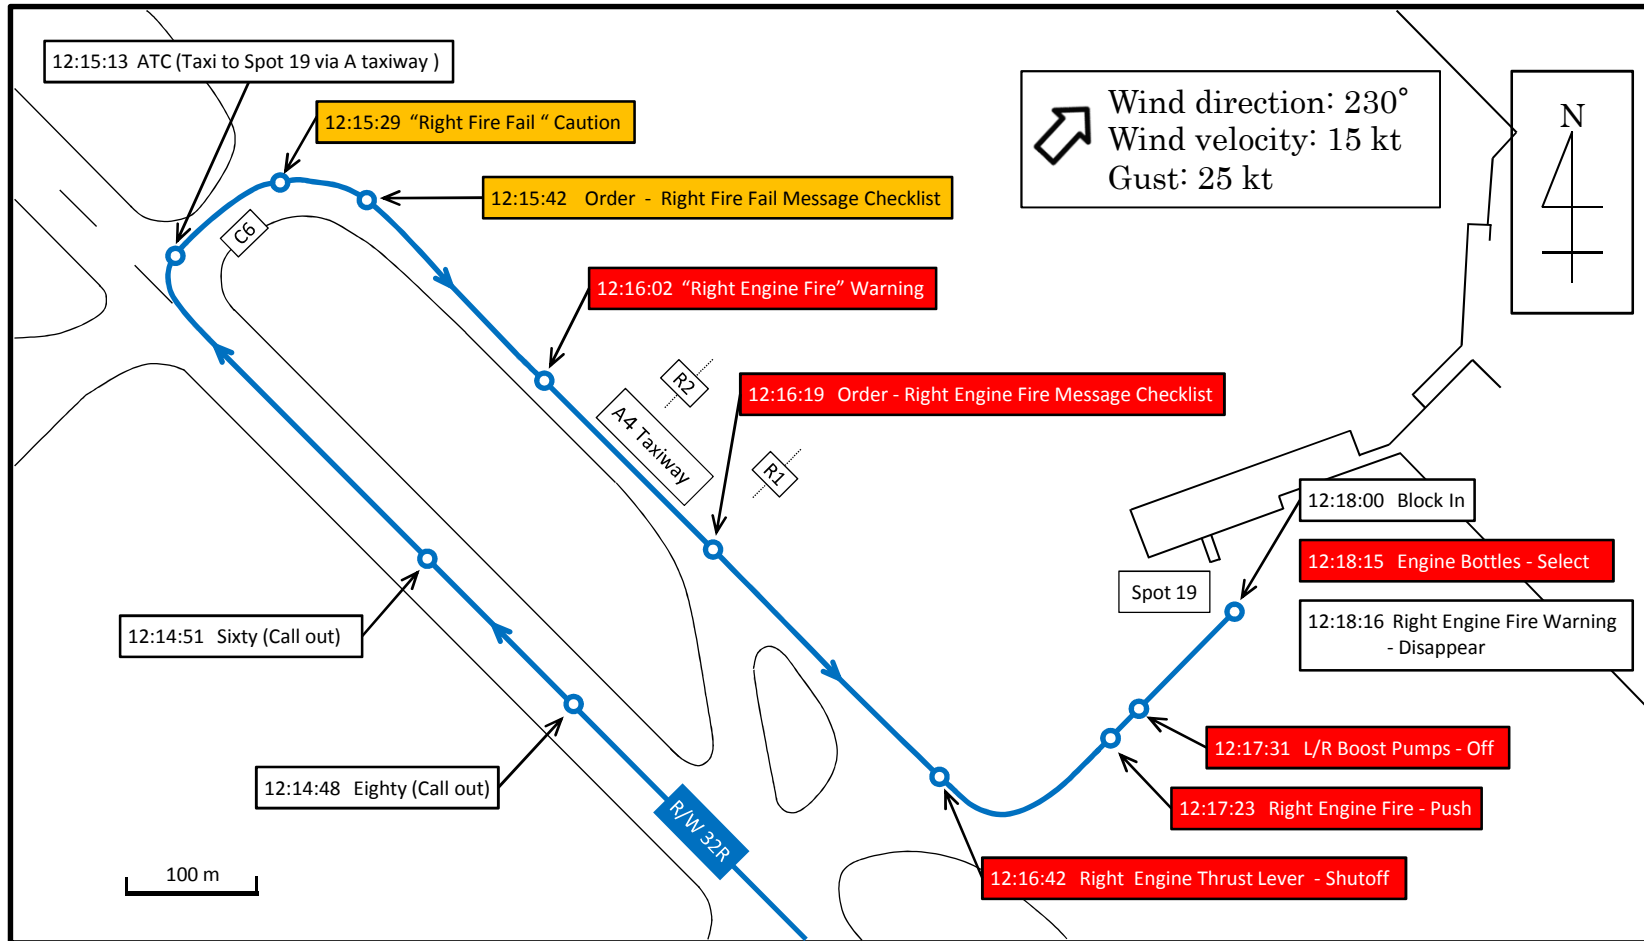
Figure 1: Estimated Taxi Route Based on DFDR, CVR, and ASDE

(See Figure 1: Estimated Taxi Route Based on DFDR, CVR, and ASDE*⁶ and Figure 2: DFDR Records)

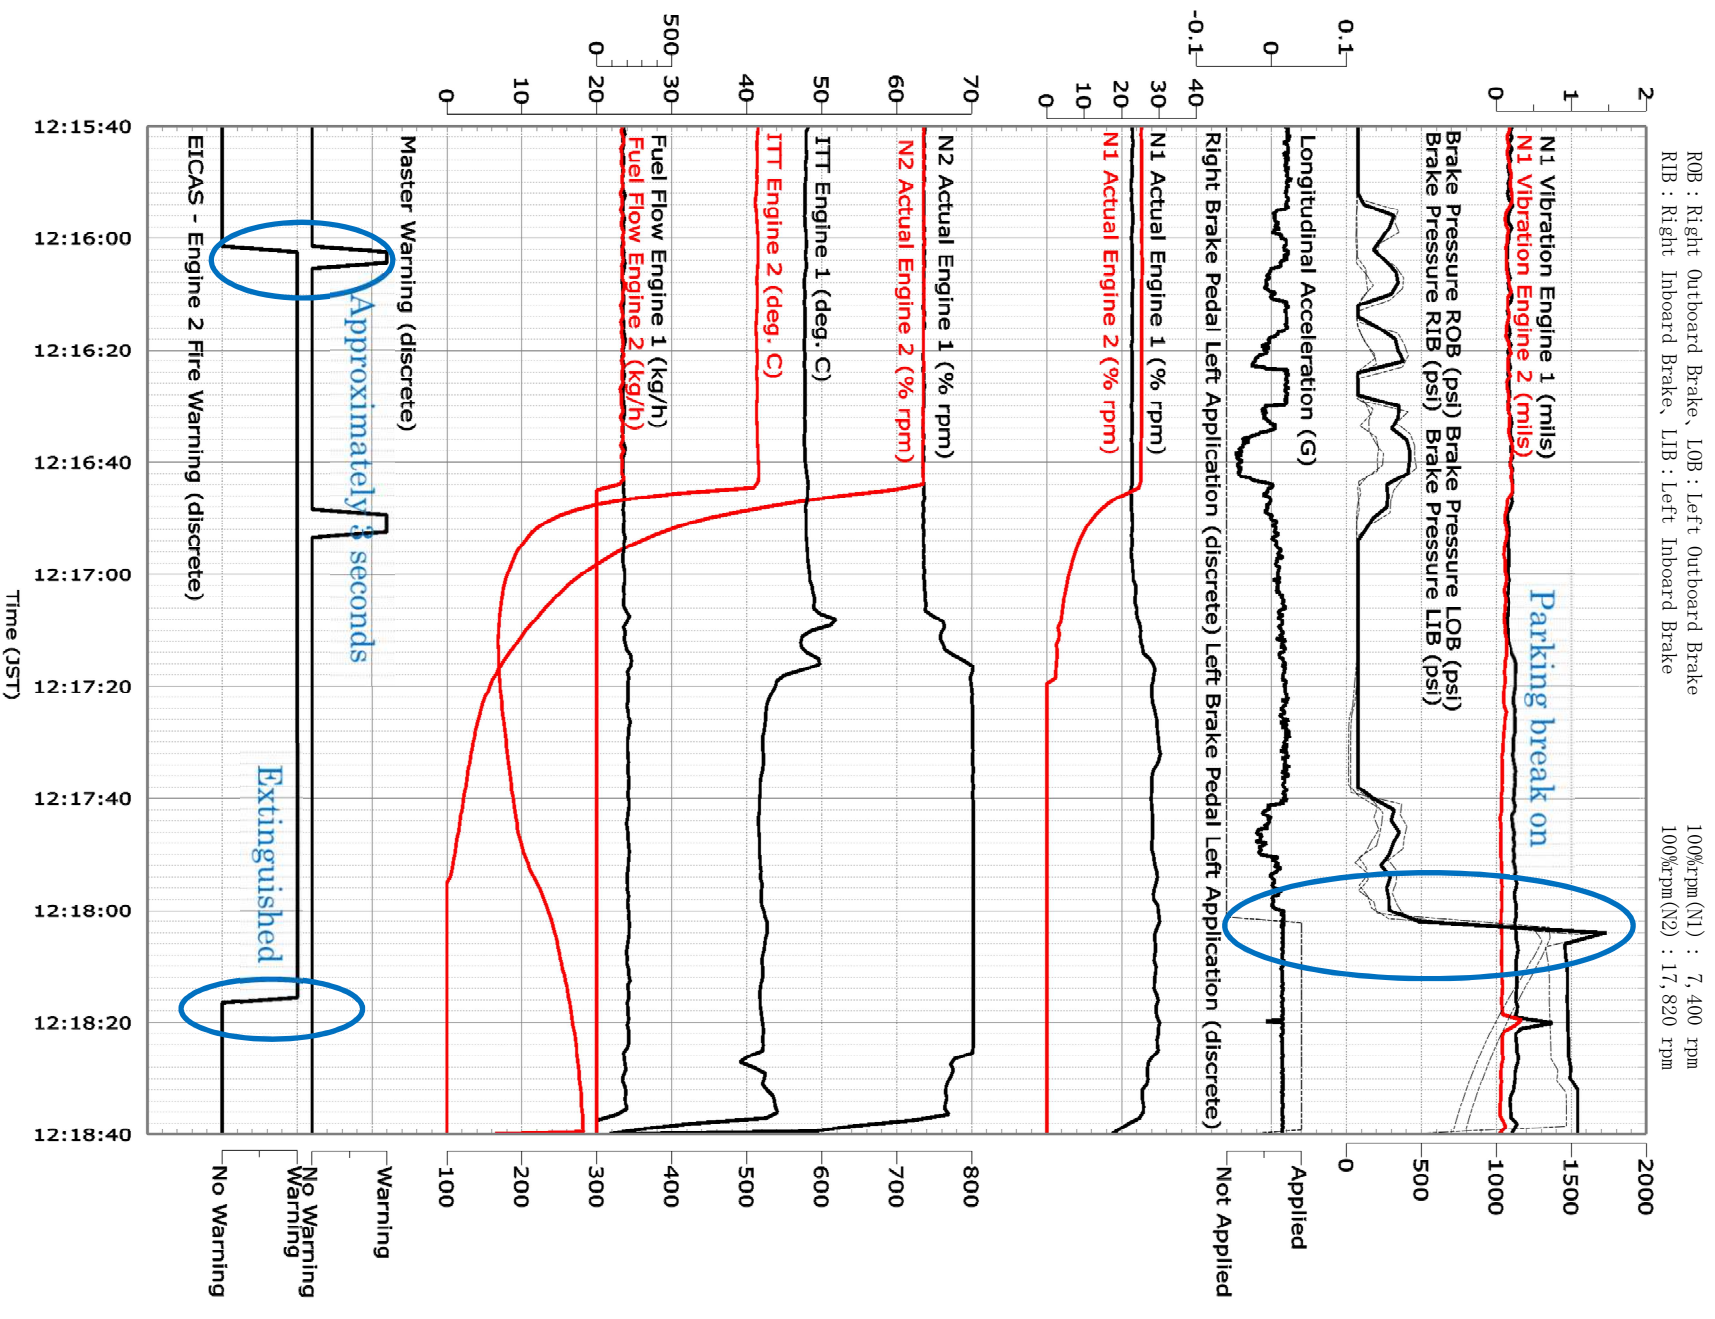
Figure 2: DFDR Records

The DFDR recorded the activation of master warning such as fire bell sounds and the right engine fire warning displaying the right engine fire warning message at the same time, and it recorded that the master warning was turned off after approximately three seconds. (See Figure 2: DFDR Records)

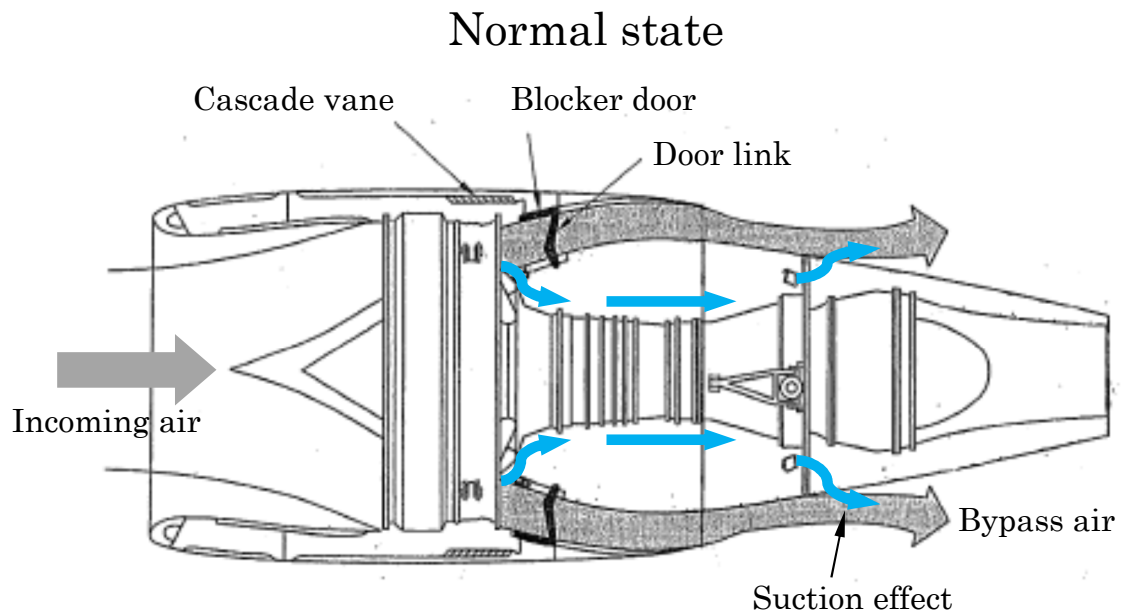
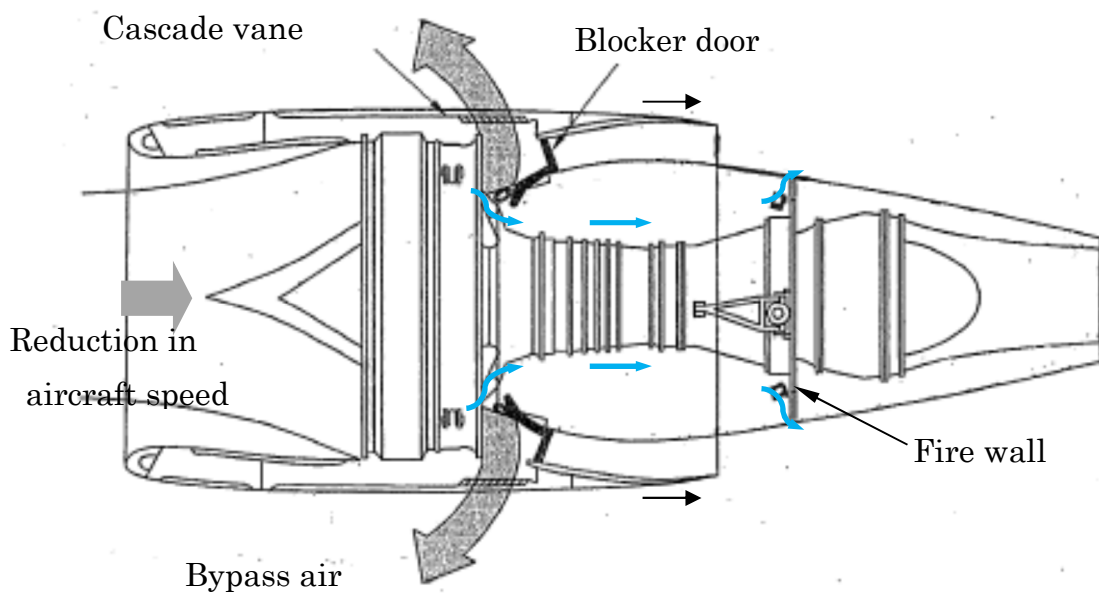
Figure 4: Cooling and Ventilation air Flow

(See Figure 4: Cooling Air Flow, Photo 4: Confirmation of Fuel Leaks and Photo 5: Thermal Insulation Blanket Slots)

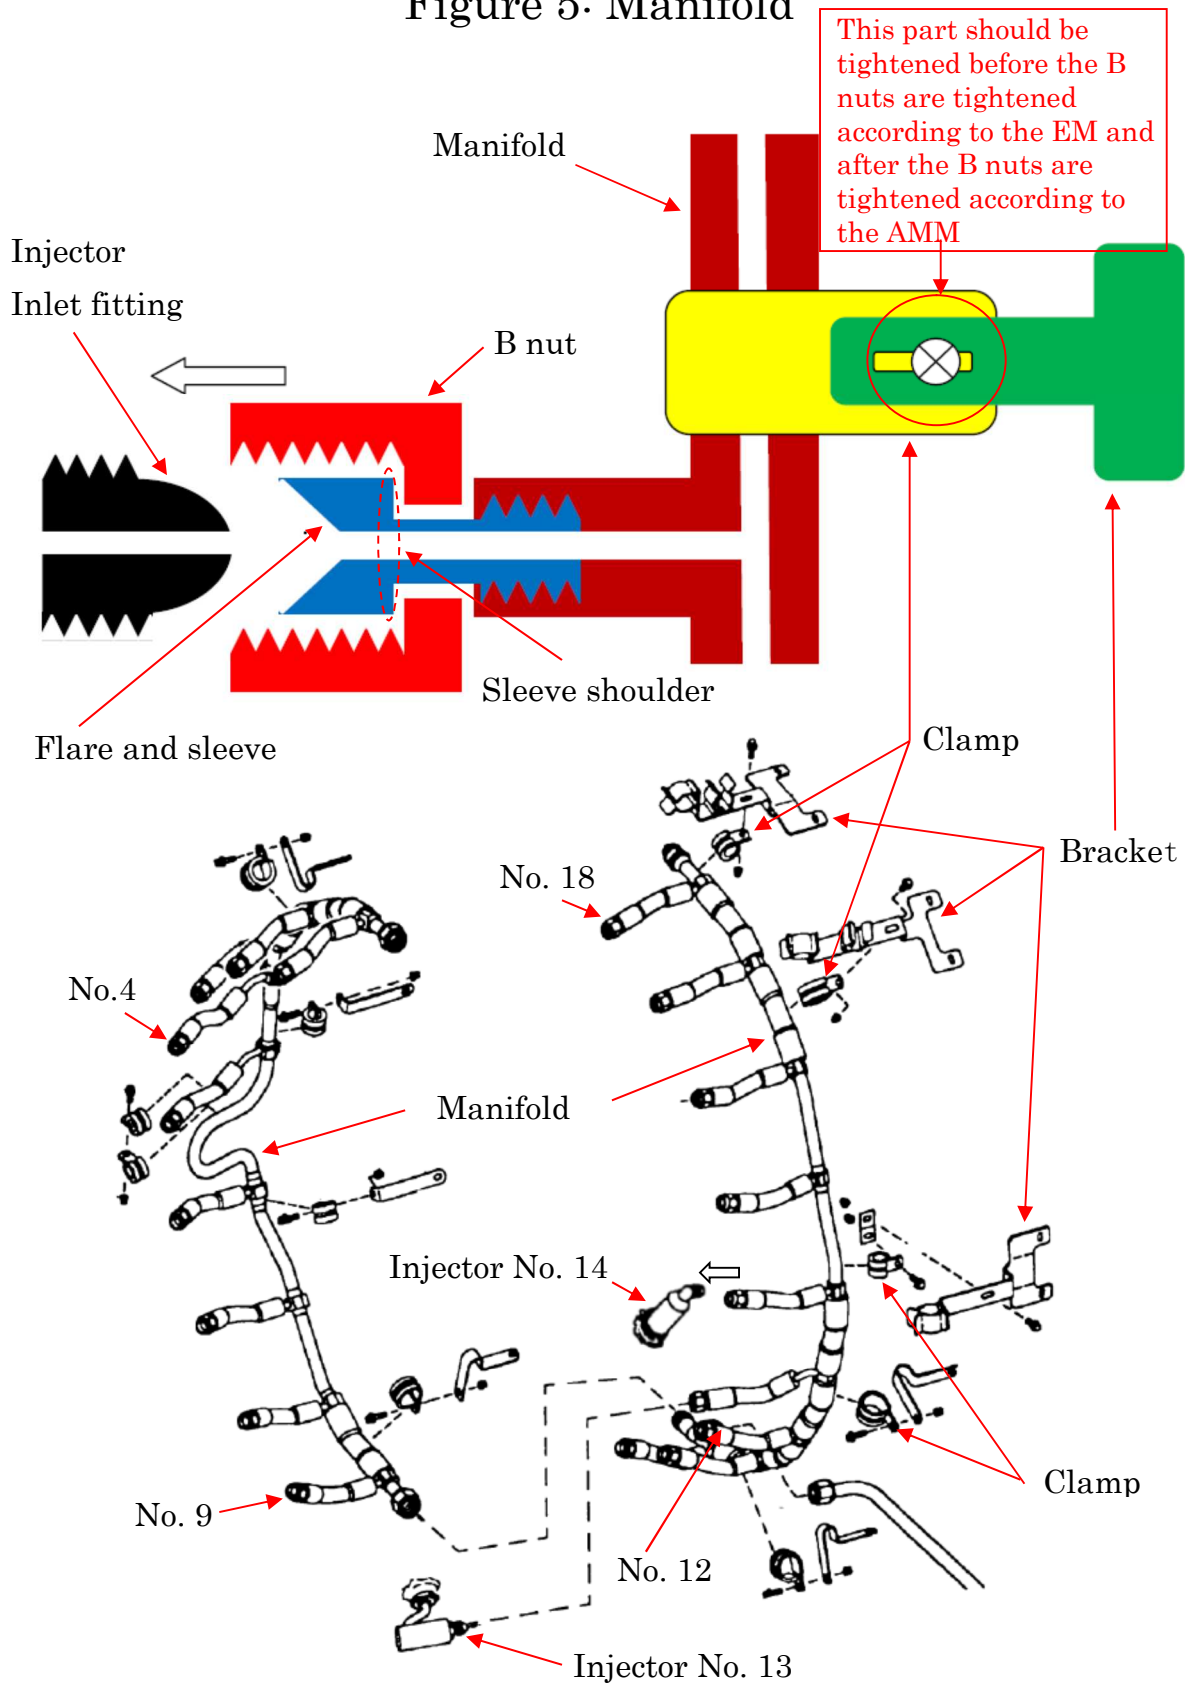
Figure 5: Manifold

Although it is somewhat likely that the reason why the B nut was loose was the insufficient tightening force of the B nut, resulting in gradually loosening caused by factors such as engine vibration, the JTSB couldn't determine the cause of the loosening.

It is highly probable that the cause of this serious incident was because the B nut connecting the right engine manifold and injector No. 14 was loose, and because fuel leaked from this area and was ignited by the heat of the engine, which caused fire. Although it is somewhat likely that the reason why the B nut was loose was the insufficient tightening force of the B nut, resulting in gradually loosening by factors such as engine vibration, the JTSCB couldn't determine the cause of the loosening. Note that among the 26 engines of the same model that were inspected in a blanket inspection after the occurrence of this serious incident, three engines were found to have looseness outside the specified value, and all of them were overhauled by IHI.

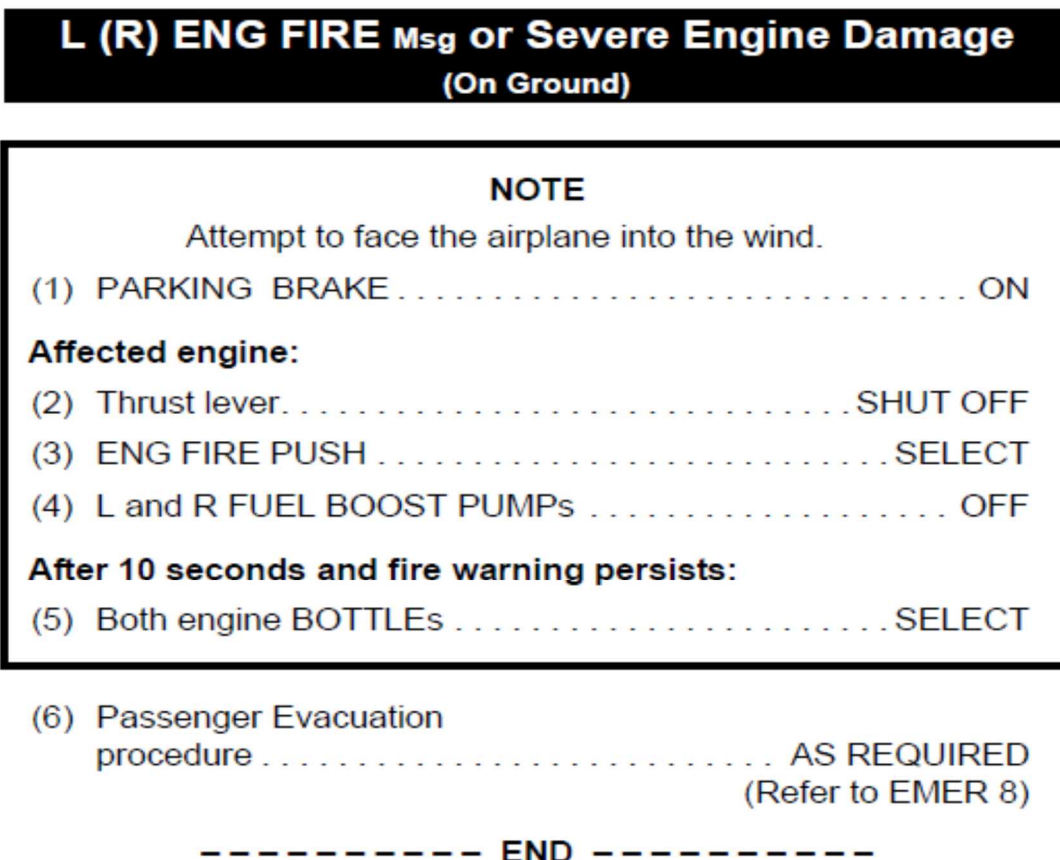
Figure 7: Engine Fire Checklist (On ground)

(See Figure 7: Engine Fire Checklist (on ground))

Enhance education and training involving important system functions for safety and reconsider the contents of training in response to an outbreak of fires.
