**AIRCRAFT ACCIDENT
INVESTIGATION REPORT**

December 21, 2017

**JAPAN AIRLINES CO., LTD.
BOEING 737-800, JA322J
PASSENGERS INJURIES
AT THE EMERGENCY EVACUAION
AT NEW CHITOSE AIRPORT, JAPAN
AT AROUND 15:10 JST, FEBRUARY 23, 2016**

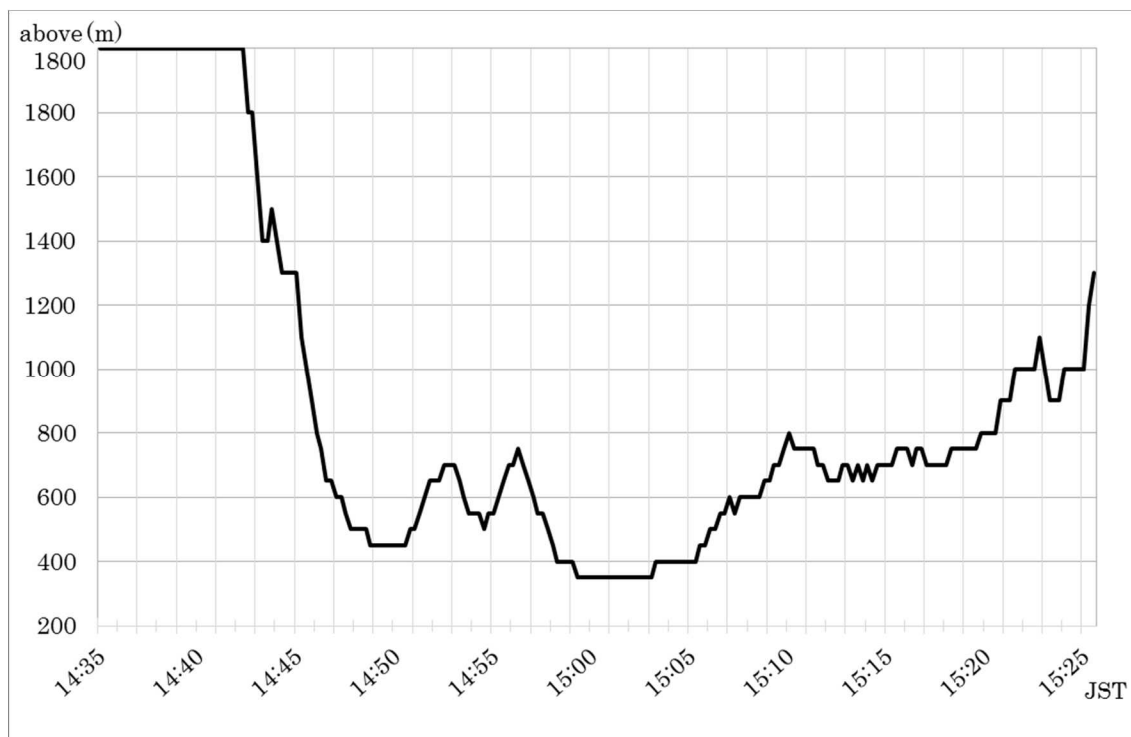
Figure 2 Data of the RVR value on the runway 19R

RVR values (one minutes mean value of the observations per every 15 seconds) observed near the touchdown zone at the runway 19R which is closest to the accident site are as shown in Figure 2. The accident site was about 700 m to about 250° direction from the observation point.

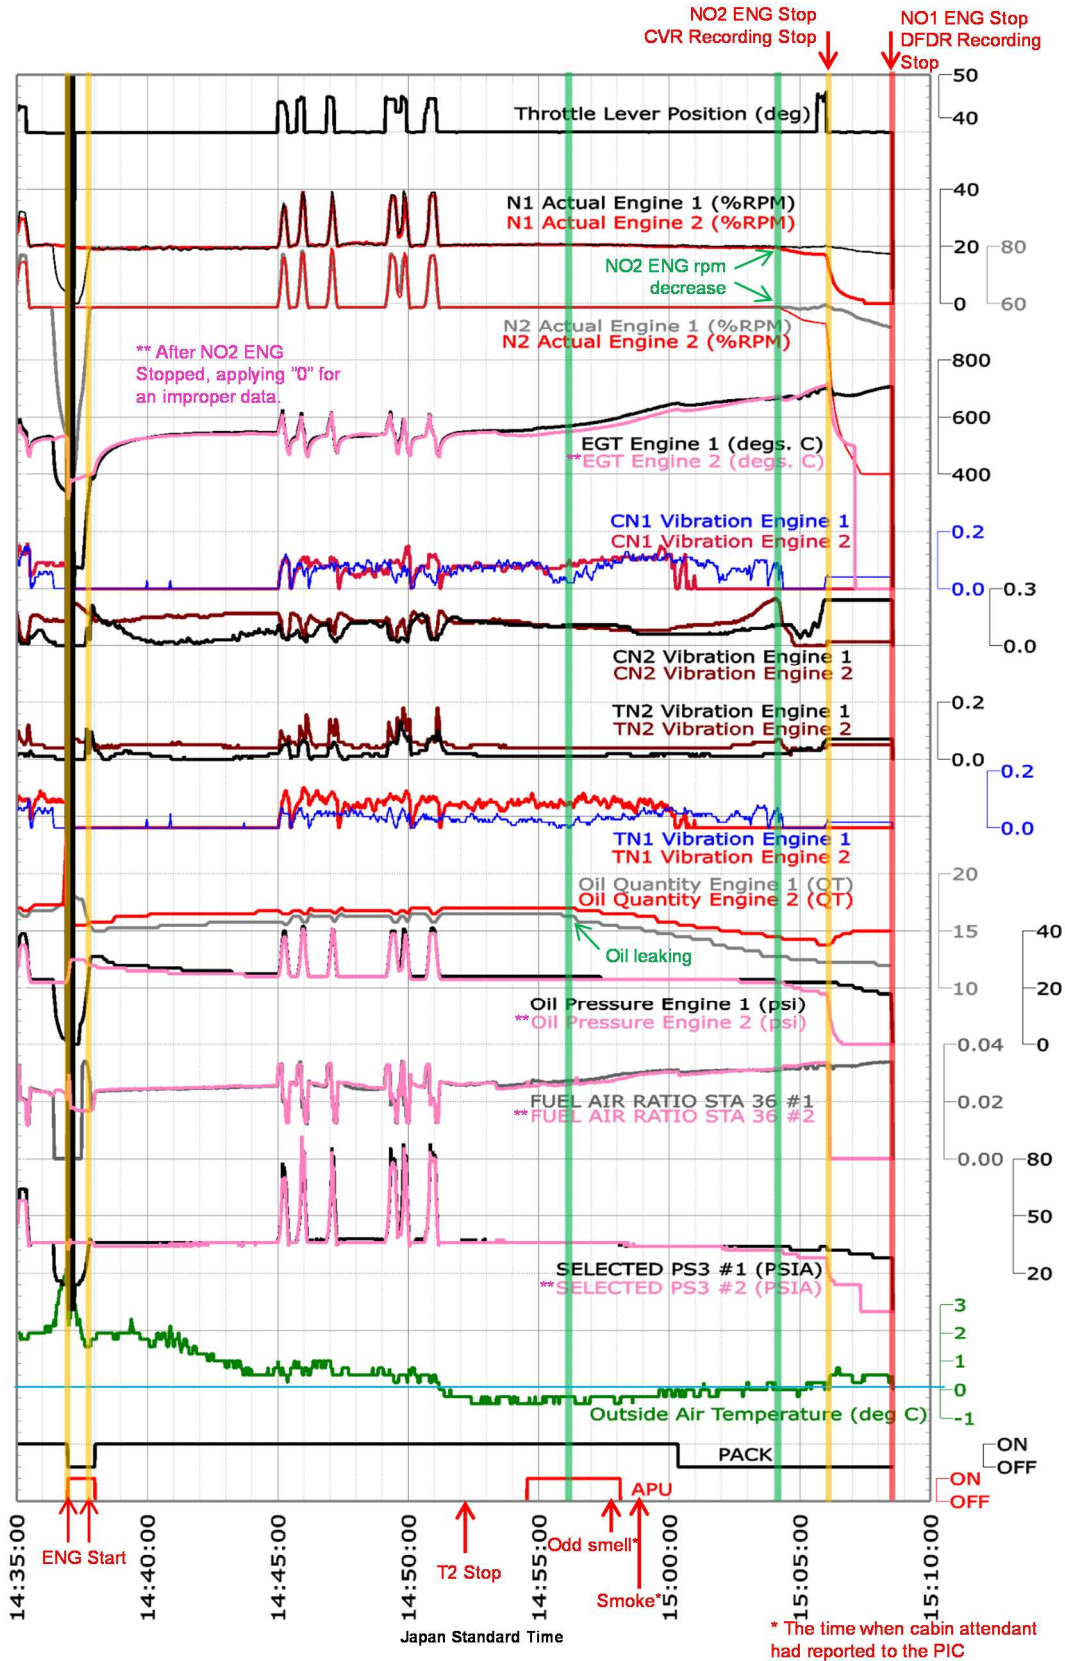
Appended Figure 2 Records of FDR

Based on the FDR records as expressed in Appended Figure 2, the outside temperature (OAT) of the Aircraft was exceeding - 1°C at the time zone of the occurrence of the accident, based on the Table 1 as shown in 2.6.2(2), from the time that the visibility became 200 m at 14:49 to the occurrence of the accident, the visibility was below 800 m. according to the statements as described in 2.1.1 and 2.1.2(1), (2) and (7), it is probable that the visibility was so deteriorated at about 14:52 that the taxiway centerline about 50 m at front could not see due to the severe snowfall.

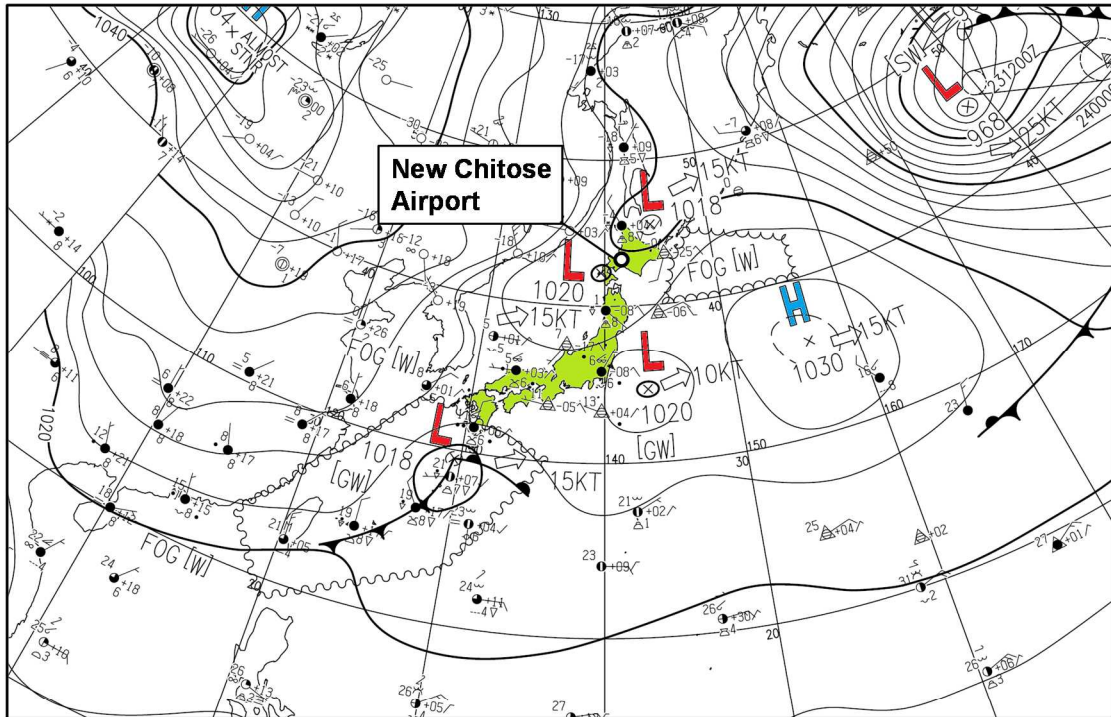
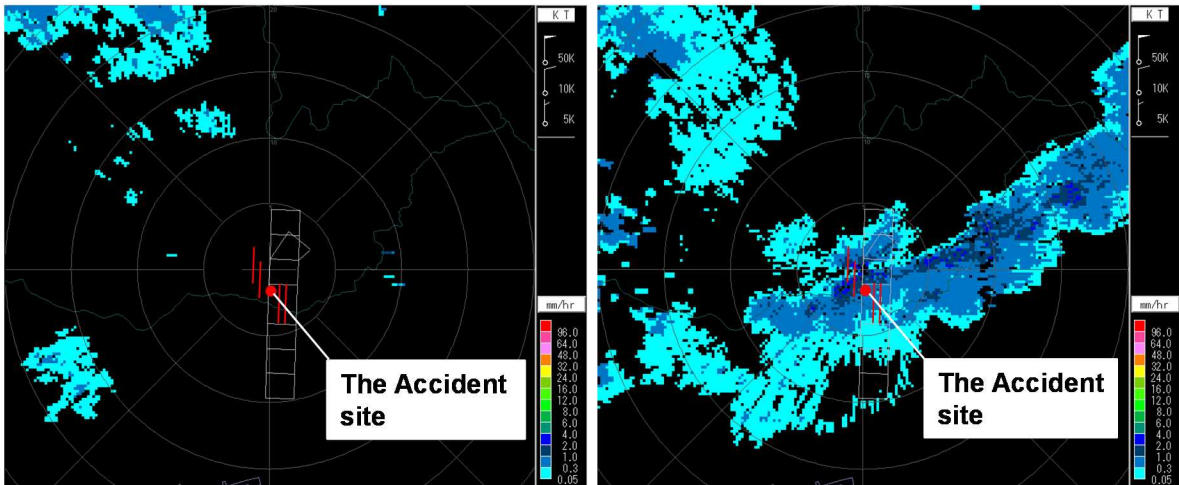
Appended Figure 4 Meteorological Condition

As described in the Table 1 on 2.6.2, at the Airport snow flurries changed from light snow flurries was starting at 14:41 and then severe snow flurries started to fall from 15:03. And then, the severe snow flurries continued to fall up to 15:13 after the occurrence of the accident. Also, the prevailing visibility was 10 km or more at 14:00, but at 14:49, the visibility became 200 m. Furthermore, as shown in Figure 2 in 2.6.4, it is highly probable that since the RVR value of the runway 19R decreased by 1,000 m or more from 14:43 to 14:50, the visibility was deteriorated as the snowfall intensified within the short time at the Airport.

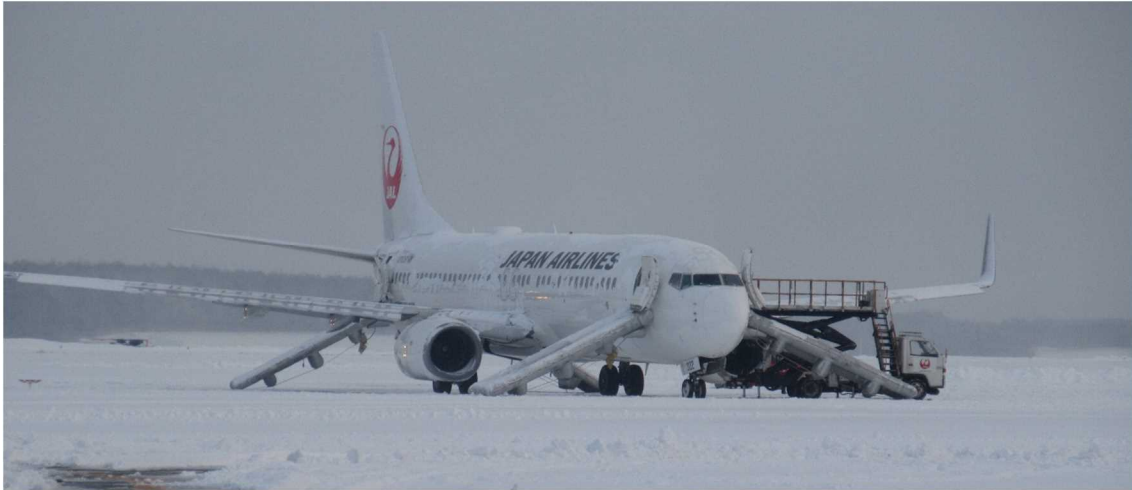
Photo 1 The Accident Aircraft

(See Appended Figure 1 Estimated Taxing Route Diagram, Appended Figure 2 Records of FDR, Photo 1 The Accident Aircraft)

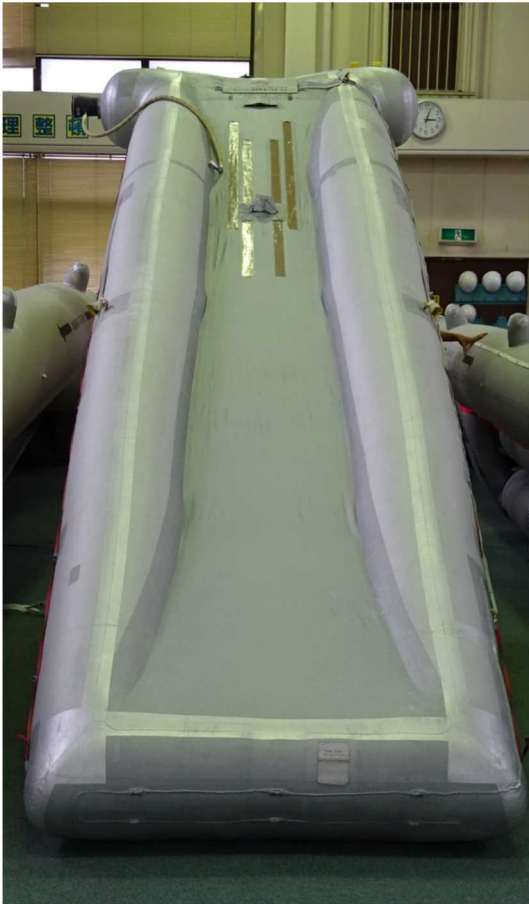
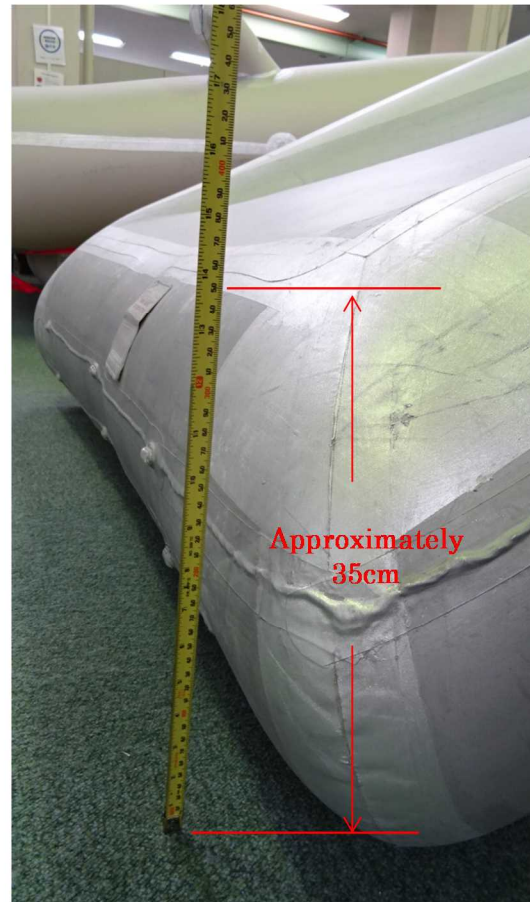
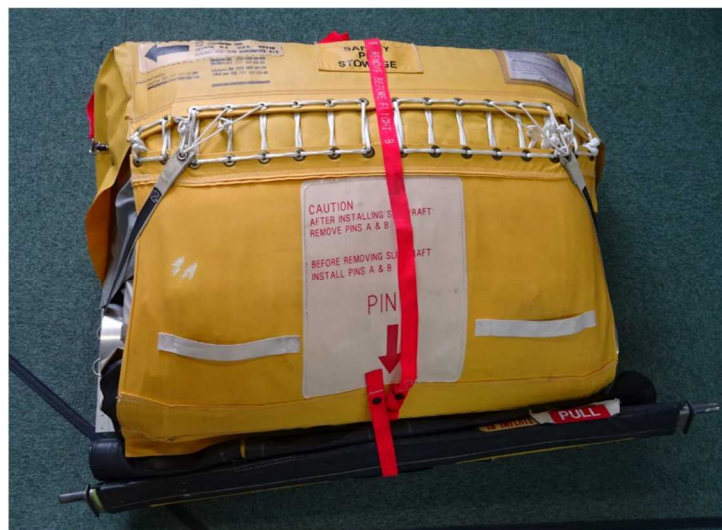
Photo 4 Slide of the same type installed on the Aircraft

As the major specification of the evacuation slide equipped on the Aircraft, the model is the type to descend one by one and major materials are urethane rubber with partial aluminum coating. When the emergency exit opened, the evacuation slide stored in a folded state will be inflated and deployed automatically. In specifications, the time to deploy should be within 4 seconds.
