**AIRCRAFT ACCIDENT
INVESTIGATION REPORT**

J A 3 2 C T

February 25, 2011

**PRIVATELY OWNED
ROBINSON R44 II (ROTORCRAFT), JA32CT
AT ABOUT 15 KILOMETERS SOUTHEAST OF TAJIMA AIRPORT,
JAPAN
AT ABOUT 09:30 JST, JULY 20, 2009**

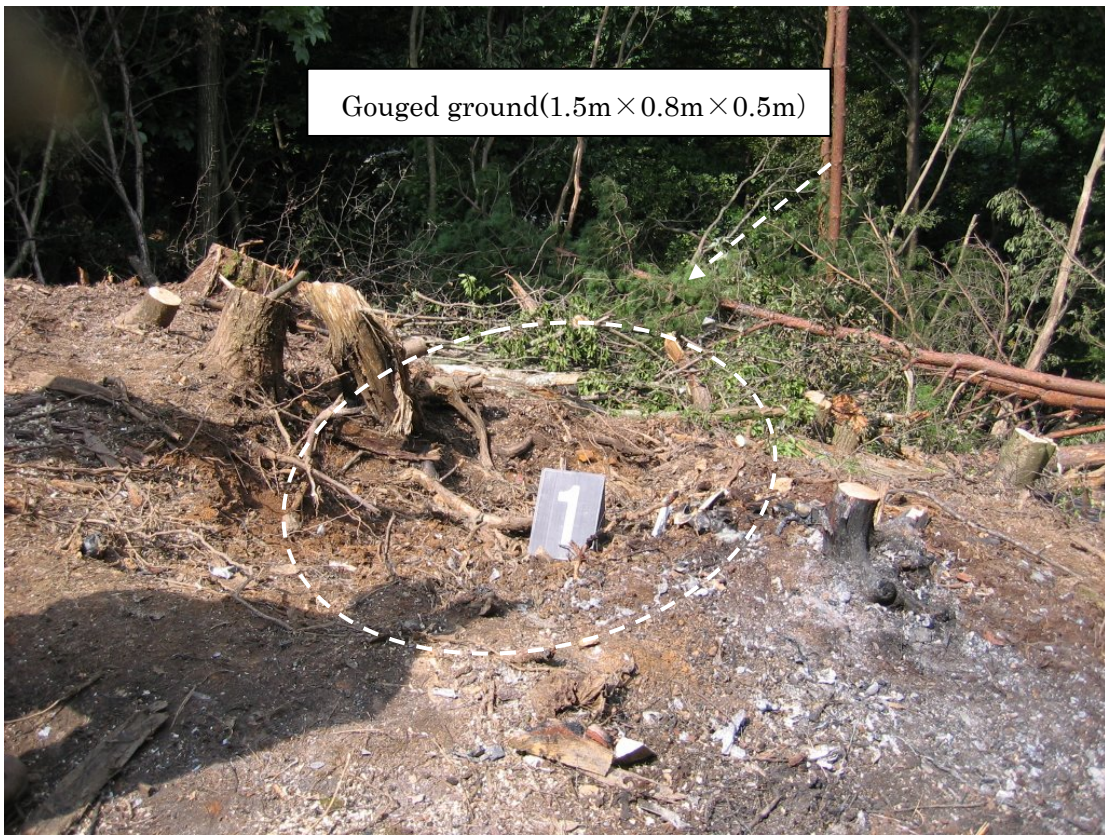
Photo 5 Impact of the Crash

(See Figure 2 Accident Site Layout, Photo 1 Accident Site, Photo 2 Wreckage of Accident Aircraft, Photo 3 Crash Site, Photo 4 Main Rotor Blades, Photo 5 Impact of the Crash, Photo 9 Pine Trees Hit by the Accident Aircraft)
