AA2014-6

**AIRCRAFT ACCIDENT  
INVESTIGATION REPORT**

October 30, 2014

## PRIVATELY OWNED CESSNA 172N RAM, JA3814 CONTACT WITH GROUND WORKER FOLLOWING DEVIATION FROM RUNWAY AT OTONE AIRFIELD, KAWACHI TOWN, INASHIKI-GUN, IBARAKI PREFECTURE, JAPAN AT ABOUT 15:55 JST, AUGUST 18, 2012

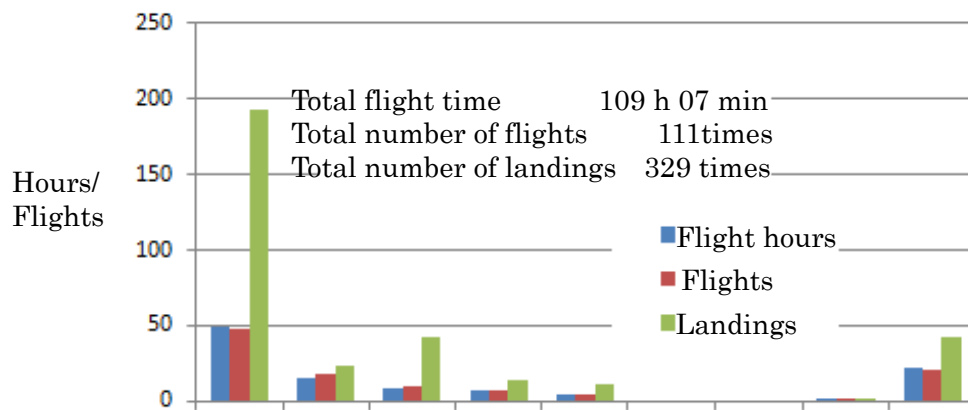
Figure B Captain's Flight Experience

The runway at Otone Field is 20 m wide (600 m long) as described in 2.7. The runway at Oshima Airport where the Captain flew three times in 2012 is 45 m wide (1,800 m long). The runway at Fukushima Airport where he flew once in 2012 is 60 m wide (2,500 m long).

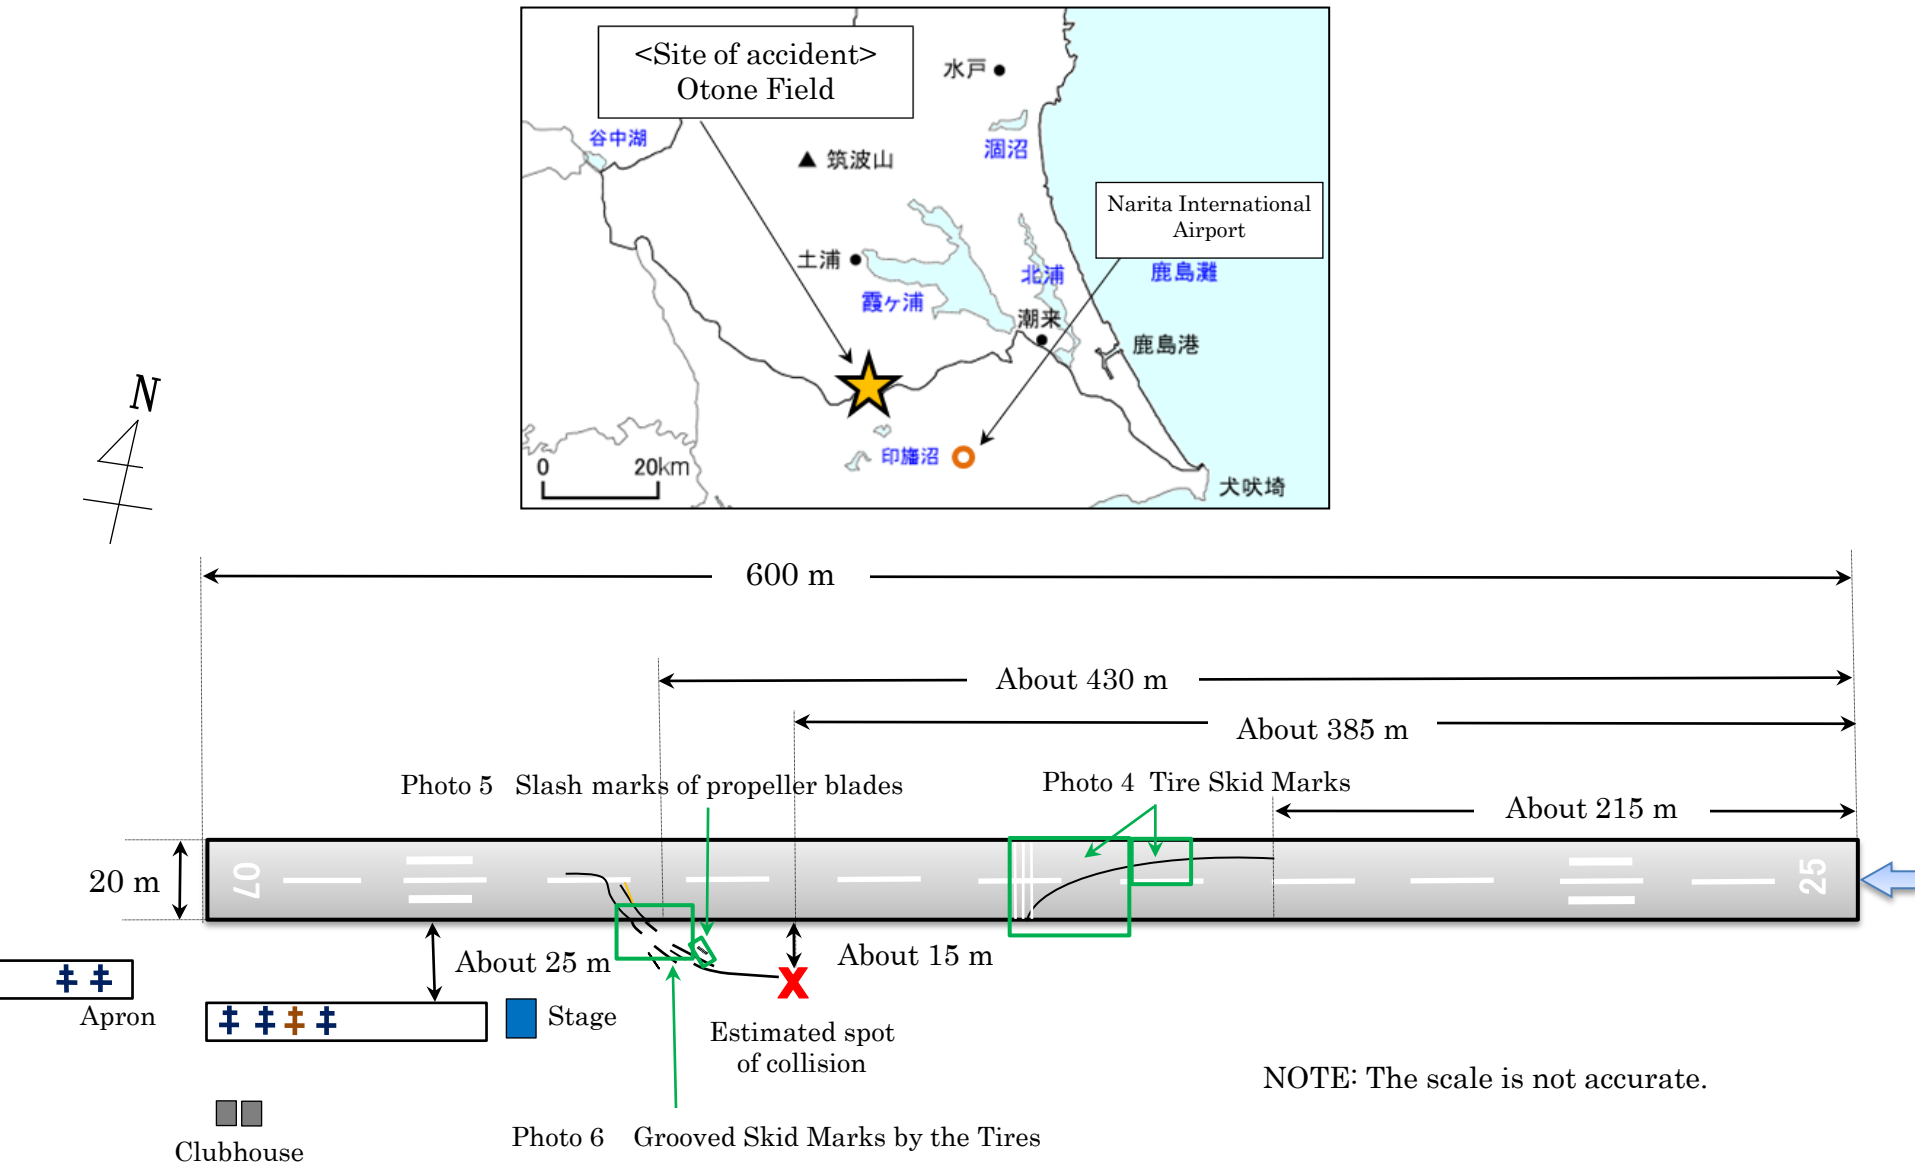
Figure 1 Marks Left at the Accident Site

(See Figure 1: Marks left at the Accident Site)

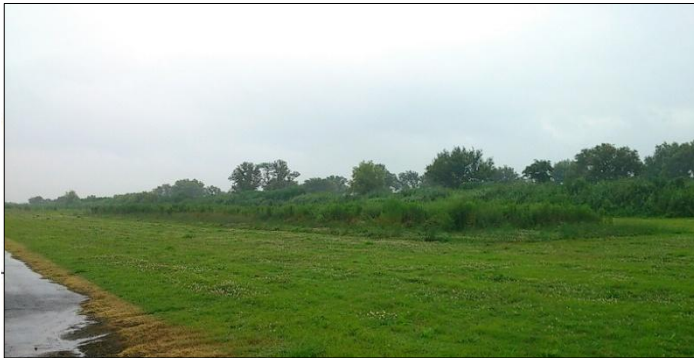
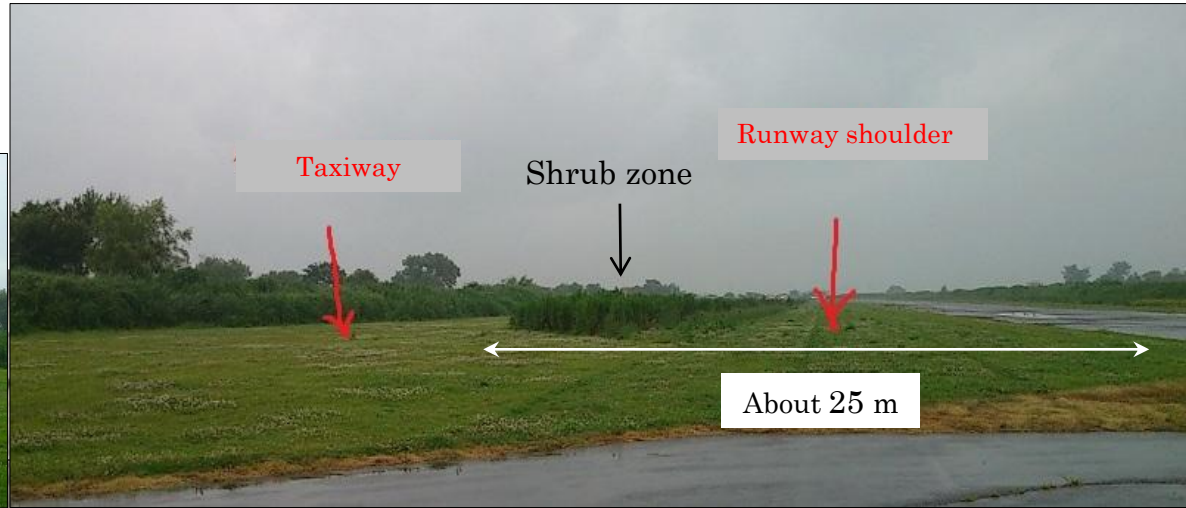
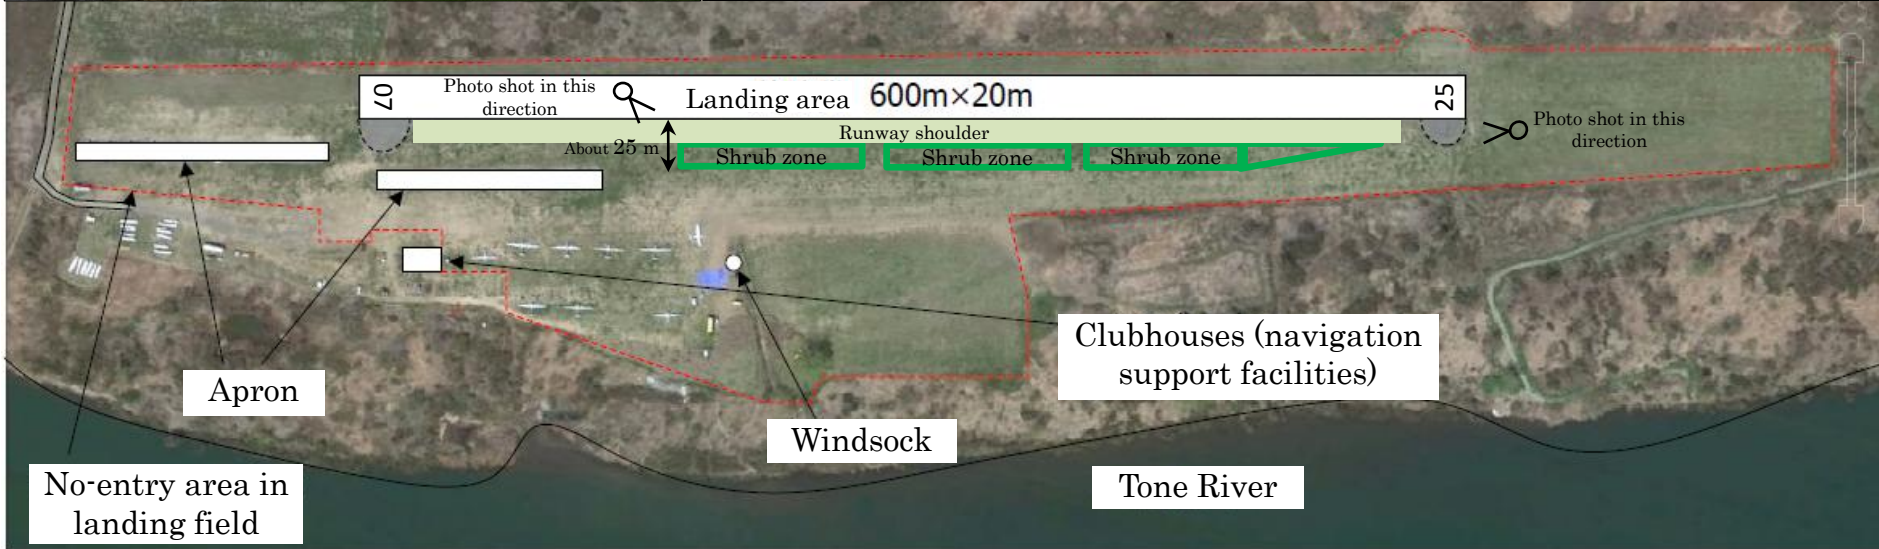
Figure 6 Otone Field Management and Operation Rules: Attachment 2

*No person shall enter areas surrounding the landing field during flight operation.  
(See Figure 6 – Otone Field Management and Operation Rules: Attachment 2)*

Following the accident, the Japan Flying Association installed fences along the borders of the restricted areas described above to clarify the specific area. In addition, shrub zones were established between the runway and the taxiway as shown in Figure 6 to secure a runway shoulder
