AA2015-4

**AIRCRAFT ACCIDENT
INVESTIGATION REPORT**

**PRIVATELY OWNED
J A 3 8 5 3**

COLLISION WITH A TOWER FOR HIGH VOLTAGE POWER LINES
A PRIVATELY OWNED CESSNA 172M RAM, JA3853
SASAHARA-CHO, TOYOTA CITY, AICHI PREFECTURE, JAPAN
AROUND 11:47 JST, MARCH 5, 2014

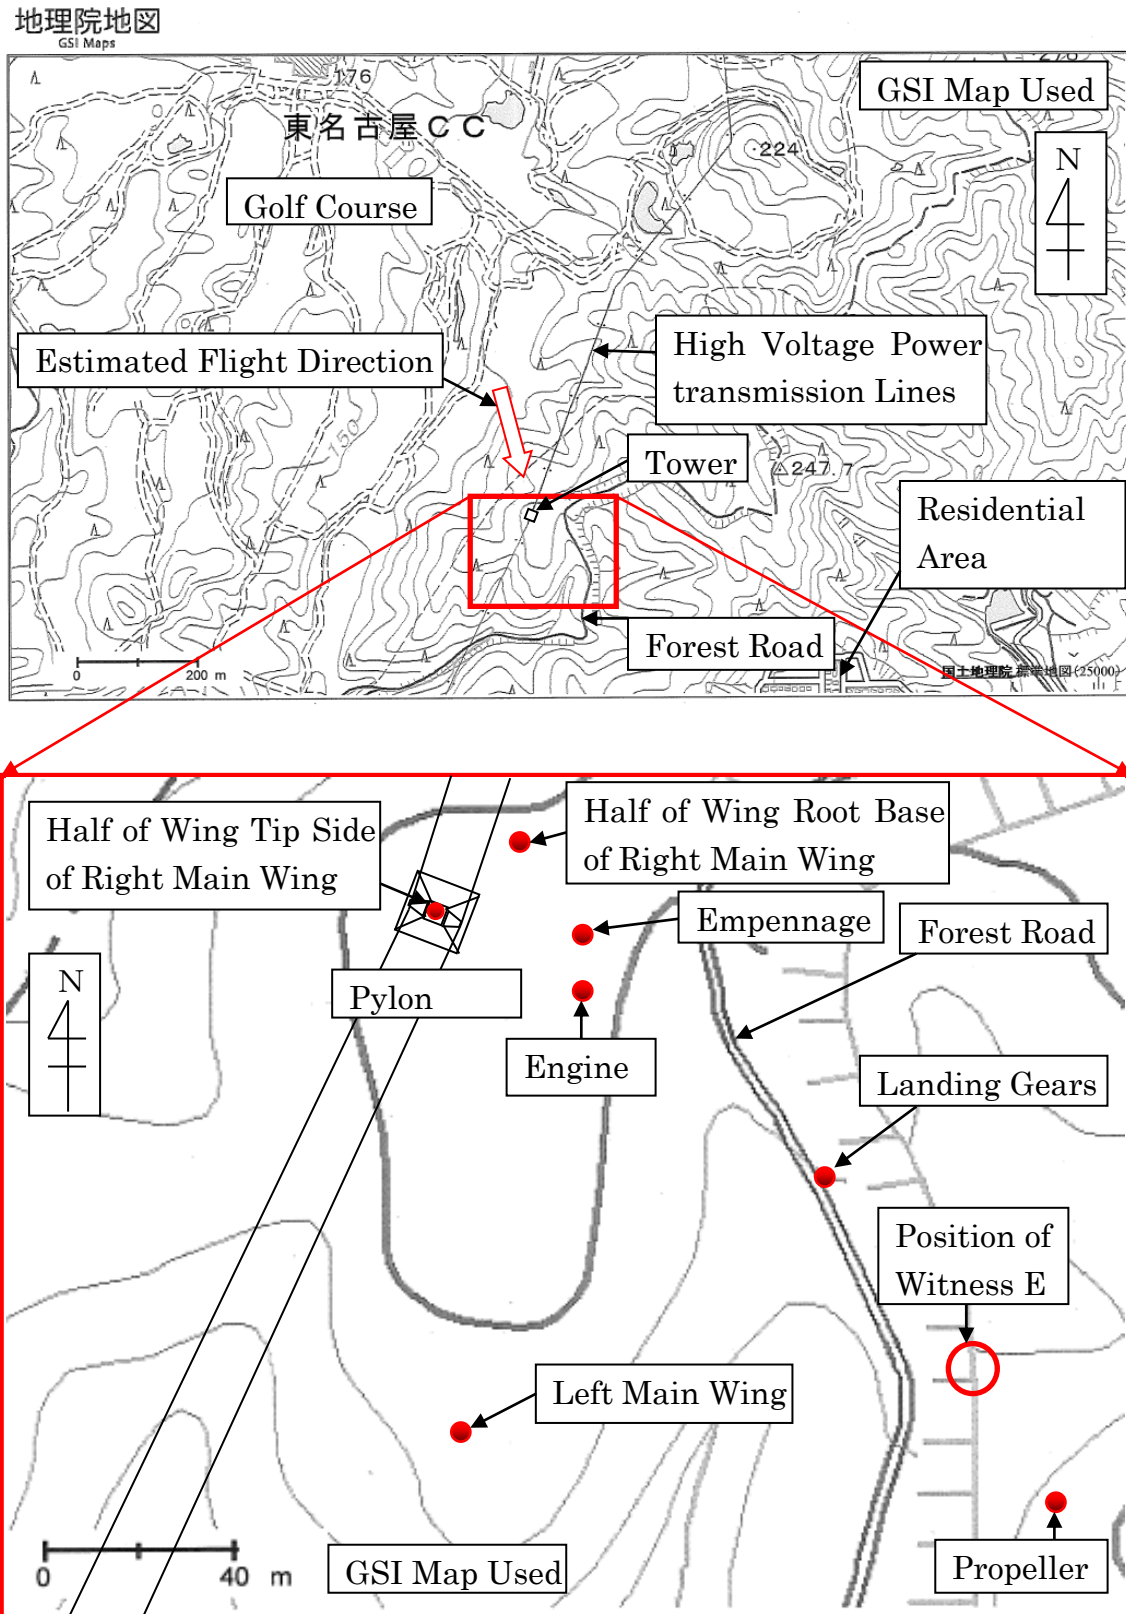
Figure 5: Accident Site Layout

(See Figure 1: Estimated Flight Route Based on Data of the GPS, Figure 2: Estimated Flight Route (Immediately before Collision) and Figure 5: Accident Site Layout.)

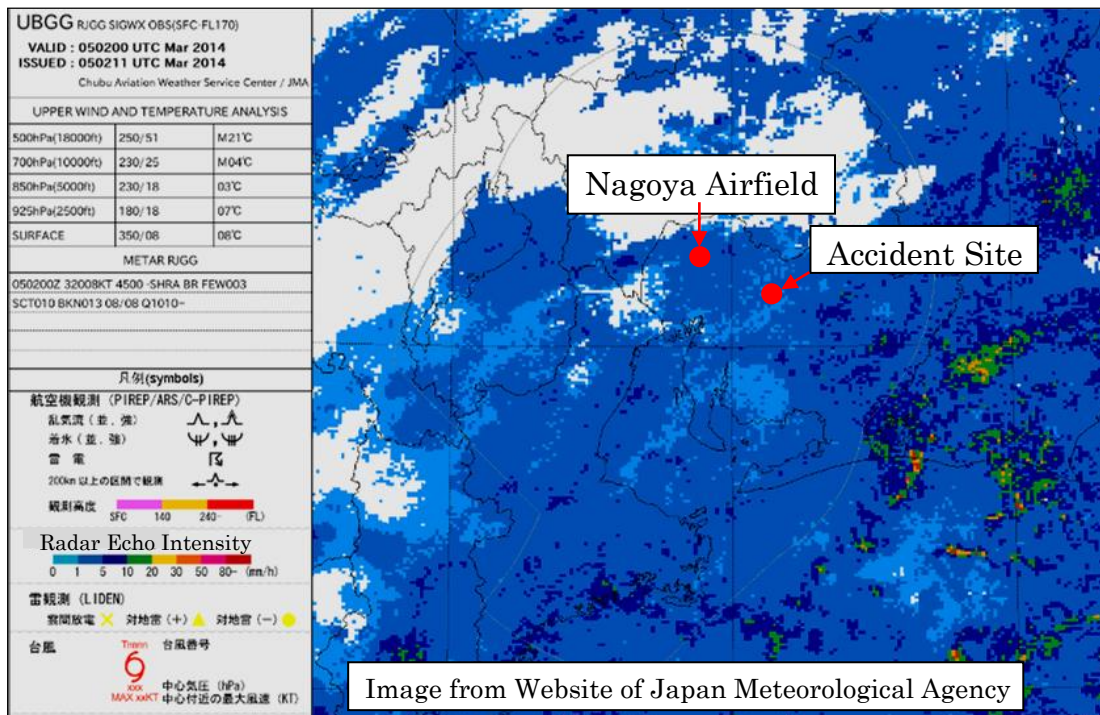
Figure 6: Narrow Regional Significant Weather Observation Chart
(11:00 March 5)

(See Figure 2: Estimated Flight Route (Immediately Before Collision), Figure 6: Narrow Regional Significant Weather Observation Chart (11:00 March 5), Figure 7: Narrow Regional Significant Weather Observation Chart (12:00 March 5) and Photo 4: Accident Site.)

(See Figure 6: Narrow Regional Significant Weather Observation Chart (11:00 March 5), Figure 7: Narrow Regional Significant Weather Observation Chart (12:00 March 5) and Figure 8: Weather Chart.)
