**AIRCRAFT SERIOUS INCIDENT  
INVESTIGATION REPORT**

**HONDA AIRWAYS CO., LTD.  
JA4000**

HALT OF ENGINE IN FLIGHT  
HONDA AIRWAYS CO., LTD.  
CESSNA TU206G, JA4000  
OVER AKITA CITY, AKITA PREFECTURE, JAPAN  
AT ABOUT 11:43 JST, NOVEMBER 16, 2013

April 10, 2015

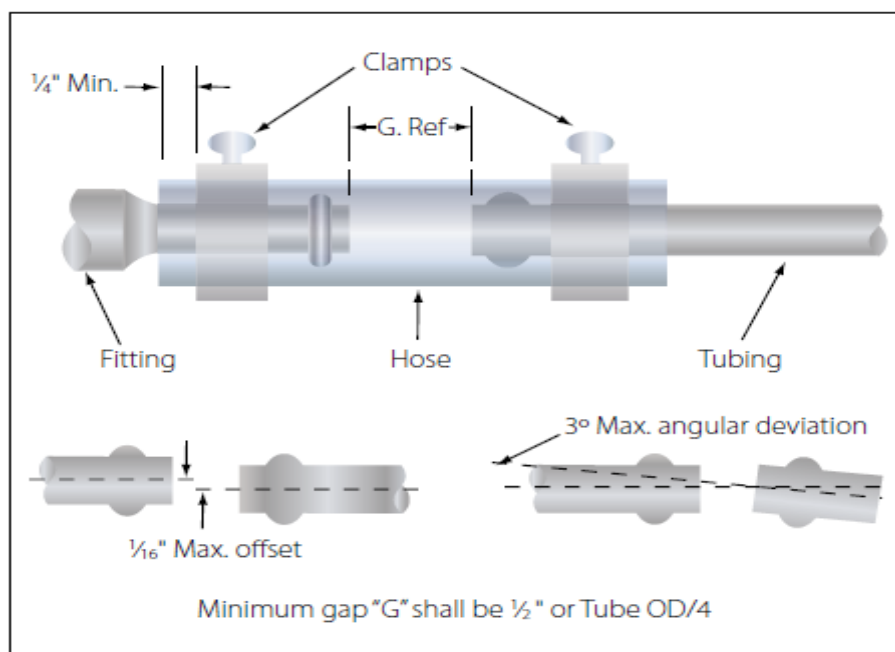
**Figure 7-25. Flexible fluid connection assembly.**

*Figure 7-25 illustrates the design of a flexible fluid connection assembly and gives the maximum allowable angular and dimensional offset.*

When connected in accordance with the manufacturer's Installation Instructions described in (3)②, the position of the clamp of the hose (hose is shown by the orange box) is in the area where the diameter of the housing on the engine body becomes thick, as shown by the blue box; therefore, there is no bead to serve as a catch mechanism for preventing detachment of the hose on the inside of the clamp as shown in Figure 7-25 described in (3)①.

In addition, as described in 2.11.1(4), the housing on the engine body side, as shown in Figure 7-25 of 2.11.1(3)①, had no catch mechanism which would prevent detachment of the clamp in the event that it became loose. It is somewhat likely that this contributed to the detachment of the loosened extension hose from the housing on the engine body.

*When repairing a low-pressure line using a flexible fluid connection assembly, position the hose clamps carefully to prevent overhang of the clamp bands or chafing of the tightening screws on adjacent parts.*

*If chafing can occur, the hose clamps should be repositioned on the hose.*
