AIRCRAFT ACCIDENT INVESTIGATION REPORT

DAMAGE TO THE AIRFRAME DURING LANDING

PIPER PA-46-350P, JA4077

SENDAI AIRPORT

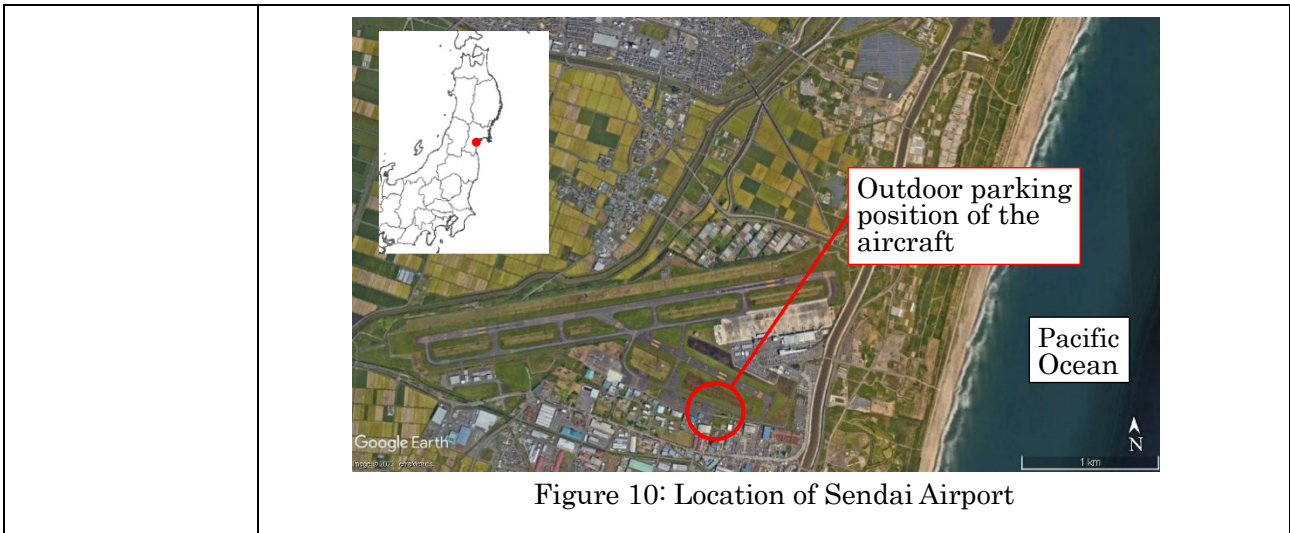
After the captain purchased the aircraft in November 2020, the aircraft usually parked outdoor on an apron at its homebase, Sendai Airport.

The Airport is located at an elevation of 5.6 ft (1.7 m) along the coastline facing the Pacific Ocean.
