**AIRCRAFT ACCIDENT
INVESTIGATION REPORT**

**PRIVATELY OWNED
J A 4 1 7 5**

DAMAGE TO AIRCRAFT DUE TO OVERRUN

PRIVATELY OWNED GULFSTREAM AEROSPACE AG-5B, JA4175

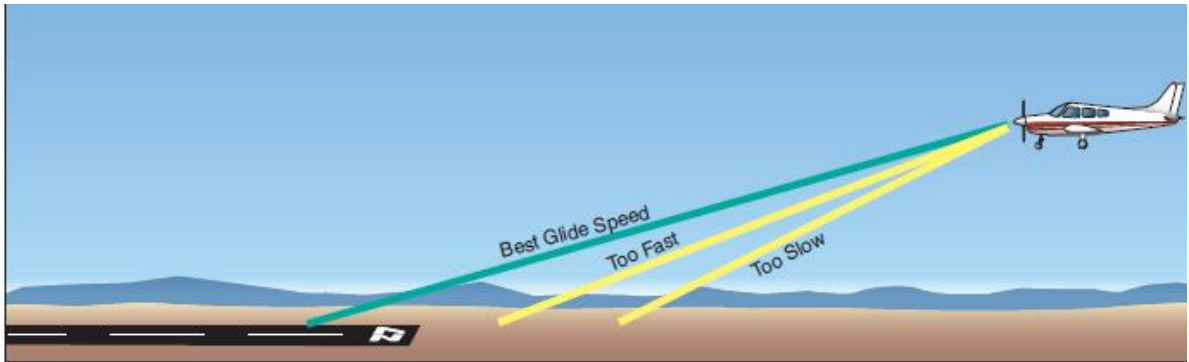
Figure: Gliding Distance Based on Glide Speed (「*Airplane Flying Handbook*」 2004. Published by FAA. p.3-17)

The figure above shows that when the aircraft's speed is "Too Slow" or "Too Fast" than the Best glide Speed, gliding distance will decrease.

As described in 2.1.2(1), after engine power began to descend, the Pilot set it at full throttle. He descended while maintaining cruising speed, but as described in 2.10.1, he attempted to make a landing with no-flap condition at a speed adding tailwind component of 8 kt to the normal approach speed of 70 kt; however, he did not have composure to check the airspeed. Moreover, as described in 2.1.2(3), Witness A had stated that the final approach speed of the Aircraft had appeared to be about twice the typical approach speed for small single-engine aircraft (70 kt). Hence, Witness A had thought that the Aircraft did not attempt landing, but was doing a low-pass at high speed.

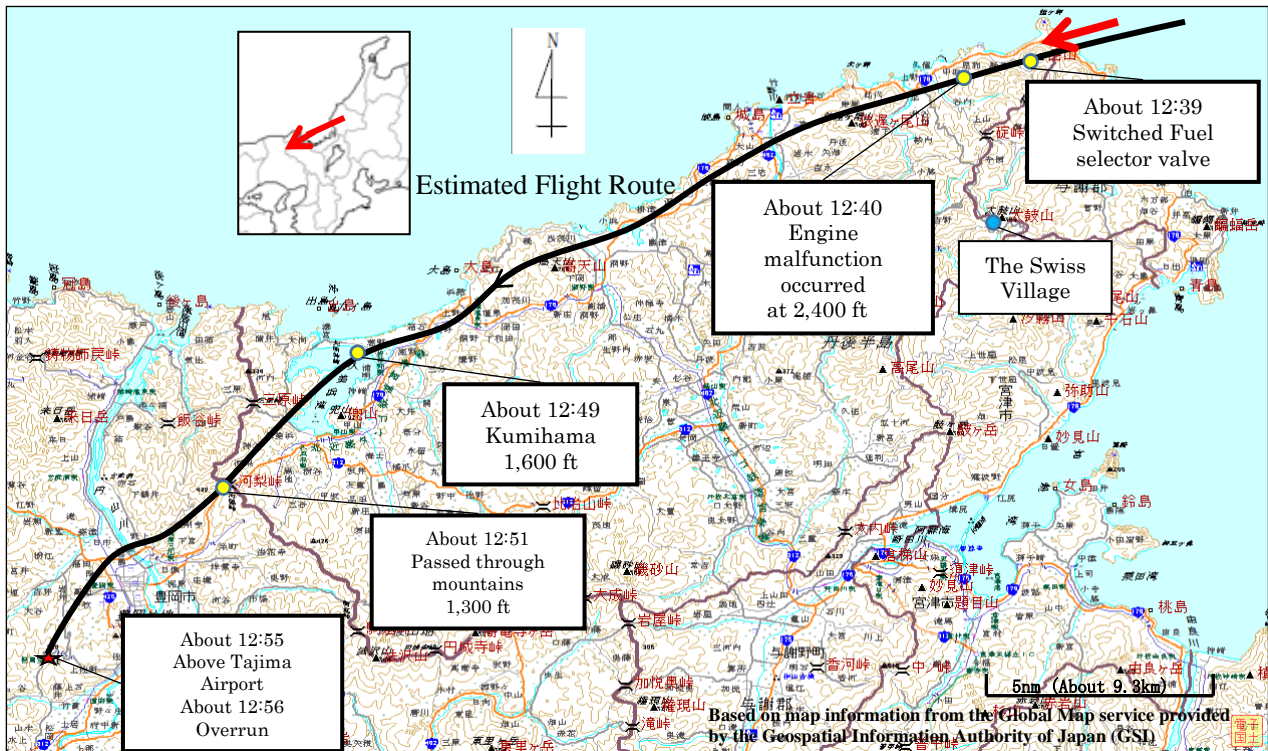
Figure 1: Estimated Flight Route

Witness A, who holds a commercial pilot certificate, was onboard an aircraft standing by taxi for departure on the north apron (refer to Figure 1: Estimated Flight Route) for a flight, when he received information regarding an aircraft making an emergency landing from Tajima Flight Service. He turned his aircraft toward the direction of the final approach leg of the runway 19 and helded there.

As described in 2.1.2(1), the Pilot received the Airport information from the Tajima Flight Service that the wind was coming from the north at 15 kt, and to the use runway 01. However, it is probable that the Pilot considered that it would not be possible to reach the runway 01 as he would have to fly a long traffic pattern from the approach direction that the Aircraft was in; therefore, requested to land on the runway 19 and approached in a straight line under the tailwind conditions.

Estimated Flight Route
(Based on statement and notes by Witness B)
