**AIRCRAFT ACCIDENT
INVESTIGATION REPORT**

**PRIVATELY OWNED
JA 4193**

DAMAGE FROM THE BELLY LANDING A PRIVATELY OWNED PIPER PA-28R-201, JA4193 SAPPORO AIRFIELD AT AROUND 15:38 JST, AUGUST 19, 2015

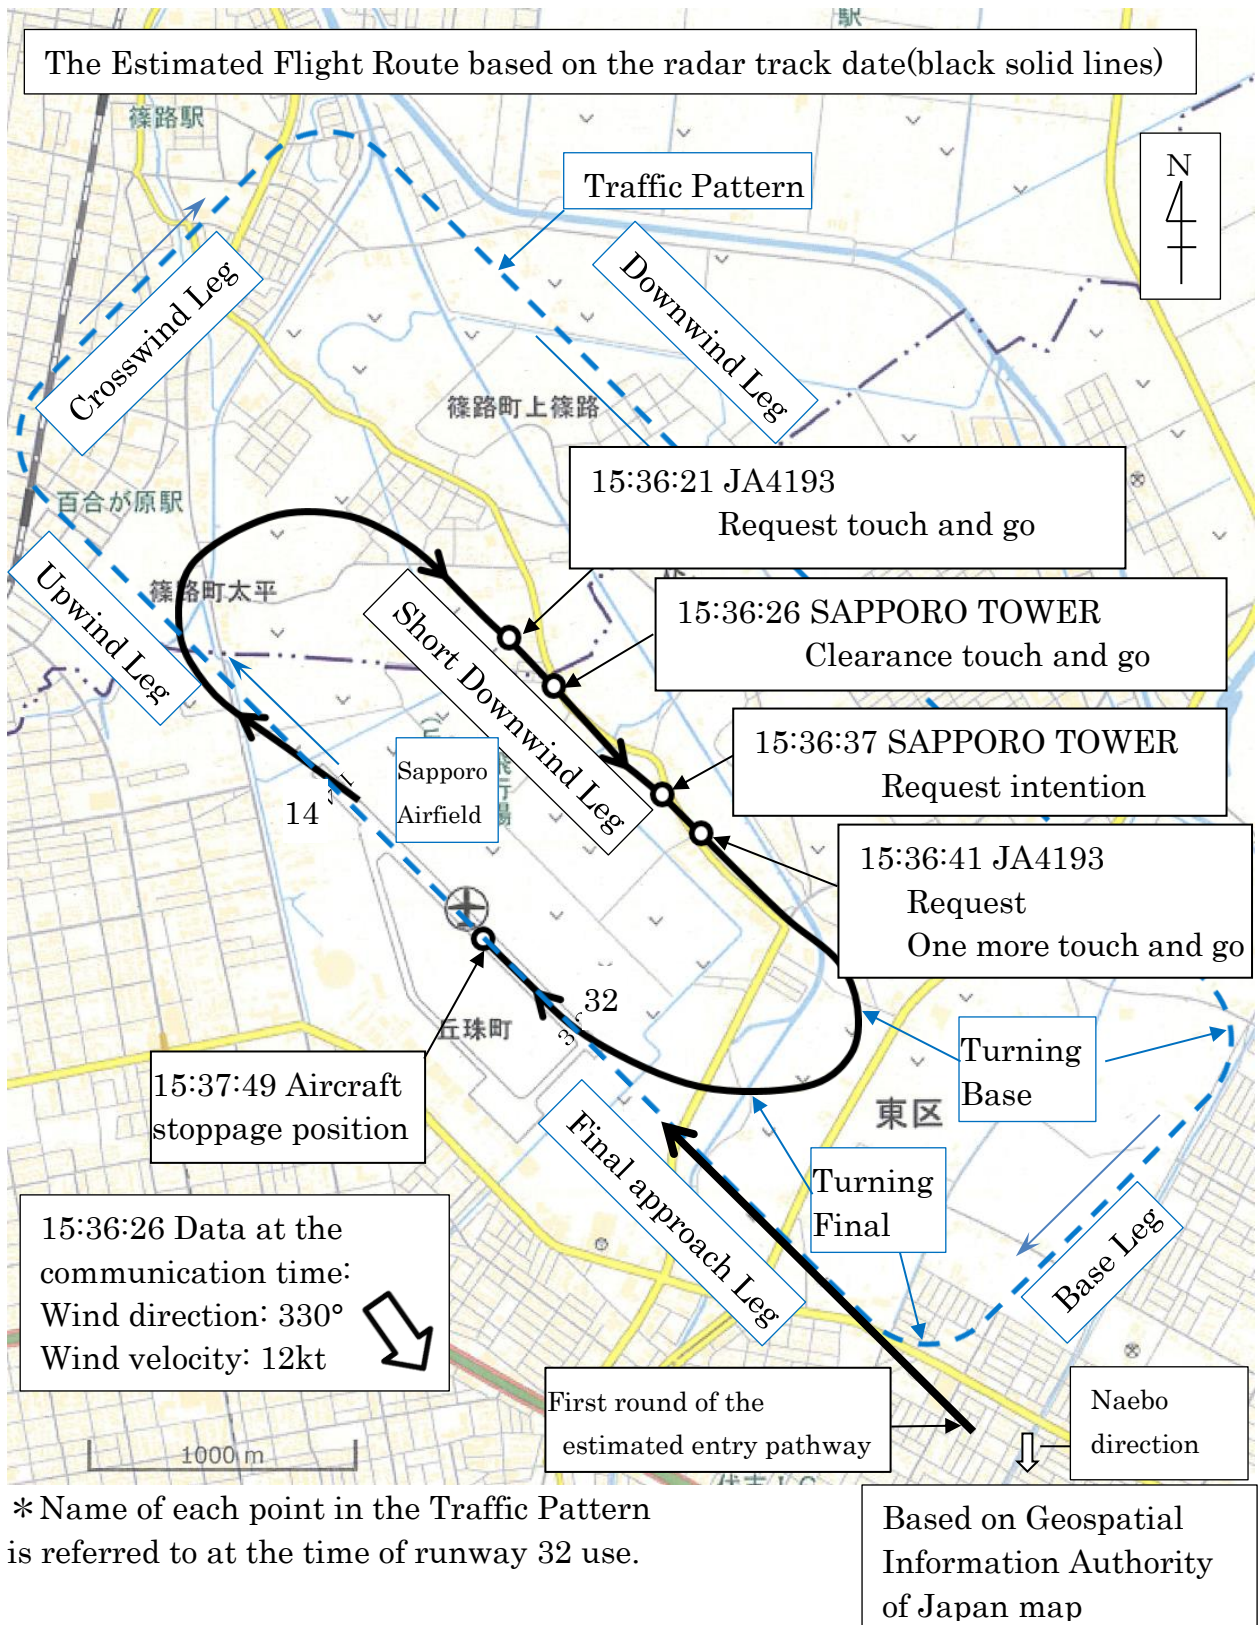
Figure1: Estimated Flight Route

green lights*⁹. On the final approach leg, because the examinee had found that the altitude was too high, he attempted to touch down as soon as possible by fully pushing-down the flap and by lowering the nose, the aircraft touched down beyond the aiming point.

As the Traffic Pattern of Sapporo Airfield is set in the northeast side of the runway only, when runway 32 is the duty runway, the course becomes the clockwise. In the case of short downwind leg, an aircraft will fly over a closer path of distance from the runway than the normal downwind leg. The name of each point in the Traffic Pattern is as Figure 1.
