# AIRCRAFT ACCIDENT INVESTIGATION REPORT

BEEHCRAFT A36, JA4577

IEJIMA AIRPORT, OKINAWA PREFECTURE, JAPAN

AT ABOUT 12:46 JST, MARCH 12, 2022

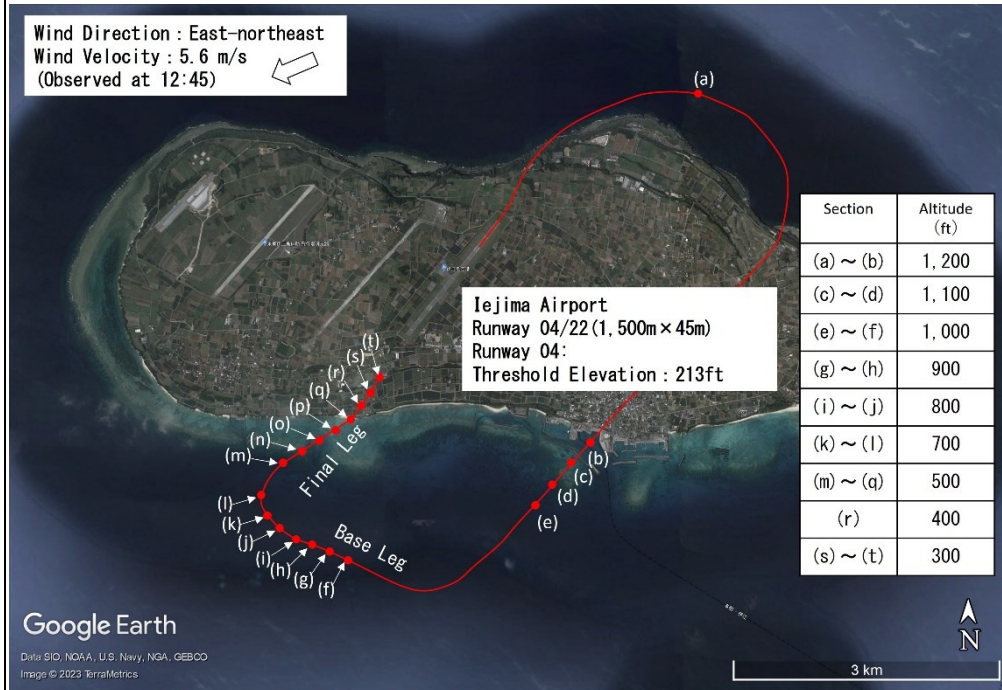
Figure2: Estimated Flight Route Based on Radar Records (Note)

According to the radar records, the aircraft turned to the right after the take-off, flew the right downwind leg at an altitude of 1,200 ft, changed the altitude to 1,000 ft. The aircraft maintained the altitude of 1,000 ft until the half of the right base leg, then commenced descending. The captain broadcast by one-way transmission, saying "Final Approach", which the

(Note) Although the position and altitude of the aircraft were out of radar coverage, which the two nearby radar sites (the air route surveillance radar (Mt. Yaedake) and the aerodrome surveillance radar (Naha Airport)) partially captured, thus the position and altitude were estimated based on those records. (See 2.7 (9) for details.)
