AIRCRAFT ACCIDENT INVESTIGATION REPORT

AIRCRAFT DAMAGE DUE TO COLLISION WITH A VEHICLE

BOEING 767-300, JA603A

NARITA INTERNATIONAL AIRPORT, JAPAN

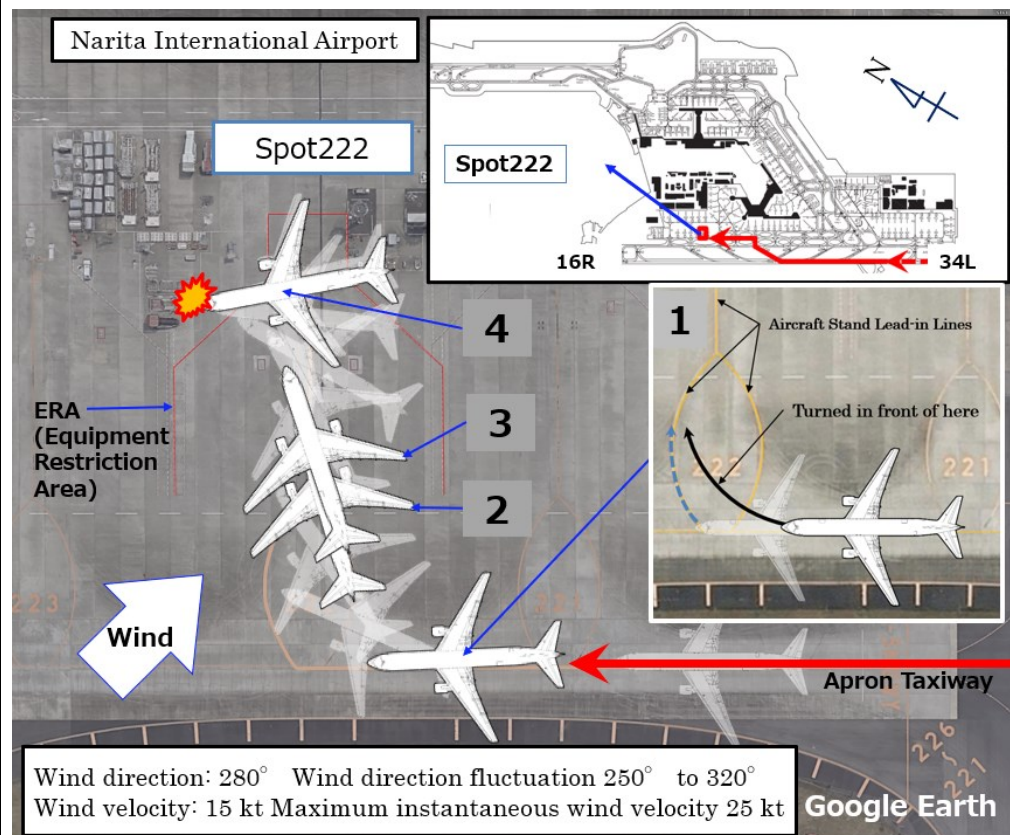
Figure 1: Spot Entry of the Aircraft

At the time of entering the Spot, thinking that turning along the Aircraft Stand Lead-in Line with a large rudder application as usual might cause the aircraft to slide, the PIC started to have the aircraft turn right short of the Aircraft Stand Lead-in Line. At this time, the ground speed of the aircraft was 7 kt. (See Figure 1, 1, Figure 2, 1)

The aircraft entered the Spot until its nose gear was on the part of the straight line of the Aircraft Stand Lead-in Line, and further turned to a heading of 046° along the Aircraft Stand Led-in Line, when its steering became ineffective. At this time, the ground speed of the aircraft was 4 kt. (Figure 1, 2, Figure 2, 2)

The PIC fully depressed the right and left brake pedals to stop the aircraft but was unable to stop it. Immediately after that, thinking the collision with the ground service equipment and others was unavoidable, in order to reduce the impact at the time of the collision, the PIC tried to reduce the aircraft speed with the reverse thrust by moving the reverse thrust lever to the reverse idle position, but the aircraft's tail veered to the right direction, and its airframe started to slide on the Spot while rotating counterclockwise, making it impossible to control the taxiing of the aircraft, although the brakes were applied. (Figure 1, 3, Figure 2, 3)

The aircraft continued to slide on the Spot while rotating counterclockwise, the lower surface of the nose had hit a ground service equipment that parked in the vicinity of the Spot when the heading direction deflected to 322°, came to a stop. (Figure 1, 4, Figure 2, 4, Figure 3)

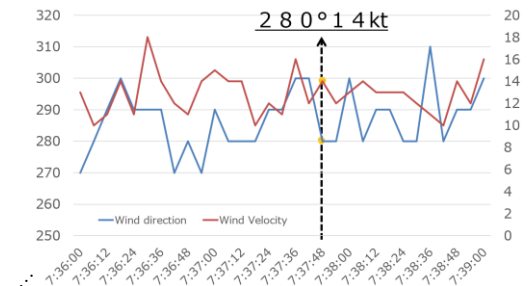
Figure 5: Wind Direction and Wind Velocity

<p>and ground height about 10 m), when the aircraft tail began to slide to the right direction, the wind direction and wind velocity were 280° and 14 kt, respectively.</p>
<p>2.7 Additional Information</p>	<p>(1) Aircraft Status</p> <p>After this accident, the mechanics of the company confirmed the integrity of the aircraft's landing gears, steering, brakes and engines, but found no failure.</p> <p>(2) Taxiing (Turn)</p> <p>According to AOR*² for Boeing 767-300 aircraft, created by the company, general precautions when turning on slippery surface with snow are stated as follows:</p> <p><i>1. Introduction</i></p> <p><i>In winter season several operational difficulties, such as takeoff and landing performance deterioration due to contaminated runways and airframe icing problems, occur. As for taxiing on slippery surface, the loss of ground maneuverability likely increases the difficulty to maintain the intended track. Evaluation of ground maneuverability on slippery surface were conducted using flight simulator. Based on the evaluations some recommendations about ground maneuvering on slippery surface are presented in the followings.</i></p> <p><i>2. Recommendations About Ground Maneuvering On Slippery Surface</i></p> <p><i>1. Make turn in slow speed</i></p> <p><i>Directional controllability on the slippery surface depends on taxi speed very largely. In the simulator evaluations the intended tracking were not achieved by nose gear steering under the speed higher than about 3 kt. When taxing on slippery surface taxi speed should not be high even for straight courses (it should be about 10 kt or less) and should be reduced early enough to attain a desirable low speed before commencing turn.</i></p> <p><i>2. Apply differential braking appropriately</i></p> <p><i>Even when Directional Control by Nose Gear Steering is difficult, Differential Brake may be effective, therefore Differential Brake shall be used, as necessary.</i></p> <p><i>3. Differential thrust should not be recommended</i></p> <p><i>The use of differential thrust to assist turn on slippery surface likely cause an over control due to the slow response of engine thrust to power lever inputs. Therefore, the use of differential thrust is not recommended. Furthermore, in the case of changing engine power it should conducted carefully and slowly not to make thrust differences among engines.</i></p> <p><i>Ground maneuverability is deteriorated not only by surface slipperiness but also by wind conditions and surface slopes, etc. In the case that these hazardous conditions are combined, careful operations are</i></p>
