AIRCRAFT ACCIDENT INVESTIGATION REPORT

PASSENGER INJURY AND AIRCRAFT DAMAGE

PRIVATELY OWNED AÉROSPATIAL AS350B (ROTORCRAFT), JA6050

June 7, 2024

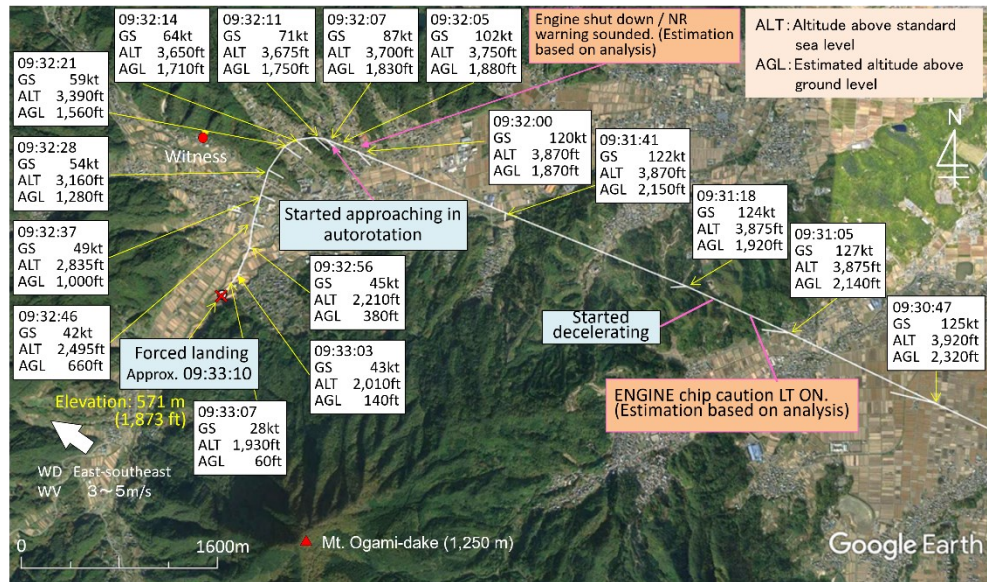
**Figure 3: Estimated Flight Route of the Helicopter
Immediately before the Forced Landing**

The accident occurred on a farm road 28 km northeast (36°21'47"N, 138°07'13"E) of Matsumoto Airport at about 09:33:10, March 23, 2021.

gradually and increased temporarily, but as shown in Figure 2, at about 09:33:06, a flare maneuver was assumed to be performed with nose-up. On the bank of the farm road, there were touchdown marks of landing gears (skids) and on the ground surface short of the touchdown point, contact marks with the tail skids, and the landing gears were broken to the backward side, therefore, the helicopter probably touched down as keeping moving slightly forward after the flare maneuver. Besides, based on the Passenger's statement that making the forced landing was something like falling freely from the height of the third floor of a building and the captain's statement that the collective pitch lever had reached to the highest position at a height of about 2 to 3 m immediately before the touchdown, the helicopter highly probable touched down on the bank of the farm road at a nearly vertical descent angle while increasing the rate of descent. Furthermore, there were contact marks with the main rotor blade on the surface of the farm road on the left side of the helicopter, and the rear seats were buckled forward left, therefore, it is probable that a load was temporarily applied that caused the aircraft to tilt to the left after the touchdown.

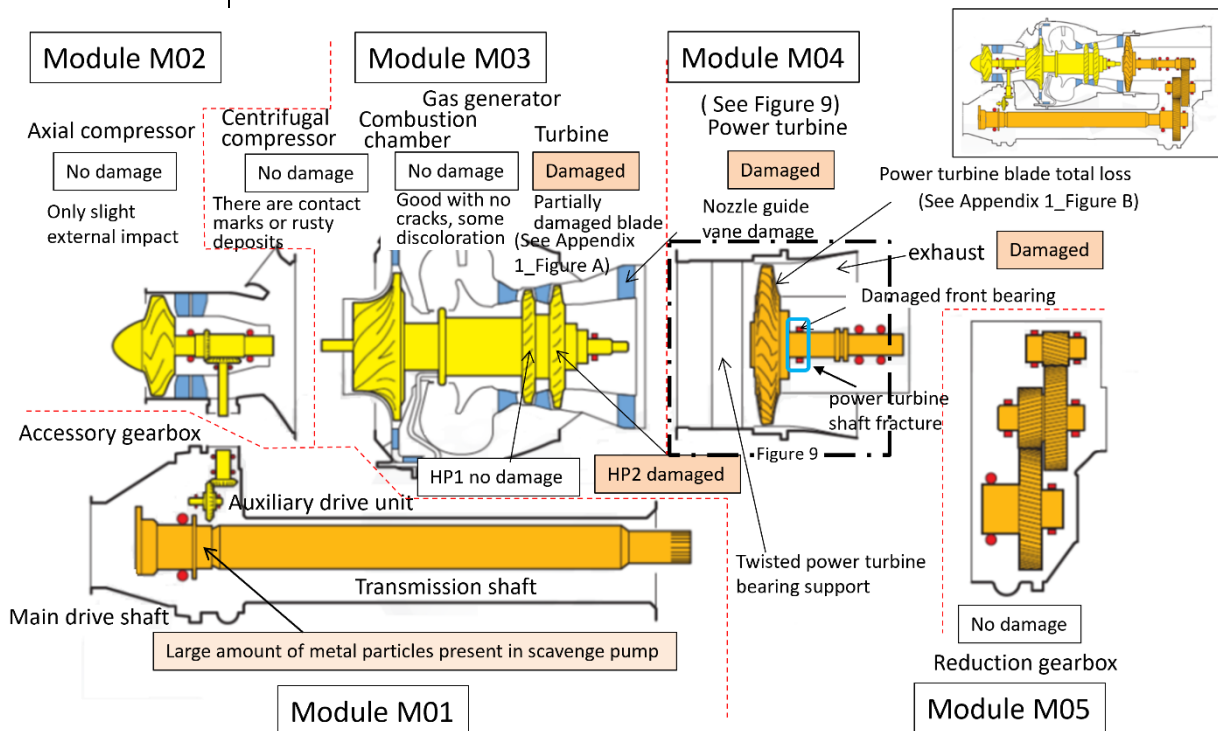
Figure 8: Engine Structure and Damaged Parts

<p>2.7 Teardown Investigation of the Engine and Maintenance Information</p>	<p>(1) Overview of Engine Damage</p> <p>In order to make a detailed examination for causes of the engine's power loss, the disassembly investigation of the engine was performed. Under the witness of an accredited representative of the French Republic, the investigations were performed in the facility of the design and manufacture company. The result was as follow:</p> <p>a. Gas Generator Section</p> <p>(a) There were the local thermal damages on the hollow shaft and the combustion chamber shroud.</p> <p>(b) Some of the HP2 turbine blades were damaged, and some were ruptured in the middle or near four-fifths of the trailing edges of the blades. In the rupture, no fatigue rupture nor sign of overtemperature were observed. (See Appendix 1 Figure A)</p> <p>b. Power Turbine Section</p> <p>(a) There were signs that the power turbine disk went in contact with the power turbine nozzle guide vane while it was rotating, and the power turbine bearing support twisted and damaged. All power turbine blades were missing and part of power turbine disk interslots were</p>

missing. (See Appendix 1_Figure B)

- (b) The power turbine front bearing rollers (5 mm diameter x 5 mm length) were found deformed: their diameter decreased by 1mm, and their length increased by 0,1 to 0.2 mm. And the front bearing inner race was melted and disappeared, a micrographic and EDS*⁶ analysis showed trace of the aggregation of metal materials (inner race, roller bearing, bearing cage, and power turbine shaft) within the outer race. (See Appendix 1_Figure C)

- (c) The forward part of the power turbine shaft was melted and fractured. In addition, the surface of the ruptured rearward part discoloration, and the hardness inspection and metallurgical analysis confirmed it had reached to a high temperature of 1,300 °C or more. (See Figure 9 and Appendix 1_Figure D)

- (d) The spline nut on the power turbine shaft was found in forward position by 2mm than nominal position, but the traces of glue residuals were noticed in the thread of the spline nut and on the shaft itself.

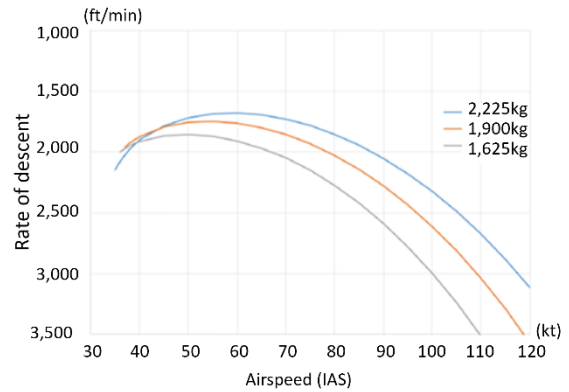
Figure 10: Rate of Descent and Collective Pitch Angle in Autorotation

When autorotation was performed, the rate of descent changes depending on airspeed and aircraft weight. According to the simulation of the design and manufacture company, as shown in Figure 10, at 65 kt airspeed, which is the reference value specified in the emergency procedures, if the rotor rpm (NR) is maintained at 400 rpm, the rate of descent will be about 1,800 ft/min. The difference by weight is such that heavier the weight, the lower the rate of descent, but the collective pitch lever position will be slightly higher. If the airspeed is reduced below 40 kt, the heavier the weight, the higher the rate of

Regarding the operations in autorotation, it is possible that due to the heavy weight, and the airspeed during approach was less than 65 kt, thus the rate of descent increased, as shown in Figure 10. In addition, it is probable that the touchdown maneuver became difficult to perform because it decelerated against the targeted road.
