AI2007-3

AIRCRAFT SERIOUS INCIDENT INVESTIGATION REPORT

BELL 206L-3, JA6114

TWO EMERGENCY LANDINGS DUE TO ENGINE STOPPAGE,
IN FLIGHT

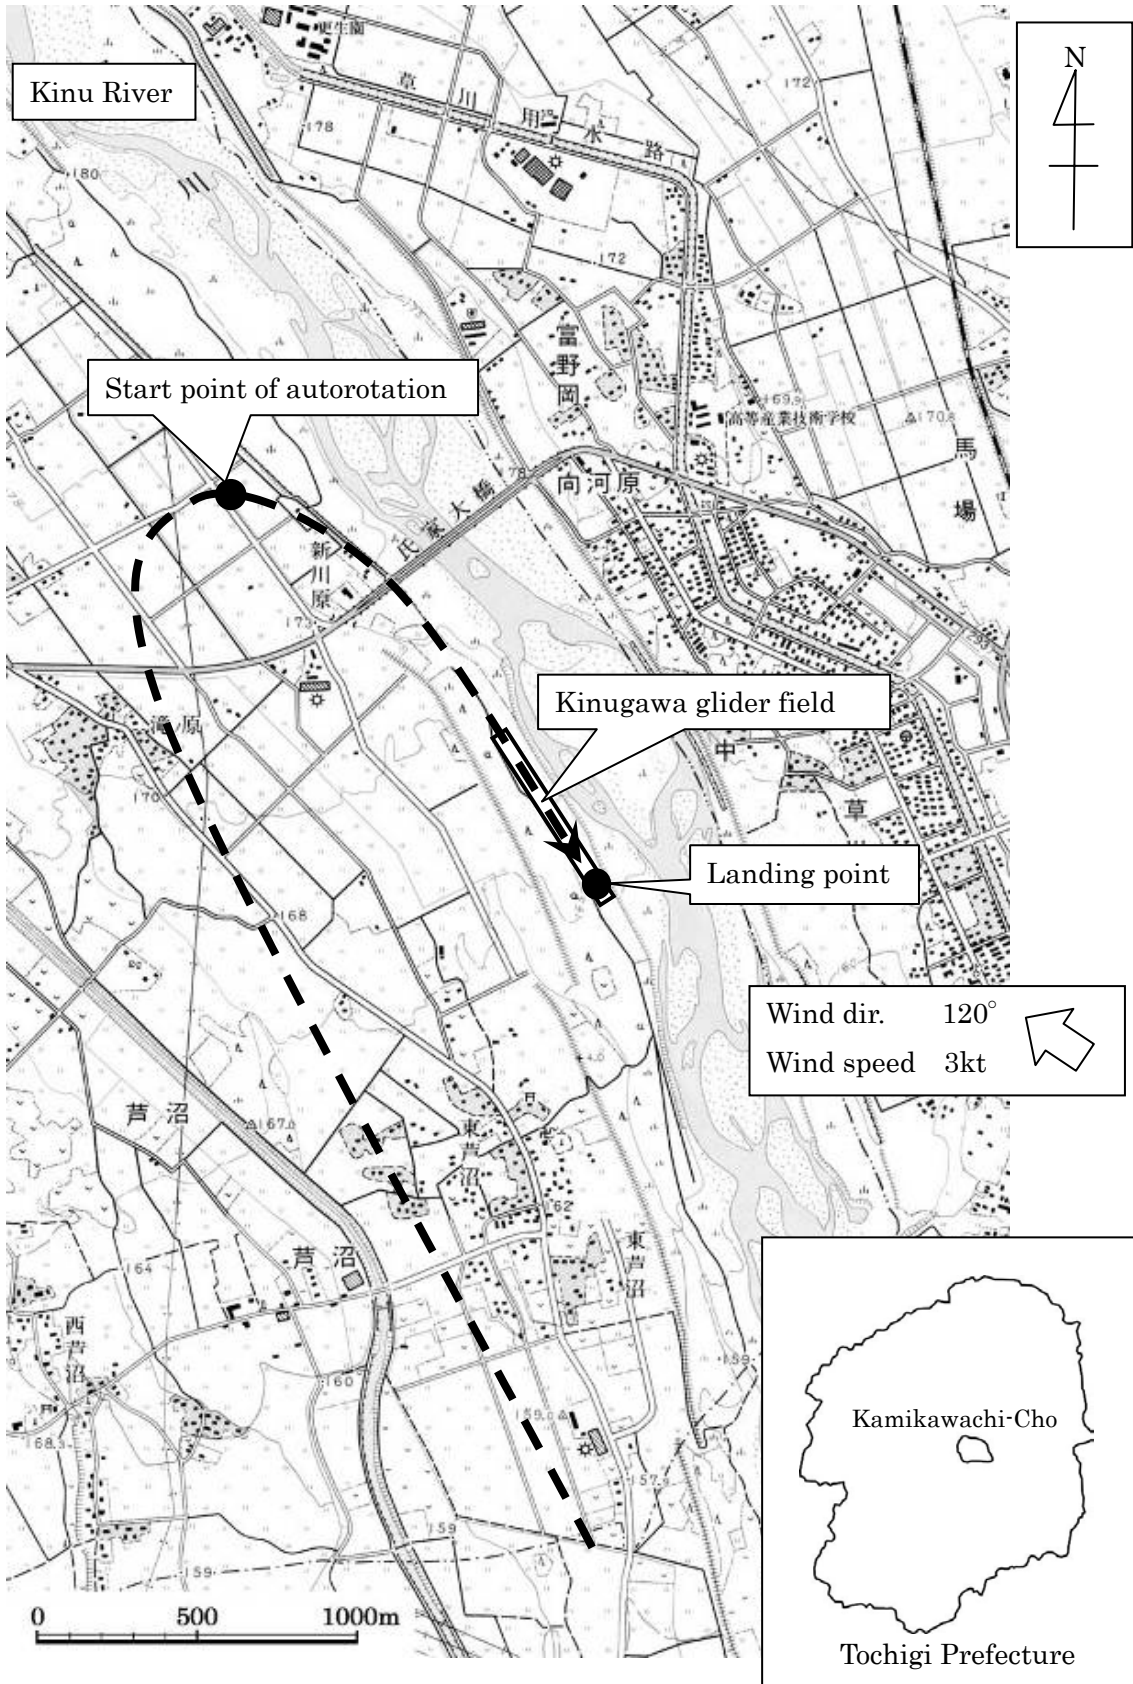
Figure 1 Estimated Flight Route (1)

The serious incident occurred about 1km northwest of Kinugawa field at an altitude of around 2,800ft at about 11:09.
(See Figure 1 and Photograph 1)
