AIRCRAFT ACCIDENT INVESTIGATION REPORT

AKAGI HELICOPTER COMPANY LIMITED.
AEROSPATIALE SA315B ALOUETTE III (ROTORCRAFT), JA6119
MISUGI VILLAGE, ICHISHI DISTRICT
(TSU CITY FROM JANUARY 2, 2006),
MIE PREFECTURE, JAPAN
AT ABOUT 15:50 JST, OCTOBER 18, 2005

Aircraft and Railway Accidents Investigation Commission
Ministry of Land, Infrastructure and Transport

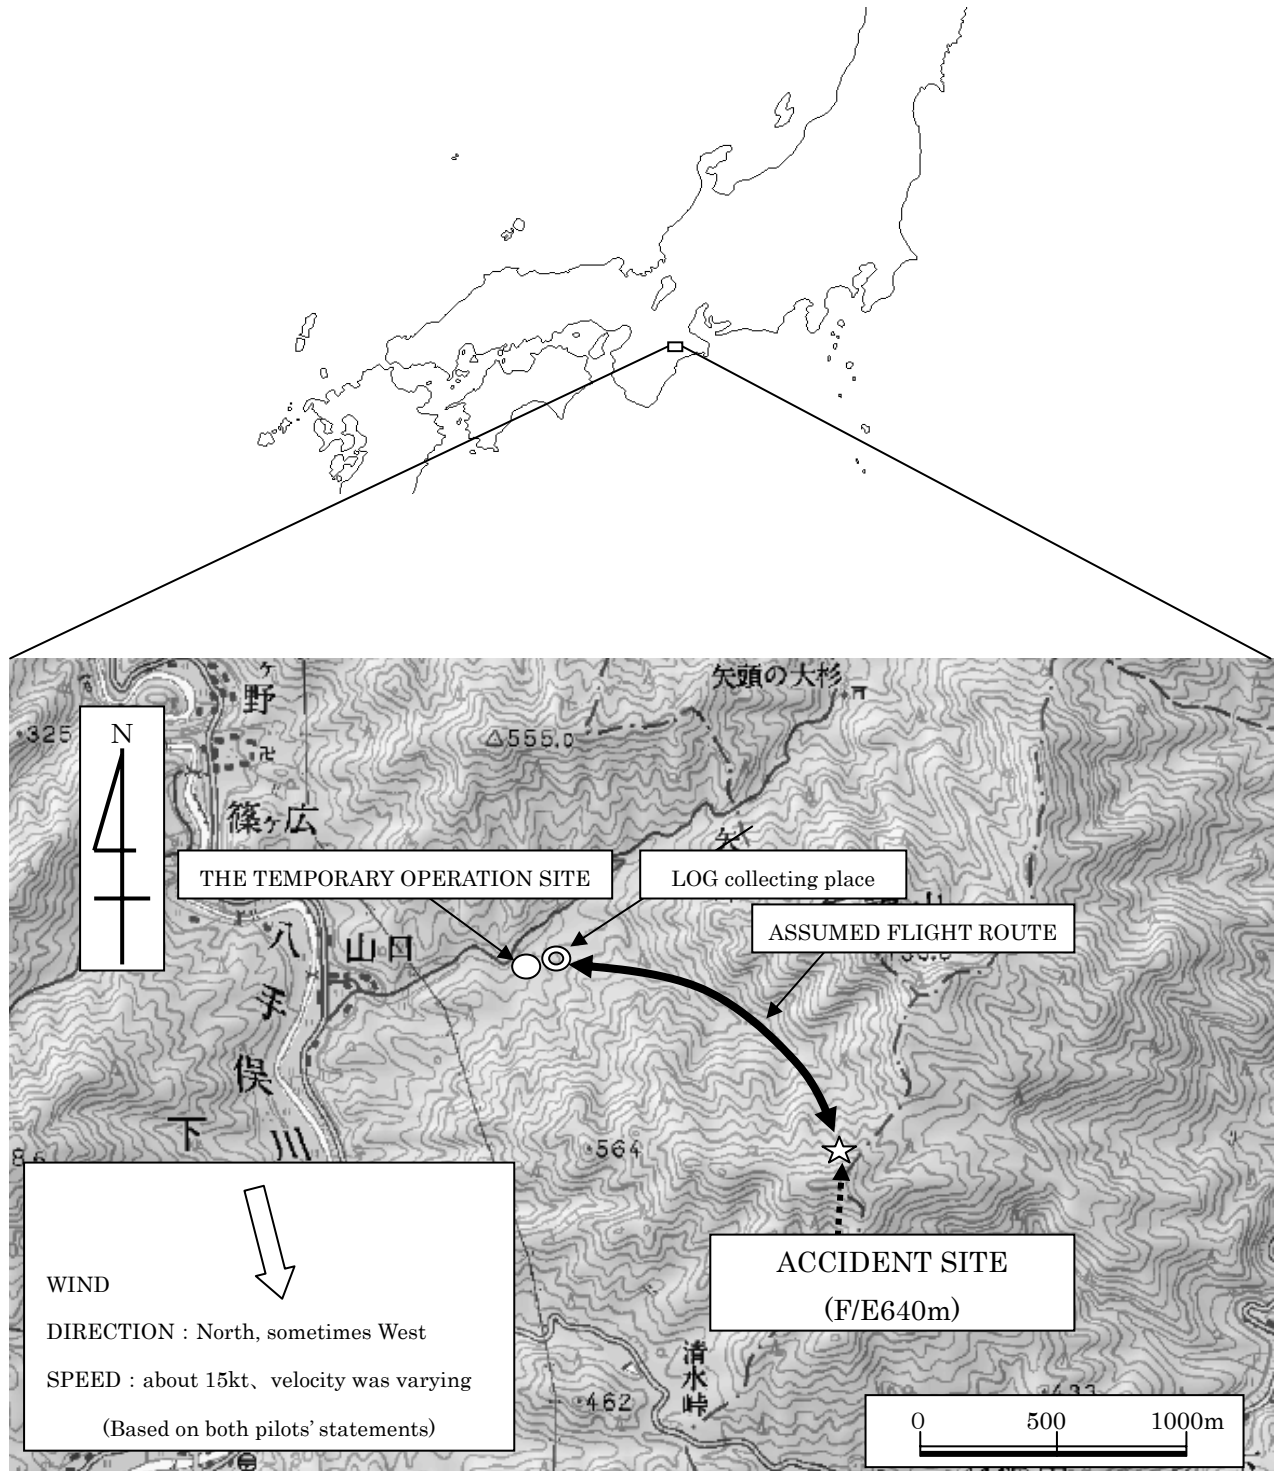
Figure 1 ASSUMED FLIGHT ROUTE

The accident occurred about half-way up the northern slope of Mount Yagashira in Misugi Village, Ichishi District, Mie Prefecture, at around 15:50.
(See Figures 1 and 3.)
