**AIRCRAFT ACCIDENT
INVESTIGATION REPORT**

JAPAN AIRLINES INTERNATIONAL Co., Ltd.

J A 6 1 1 J

BOEING 767-300

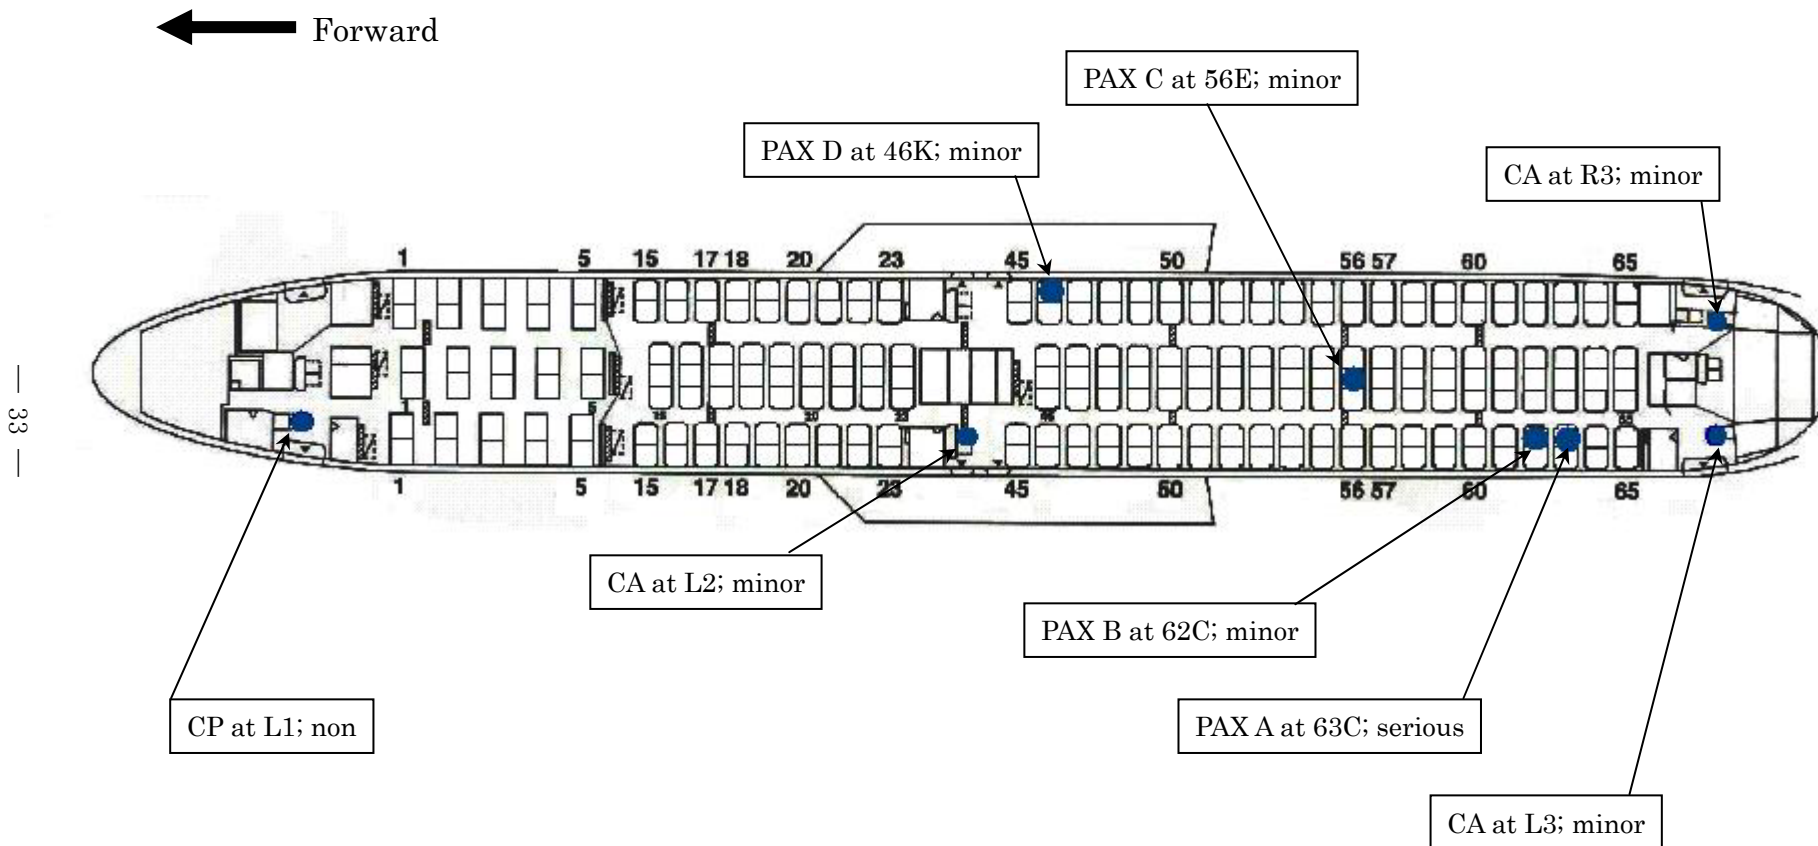
Figure 13 Injured Passengers and CAs' Position on Occurrence

The six people (three of whom were CAs) who suffered minor injuries wore seatbelts; however, it is estimated that they were injured in their neck (cervical vertebra) or waist (lumber vertebra) because these regions are prone to be affected by the turbulence of the aircraft, as described in 3.4. In particular, as the CAs in charge of L3 and R3 were blocked from having a good view of the cabin from their seats, it is considered that they had difficulty trying to maintain a stable posture against the turbulence while also trying to ascertain the condition of the passengers.
