AIRCRAFT SERIOUS INCIDENT INVESTIGATION REPORT

AN ATTEMPTED OF LANDING ON A RUNWAY BEING USED BY OTHER AIRCRAFT KAGOSHIMA AIRPORT

AT AROUND 11:25 JST, JUNE 2, 2022

August 2, 2024

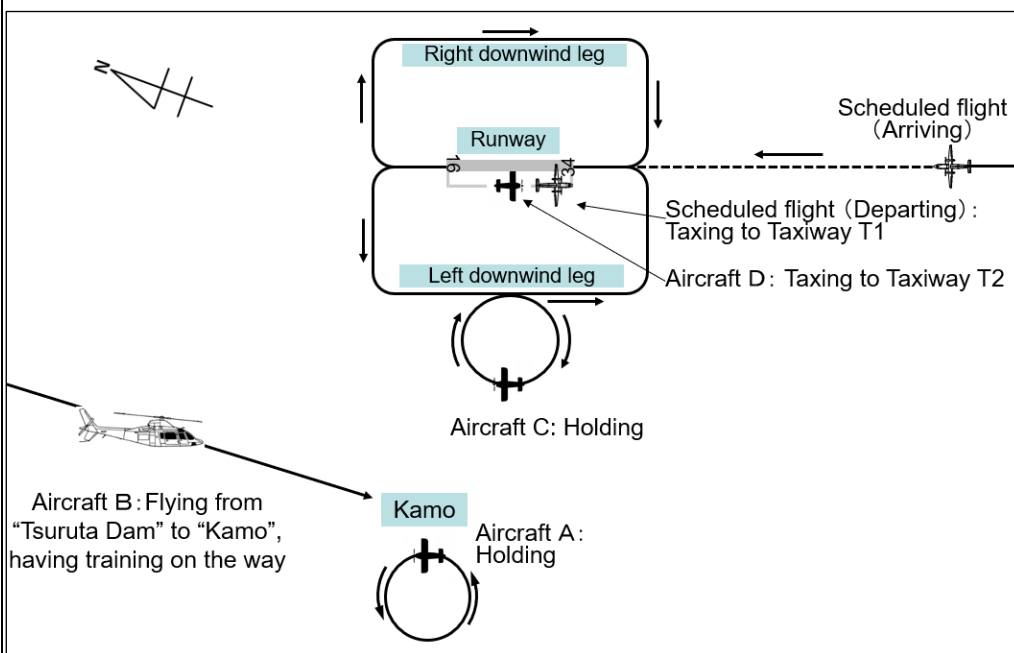
Figure 4: Position of Aircraft Flying around the Airport at about 10:58

At about 10:58, the Tower took over the radio communication of Aircraft A which had been holding at “Kamo” from the TCA. As the Tower had the training aircraft (hereinafter referred to as “Aircraft C”) wait on the left downwind leg, thus instructed Aircraft A to continue to hold at “Kamo”.
