**AIRCRAFT SERIOUS INCIDENT  
INVESTIGATION REPORT**

**PEACH AVIATION CO., LTD.**

**AIRBUS A320-214, JA802P**

**EMERGENCY OPERATION TO AVOID CRASH INTO WATER SURFACE**

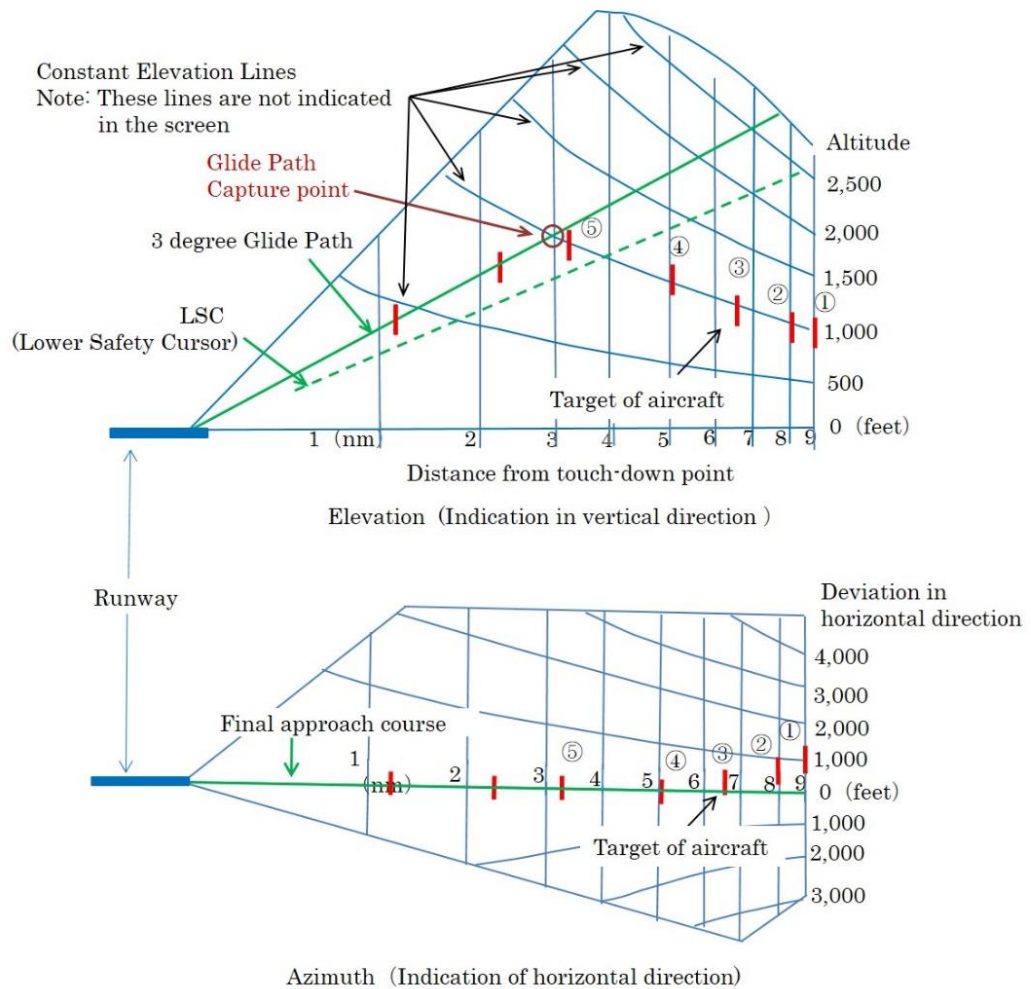
**Figure 14 Summarized drawing of PAR Screen Display**

As shown in **Photo 2-1**, the line indicating upper limit of the Radar Safety Zone and the line indicating the lower limit of the Radar Safety Zone in the front side of glide-path capture point are not displayed in the observed PAR Screen. The Constant Elevation Lines shown in **Figure 14** are not also displayed.

Since PAR Screen does not have a displaying function that issues Low Altitude Warning, Low Altitude Warning is not displayed or sounds in the Final Controller position. Please note that (2) to (5) in **Figure 14** are standard instructions as samples which a Final Controller issues.

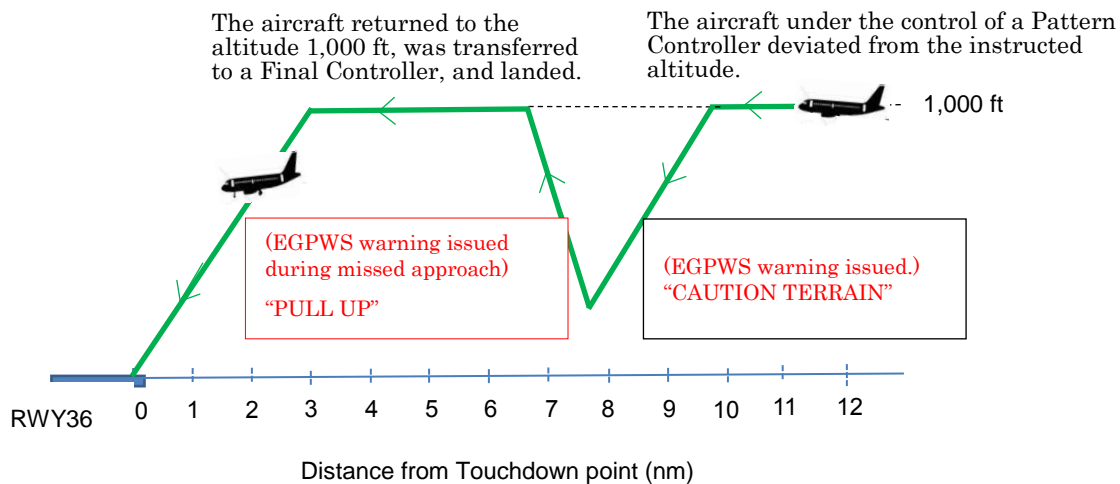
**Figure 17 Trajectory Image of the Similar Event Based on the information from the Operator.**

The aircraft under the control of a Pattern Controller maintained the instructed altitude of 1,000 ft with AP engaged; however, it began descent at the point of about 9 nm from the runway threshold. Subsequently, "CAUTION TERRAIN" of the EGPWS warnings was issued around the altitude of 400 ft, and then the flight crewmember who noticed it immediately executed a recovery operation to get altitude. "PULL UP" of the EGPWS warnings was issued during the recovery operation. While recovering, the Pattern Controller gave an instruction of maintaining the altitude of 1,000 ft. After returning to 1,000 ft, the aircraft continued PAR approach and landed at the Airport. The recorded lowest altitude was 327 ft according to the operator.

According to Civil Aviation Bureau, Ministry of Land, Infrastructure, Transport and Tourism, (hereinafter referred to as "CAB") the MSAW system was set up to inhibit LA at the position of the Pattern Controller at that time. However, since Naha Tower at that time noticed the LA warning with aural warning and notified it to the Pattern controller; consequently, the Pattern Controller instructed the aircraft to maintain the assigned altitude. (see **Figure 17**)

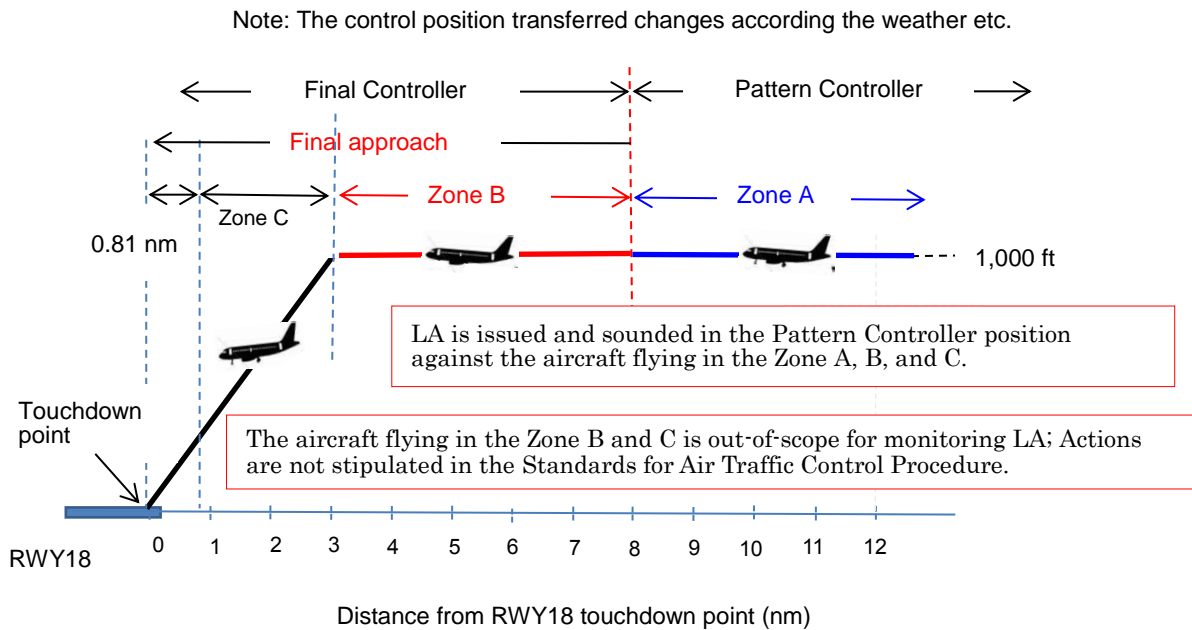
**Figure 18 Image of Zone Classification for Issuing and Monitoring of LA**

In **Figure 18**, an aircraft in Zone A shows is under the control of the Pattern Controller and aircraft in Zone B or C is under the control of the Final Controller. The aircraft in Zone A, B and C are all displayed in the ARTS Screen in the Pattern Controller position. If the aircraft descends or is predicted to descend lower than the configured altitude within the designated area, an LA will be issued and aural warnings will sound.

According to the revised Standards for Air Traffic Control Procedure, an aircraft in Zone A is an object to be monitored and the procedures when an LA is issued are stipulated in the Standards, on the other hand, because an aircraft in Zone B or C is out-of-scope for monitoring LA, any actions to be taken is not stipulated in it.

As described in 2.22.2, according to the Civil Aviation Bureau, an LA is not issued to an aircraft in Zone C under the control of the final controller as shown in Figure 18, Section 2.22.2, and it is difficult to stipulate procedures to be taken when an LA is issued to an aircraft in Zone B. From these, it is probable that Standards for Air Traffic Control Procedures did not stipulate procedures to be taken by the final controller when an LA is issued to the aircraft under his or her control.

Meanwhile, the instruction of "MAINTAIN ONE THOUSAND," which was given to the Aircraft by the Final Trainee at the serious incident, is a phraseology to be also used when aircraft actually maintains an altitude of 1,000 ft. A pilot flying in Zone B in Figure 18, Section 2.22.2 assumes that an aircraft is maintaining an altitude of 1,000 ft. He or she might interpret the phraseology of "MAINTAIN ONE THOUSAND" as an instruction to maintain the current altitude of 1,000 ft. Therefore, it is probable that the instruction was not appropriate when the Controller tried to give an immediate warning about deviation of altitude to the pilot of aircraft descending.

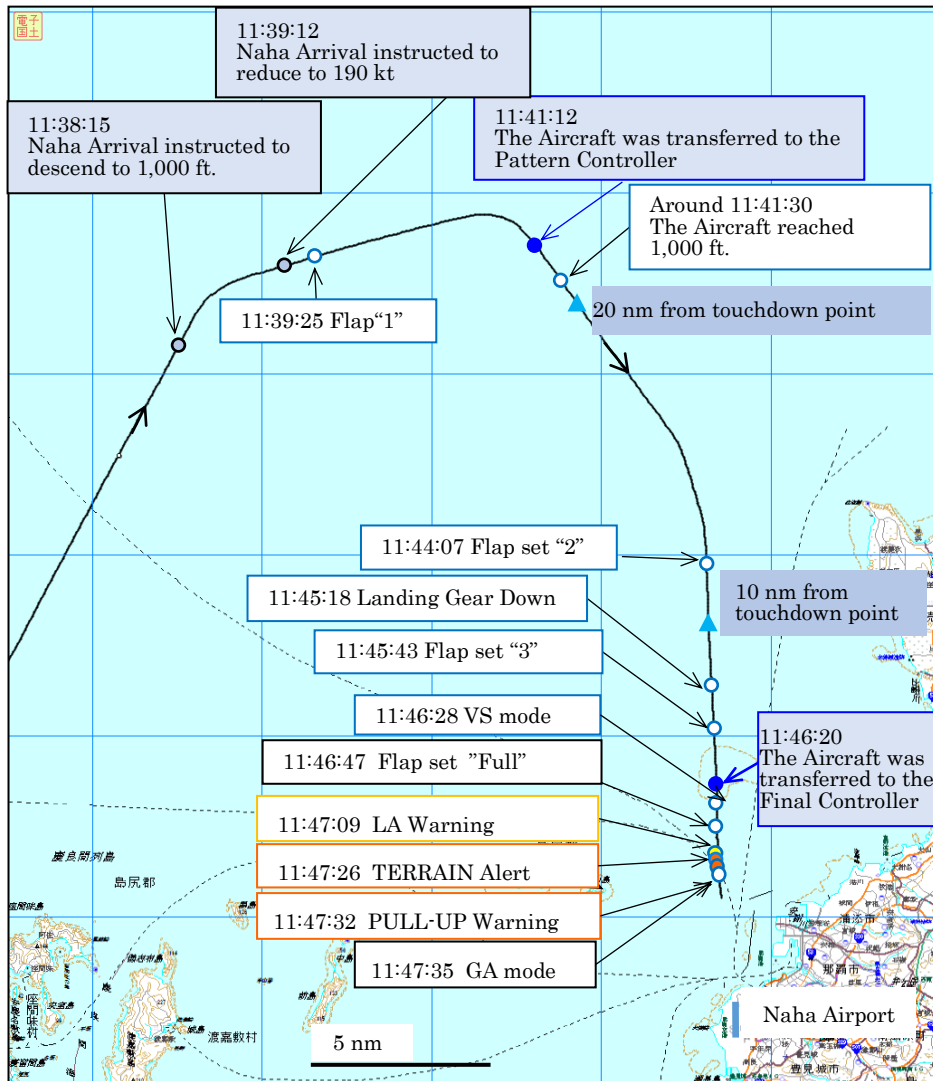
Appended Figure 1 Estimated Flight Route

As described in 2.1.1 and as shown in **Appended Figure 1** "Estimated Flight Route," the Aircraft was transferred from Naha Arrival to the Pattern Controller at Naha Ground Controlled Approach Facility at 11:41:12 and reached a pressure altitude of 1,000 ft around 20 nm north of the Airport at about 11:41:30. Accordingly, it is probable that the Aircraft was maintaining the altitude and was provided radar-guidance to the final approach course.

It is probable that the Captain, who was following the standard procedures described in **Figure 2**, Section 2.9.2 and taking into consideration the distance from the runway, set the Aircraft for landing configuration and decelerated. Moreover, it is probable that, as shown in **Appended Figure 1**, the Aircraft extended the landing gears at the position of about 9 nm at 11:45:18, and the flaps were set to "3" at 11:45:43. In view of the fact that this series of the Captain's operations conformed to the rules of setting the aircraft for landing configuration and completing the Checklist before the time of beginning descent, it is probable that the Aircraft had been flying in accordance with the Captain's flight plan until this time.
