**AIRCRAFT SERIOUS INCIDENT
INVESTIGATION REPORT**

ALL NIPPON AIRWAYS CO., LTD.

J A 8 0 4 A

**EMERGENCY EVACUATION USING SLIDES
ALL NIPPON AIRWAYS CO., LTD.
BOEING 787-8, JA804A
TAKAMATSU AIRPORT
AT 08:49 JST, JANUARY 16, 2013**

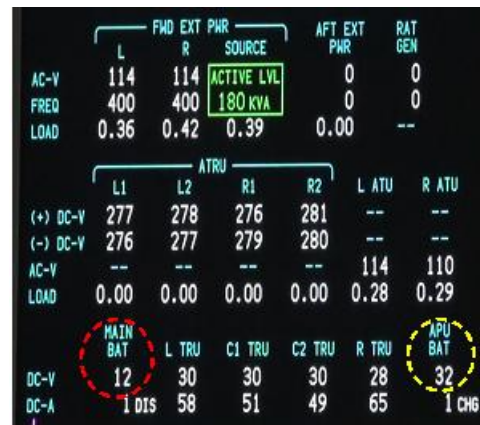
Fig. 2.11.1-2: APU Battery Sneak Voltage

In order to confirm this phenomenon on the airplane, the card was reinstalled and the main battery was removed. We confirmed the illumination of wingtip lights and fuselage end light, and the multi-function display (MFD) screen in the cockpit showed the main battery voltage of 12 V as shown in Fig. 2.11.1-2.

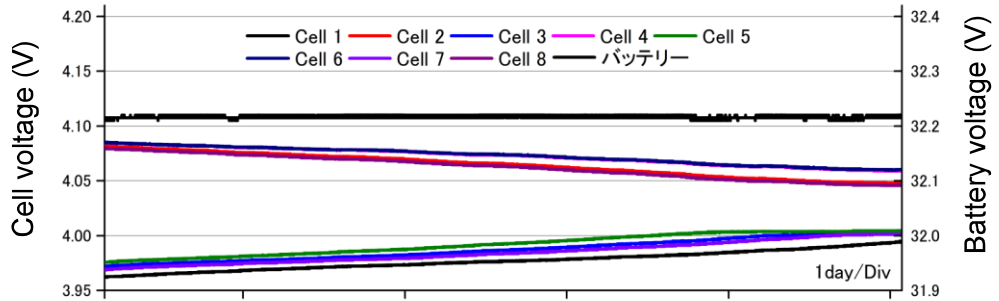
Fig. 2.11.3-1: Cell Balancing Test

In order to confirm cell balancing function, the removed main battery BCU from the airplane was connected to a battery. Voltage of cells 1, 3, 5 and 7 was lowered to test the function. The voltage curves showed that the voltage of each cell converged within the range of 4.00 V-4.07 V as shown in Fig. 2.11.3-1.

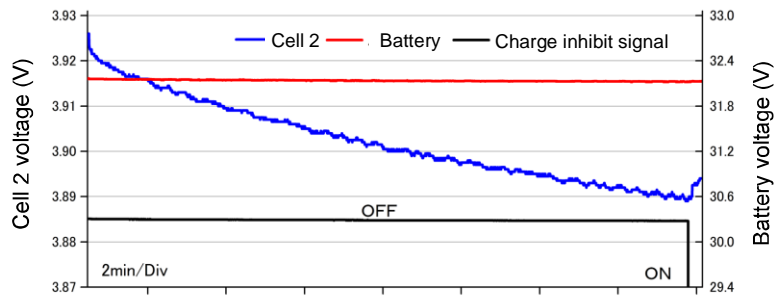
Fig. 2.11.3-3: Detection of Cell Voltage Imbalance

In order to confirm the cell voltage imbalance detection function, we connected a resistor to cell 2 and discharged the battery and waited for the function to activate. Fig. 2.11.3-3 shows that when the cell 2 voltage went below 3.89 V, charging inhibit signal became activated.

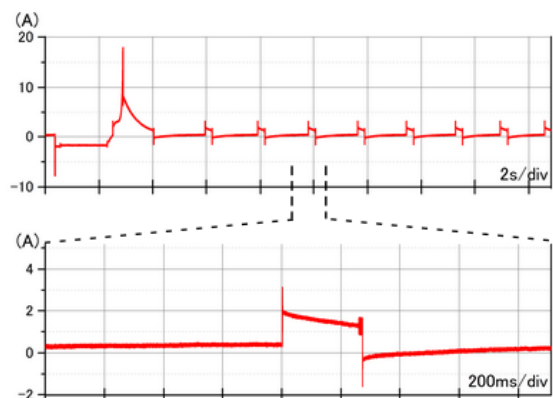
Fig. 2.11.6.1-1: Fluctuation of Charging Current

In the test simulating an input voltage interruption into the BCU (load 0 A, power interruption 20 msec), small current oscillation was observed in charging currents of both main battery BCU and APU battery BCU. (See Fig. 2.11.6.1-1)

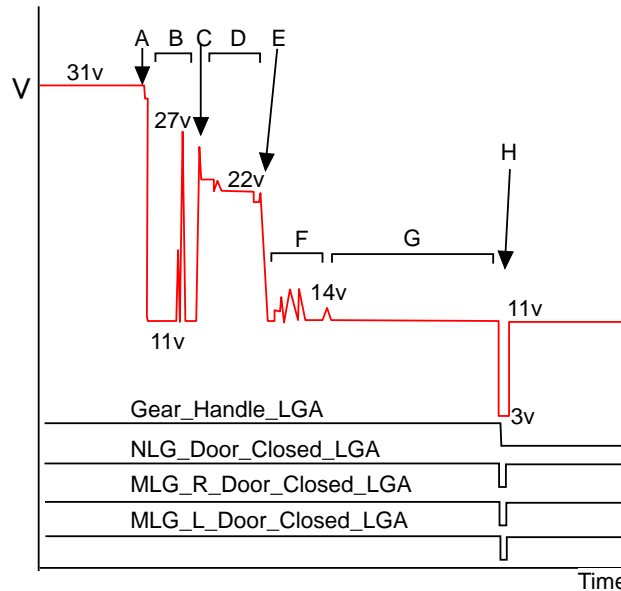
Fig. 2.11.6.7: Battery Voltage Fluctuation, Takamatsu Event

Judging from cell deformation, initiator cell is either cell 3 or cell 6. Cell 3 arced from its negative current collector through case (the corner of S1 and S4) to brace bar. Arcing requires melted plastic fixation frame. For this to happen, another cell should have vented before cell 3, and cell 6 was the first cell to vent.

Cell 6 vented and battery voltage dropped from 31 V to 29 V then suddenly dropped to 11 V (Battery output voltage is approximately 1 V higher than the voltage recorded on the FDR. The difference is due to the voltage drop across the BDM between the battery and the location of FDR voltage sensor.) Event G explains why 11 V was recorded. The actual battery voltage is less than 11 V, possibly 0 V as the contactor was very likely open.

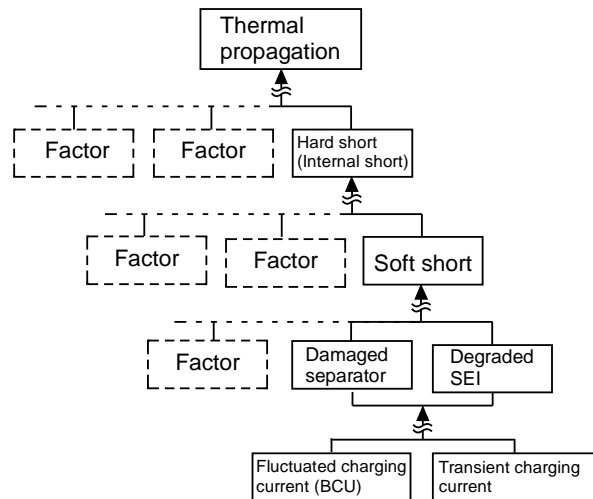
Fig. 2.11.6.8: Cause-Effect Diagram (partial)

leads to “degraded SEI” and/or “separator damage.” And as Fig 2.11.6.8 illustrates with other contributing factors, “Soft short”, to “Hard short (internal short)” occurs

resulting in a thermal propagation. But the cause and effect diagram did not include the effects of cold temperatures.

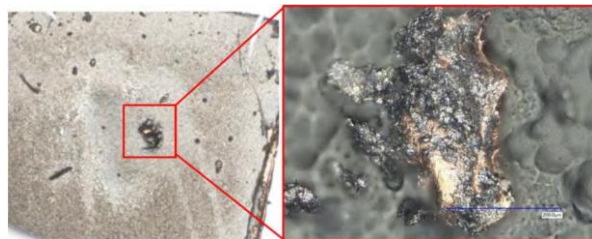
Fig. 2.11.6.9-2: Copper Particle Discovered on Separator

The copper current collector had a small copper piece penetrating through some layers of the separator. This feature was likely introduced during cell manufacturing and did not have an immediate effect on cell characteristics or performance. Over time, this feature could have penetrated additional layers of separators and created an internal short.

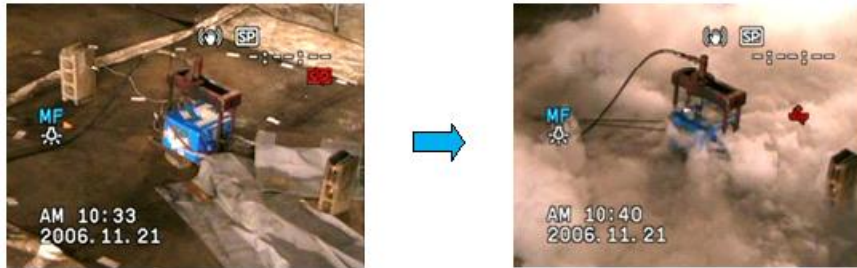
Fig. 2.12.7.1: Observed Smoke

In 2006, with consultations with Thales and Boeing, GYT conducted one of several battery nail penetration tests to assess the impact of an internal short circuit. The test configuration was: nail penetration to cell 2, without connecting wire to the BCU for charging/discharging, and without battery box ground wire, under non-controlled ambient temperature. The penetrated cell vented with smoke without generating smoke. No other cells vented.

This test was a part of engineering tests and the test result was presented to the FAA at a briefing when Boeing was finalizing the LIB technical requirements. As a result, the internal short circuit test was not included in the TC engineering test.

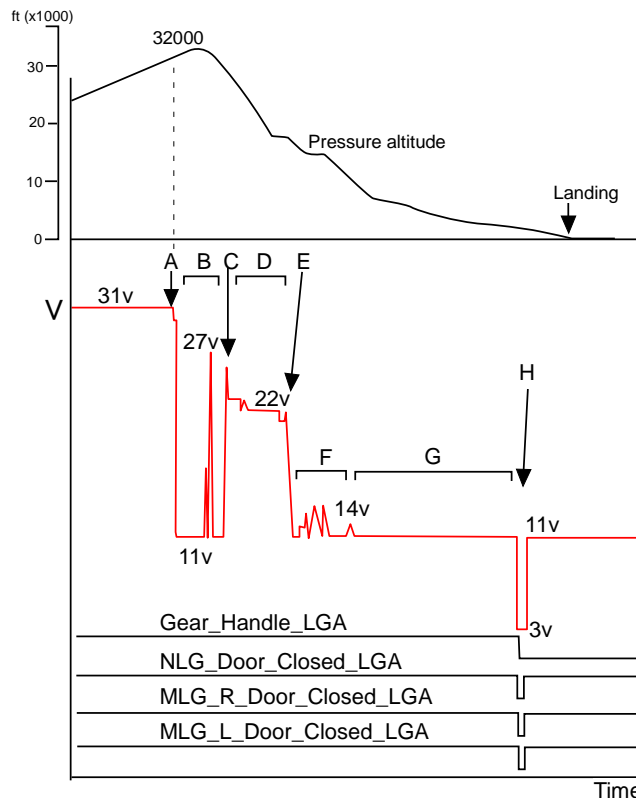
Fig. 3.8.3-1: Battery Voltage Fluctuation during Takamatsu Event

The FDR battery voltage fluctuation depicted in Figure 3 illustrates that the voltage dropped from 29 V to 14 V in 2 sec, followed by another drop to 11 V in 2 sec. The actual main battery voltage at the time when FDR recorded main battery voltage as 11 V was very likely less than 11 V as described in section 3.6. The possible causes for voltage drop are as follows:

Main battery voltage dropped from 31 V to 30 V. It is very likely that a cell experienced an internal short circuit (see section 3.10) which resulted in rapid cell heating and case swelling and subsequent venting during this drop. As described in section 3.8.1 b., cell 6 was the very likely cell as the initiator. Plastic insertions around cell 6 melted due to cell heat generation.

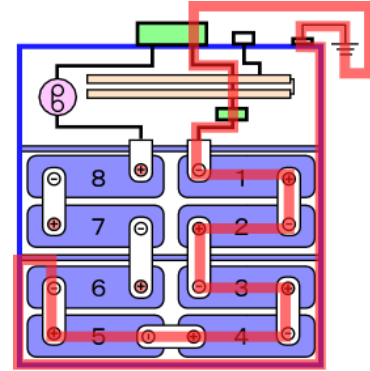
Fig. 3.8.3-2: Short Circuit Path

Recorded 26 V implies possibility of contactor closing and a short circuit of the second cell. The voltage drop to 23 V suggests the possibility of the venting of the second cell. Cell 5 was not vented as described in section 2.8.3 e and Kakuda testing demonstrated that the second venting cell was the cell located next to the S1 or S3 of the venting cell. In light of these facts, the second vented cell was probably cell 7.

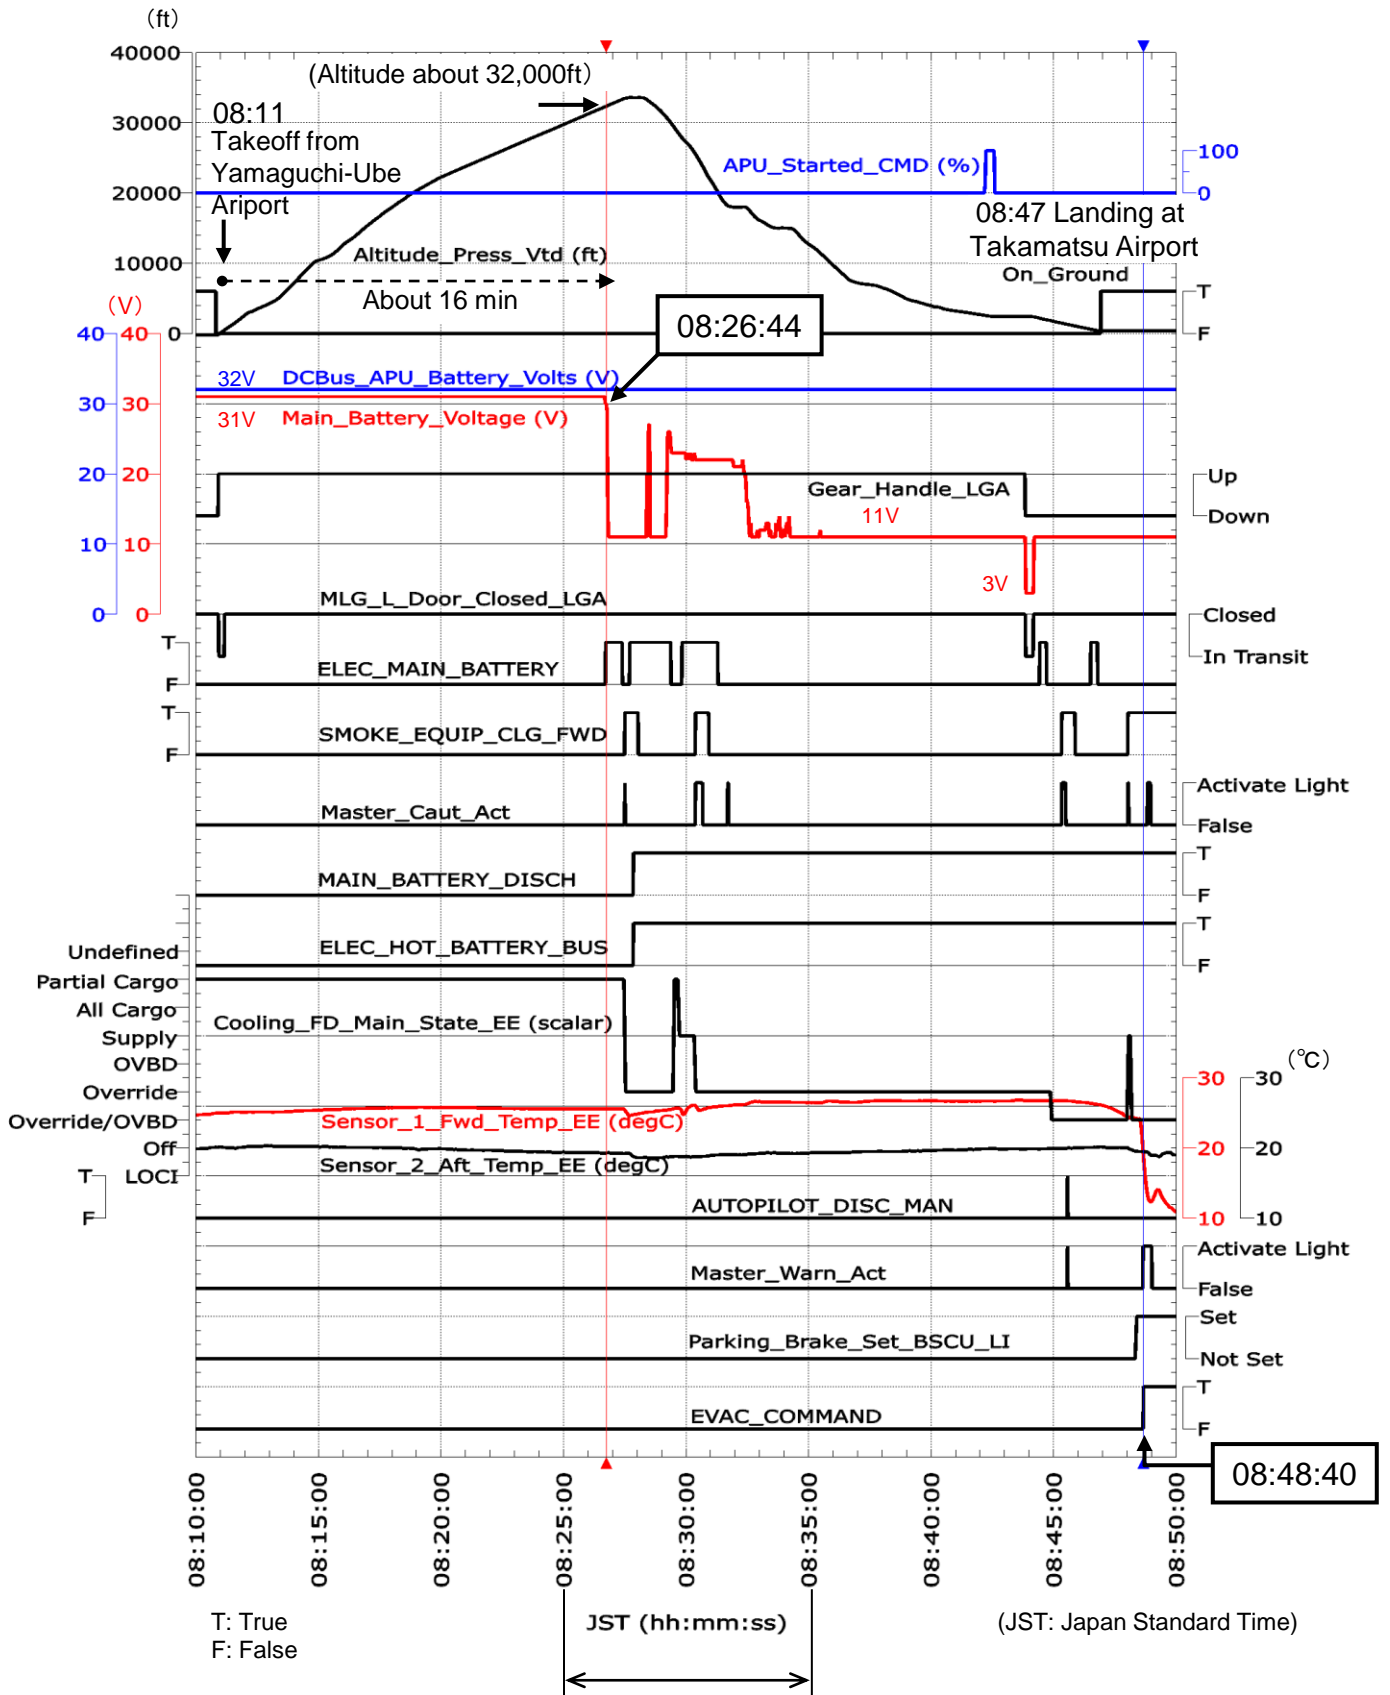
Figure 2: FDR Records

As shown in Figure 2: FDR records, the smoke ventilation system started to function after the main battery voltage dropped. It is highly probable that the system operated as designed. The smoke was extracted overboard through the override valve and forward outflow valve, but part of it was sucked in from the cabin air compression inlet, forwarded to the cockpit and cabin to be sensed.

Over-discharging accompanies voltage decrease; however, the FDR records in Figure 2 showed no main battery voltage decrease. This fact demonstrates the absence of over-discharging at battery level.

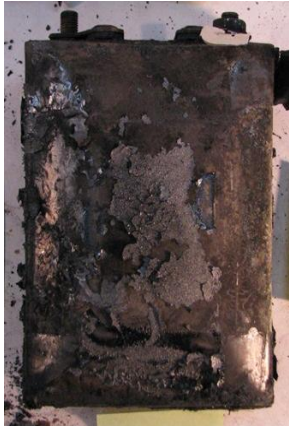
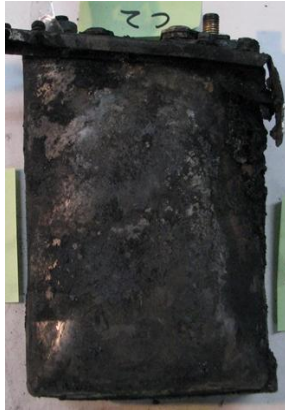
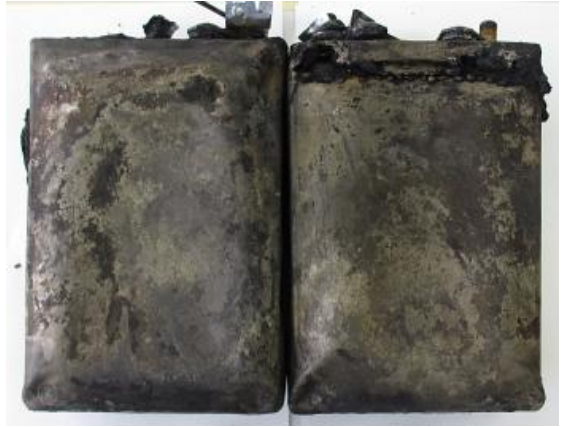
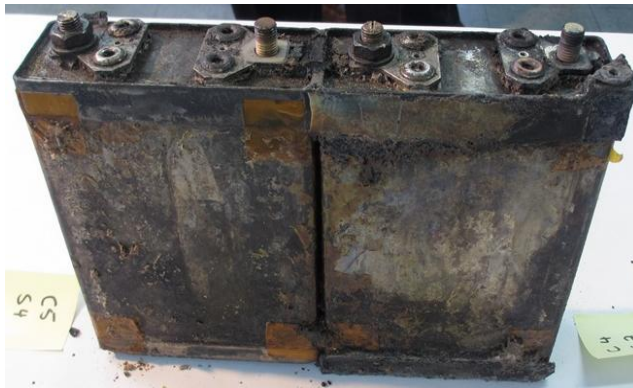
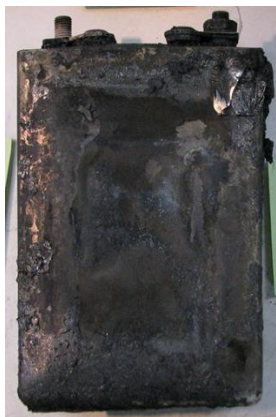
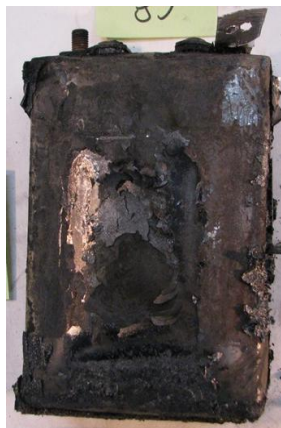
Figure 9: Damage of Each Cell

(See Figures 5 through 15 (page 77 through page 84) for the visual presentation of the damage.)

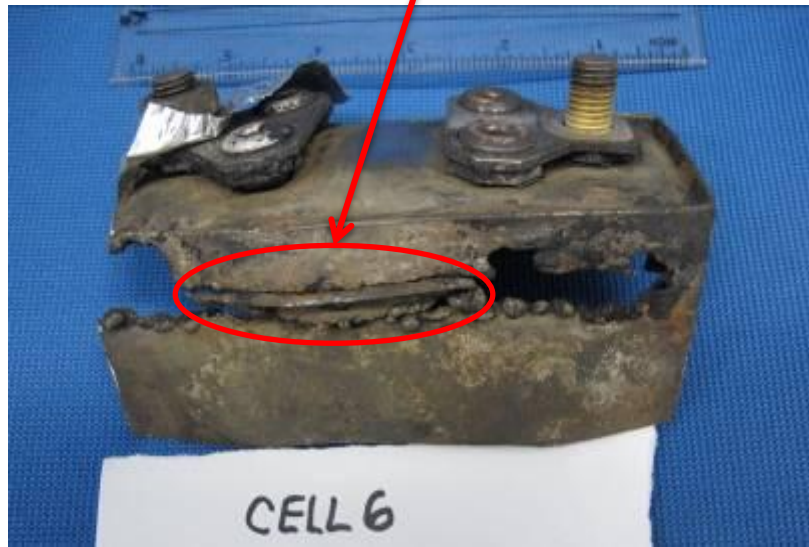
Part of this portion was welded to the cell case.

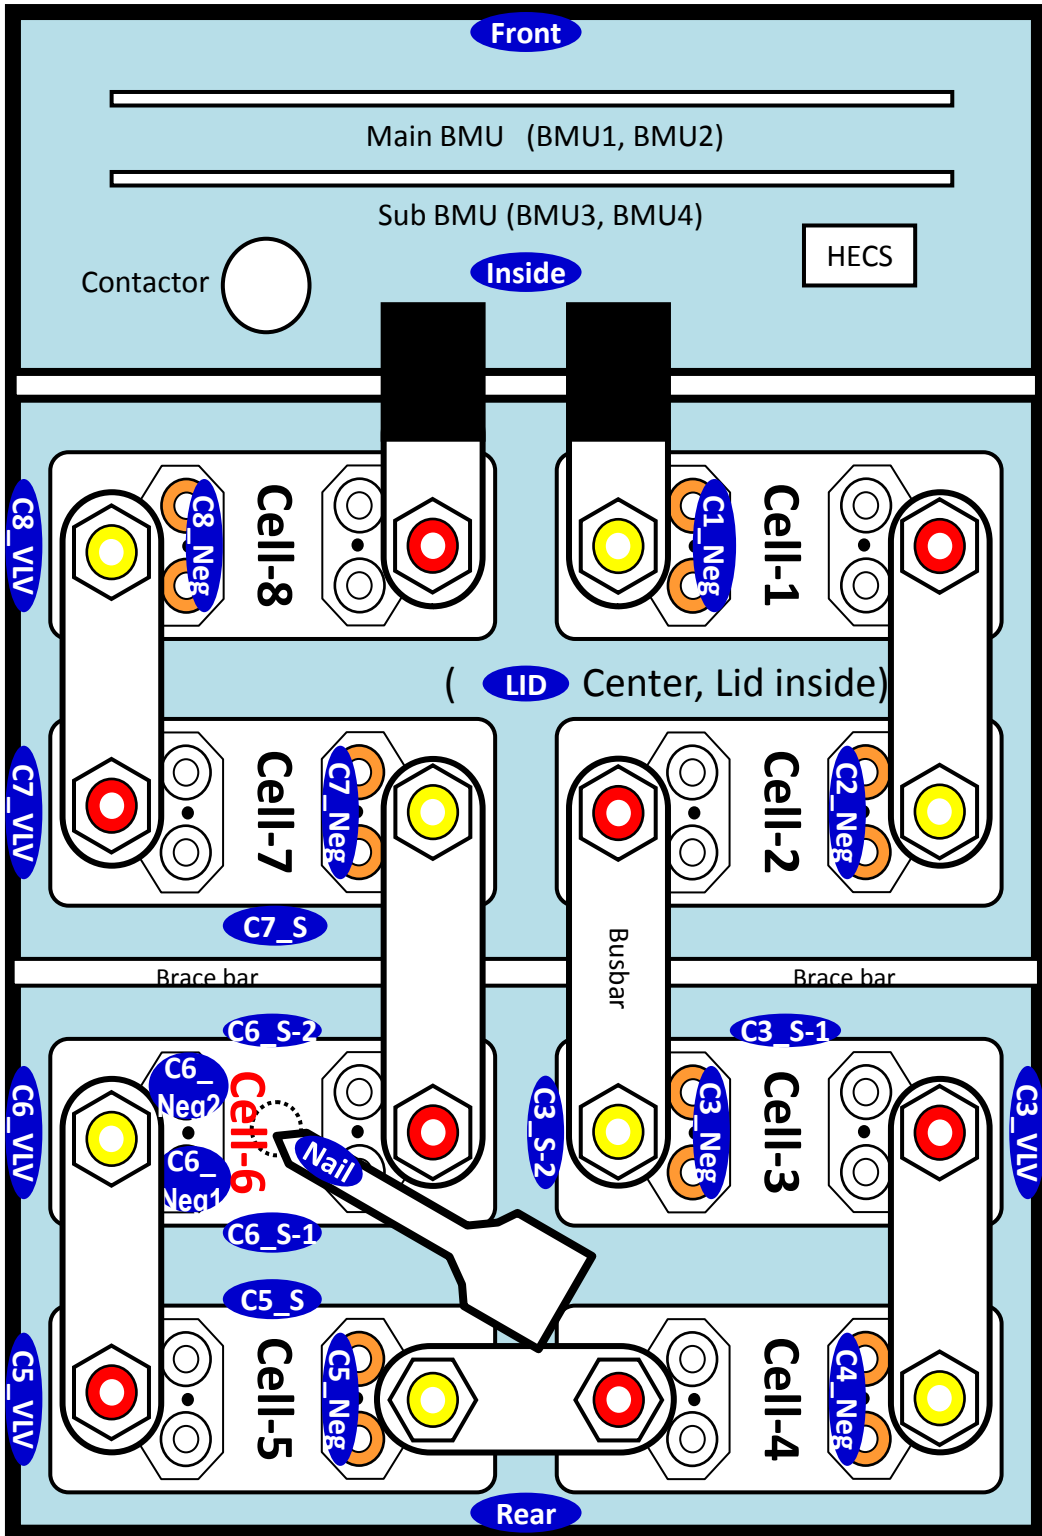
We performed battery testing at JAXA Kakuda Space Center (hereinafter referred to as “Kakuda Test”) in November, 2013 in order to observe heat propagation at full battery level. Three test configurations are shown in Table 2.11.5. The tests were videotaped and recorded using data loggers at 10 Hz interval. Recorded parameters are temperature, cell voltage, battery incoming voltage (between cell 1 negative terminal and cell 8 positive terminal), battery outgoing voltage (at J3 connector), ground wire currents (HECS output) and J1 signal. (See Figure 2: Thermo-Couple Location in Appendix 2)

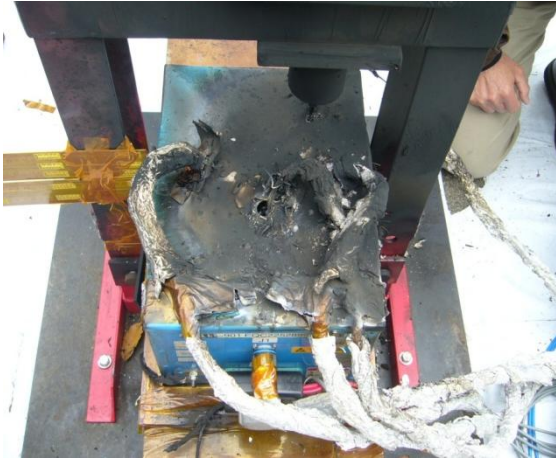
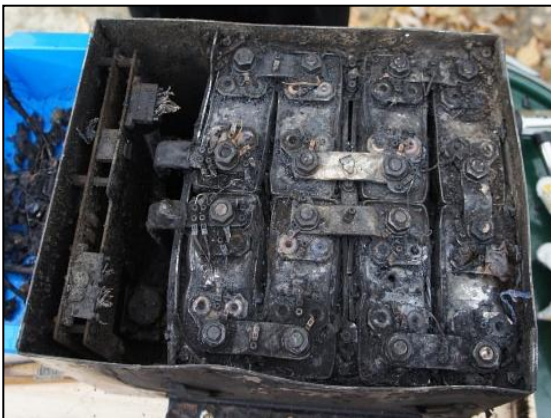
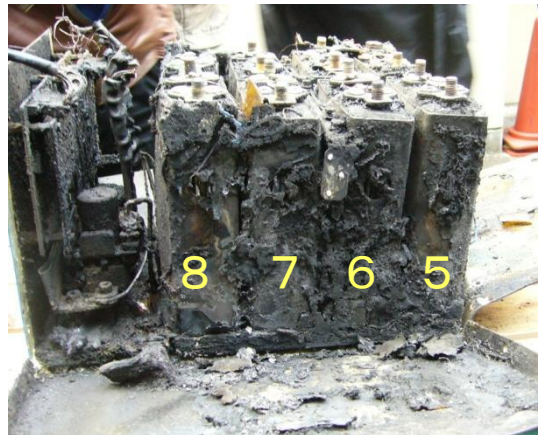
Figure 4: Post-test Conditions (Configuration 2)

Fused ground wire

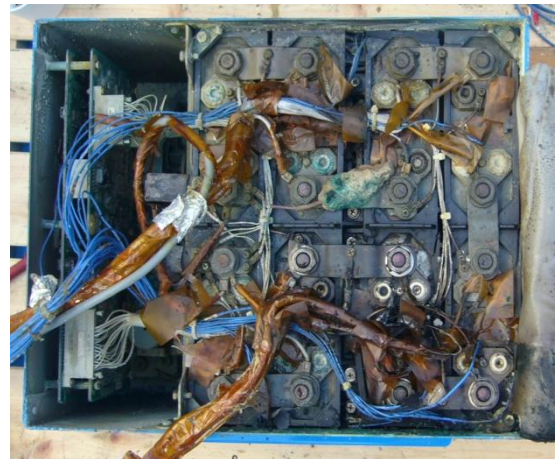
Figure 7: Damage to Current Collectors

Config. 2

Config. 3
