December 2, 1994

**Aircraft Accident  
Investigation Commission  
Ministry of Transport  
Japan**

AIRCRAFT ACCIDENT  
INVESTIGATION REPORT

All Nippon Airways  
Boeing 747-400, JA8096  
Tokyo International Airport  
May 2, 1993

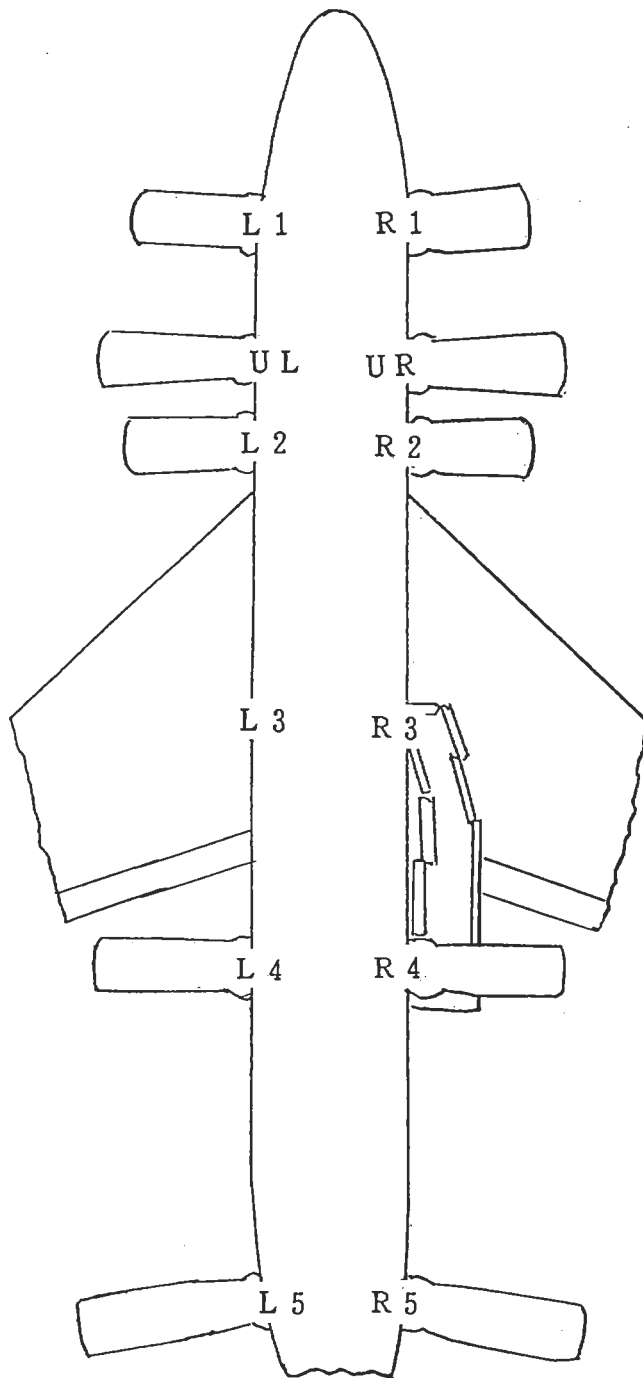
Fig.3 Emergency Exits and Escape Slides

The following are diagnosis of the injuries by the hospital and statements of the seriously injured on how they evacuated:  
(see attached Fig. 3)

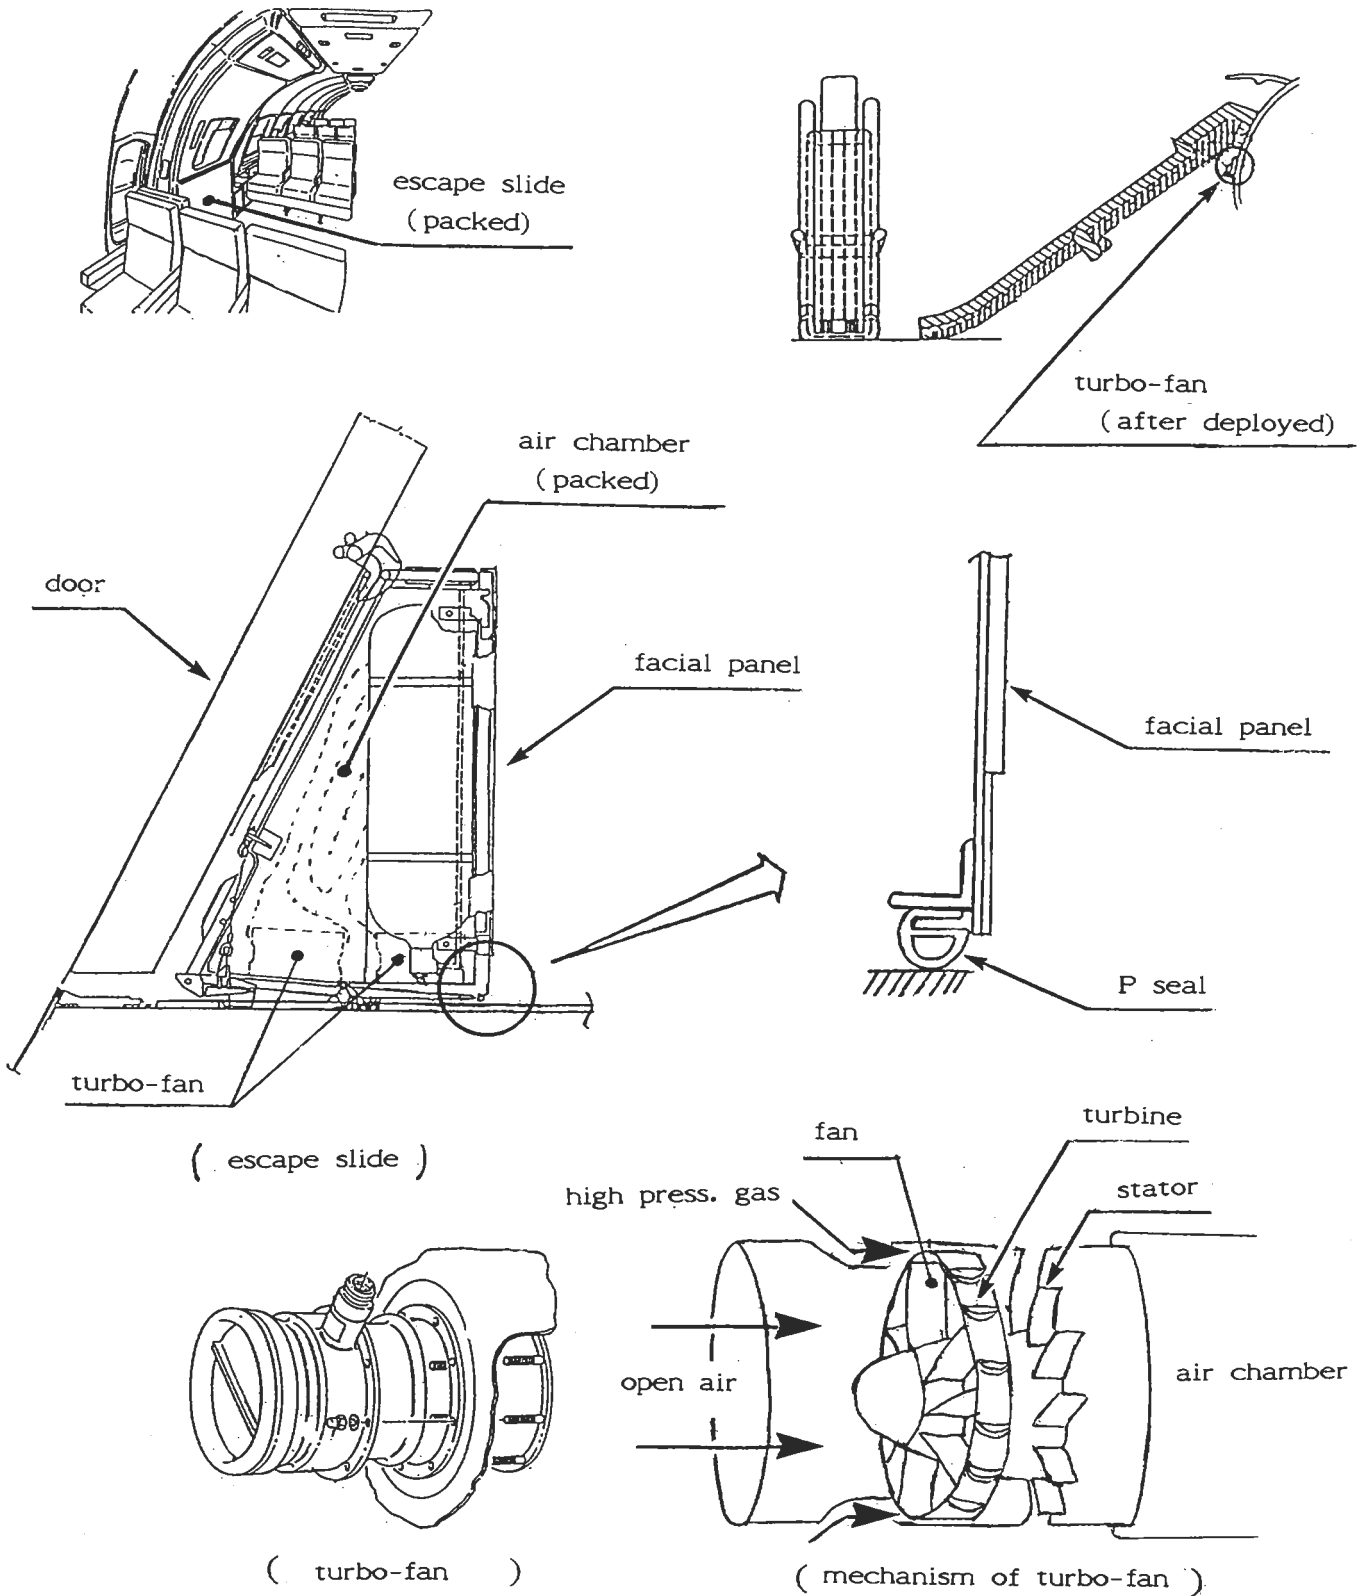
Fig.6 Upper-deck Escape Slide

The high-pressure gas is brought into the air chamber after rotating the turbine, and the fan is rotated by the rotation of the turbine, and the air chamber is inflated by the open air thus sucked in. The turbine and the fan rotate at 3,000 rpm (nominal). (see attached Fig.6)

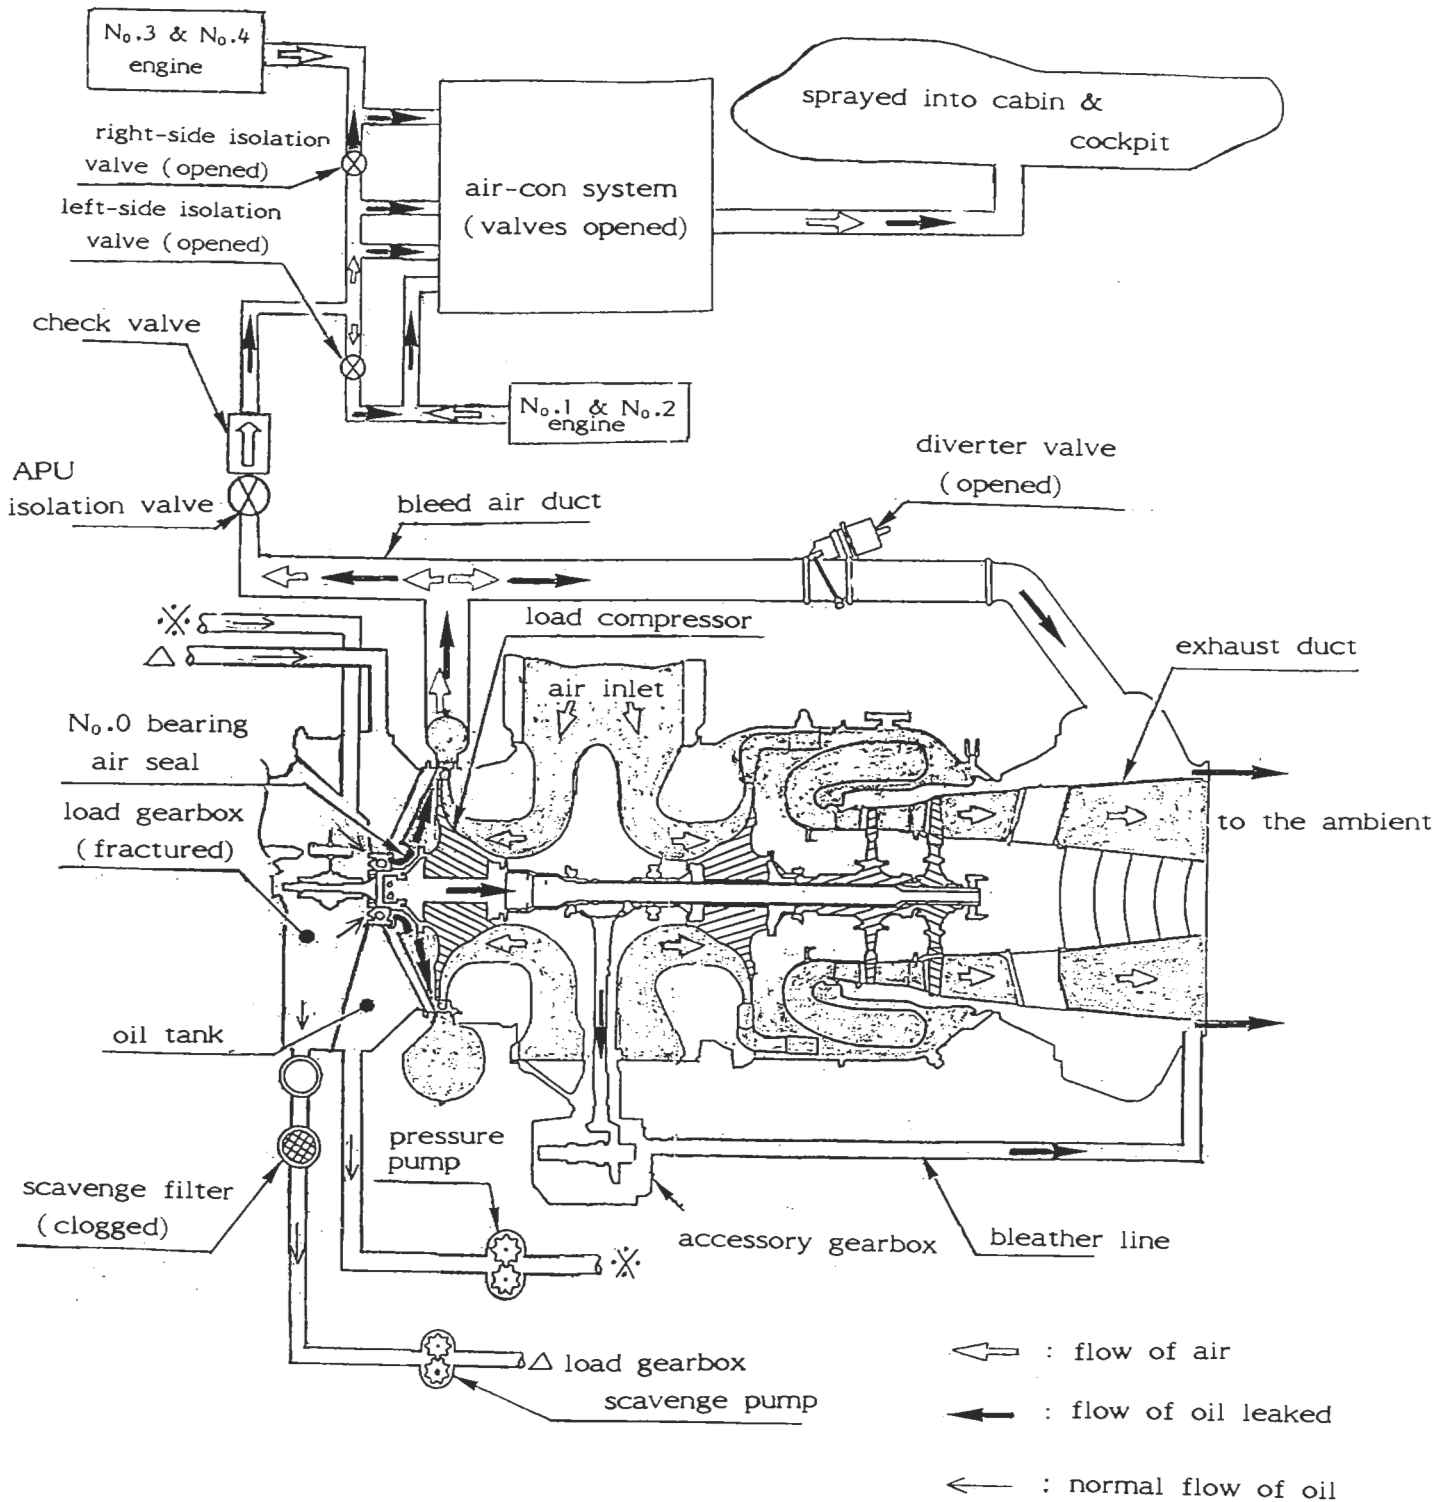
Fig.7 Estimated Route of Oil leaked from APU Oil System

(see attached Fig.7)

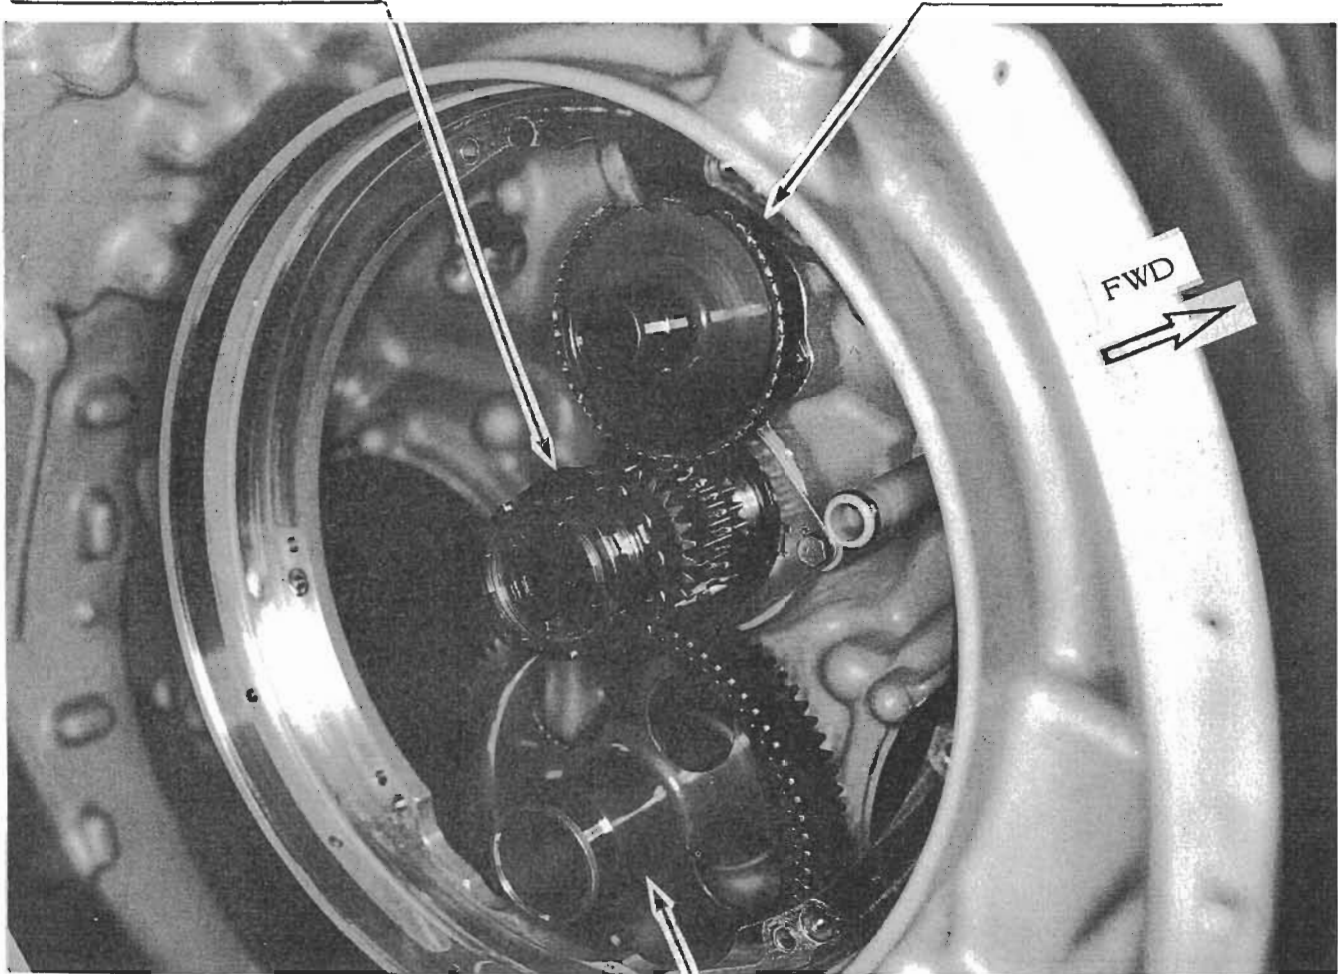
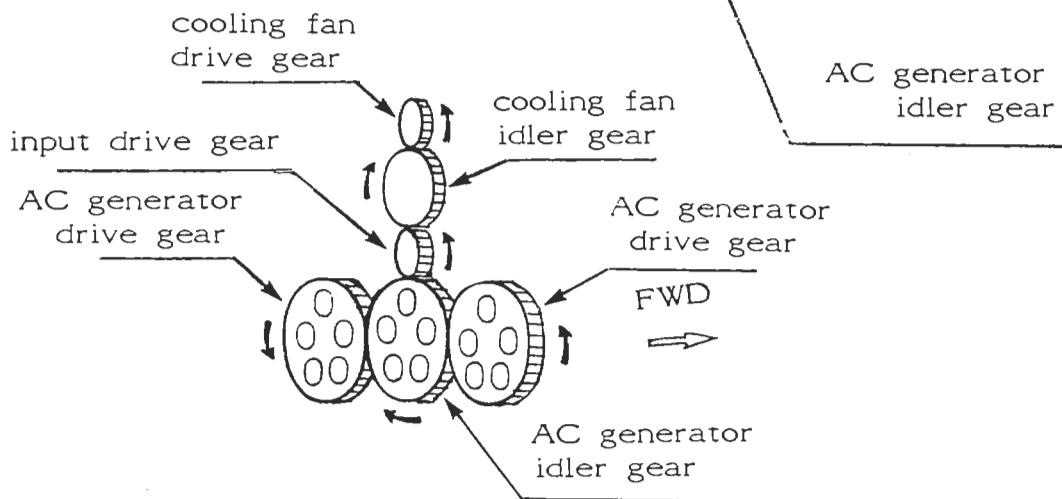
Photo. 3 APU Load Gearbox

(see Photo.3 through Photo.6)

input drive gear

cooling fan idler gear
